Delaware Aqueduct Leak Action Plan

Wawarsing Public Advisory Committee

November 19, 2010

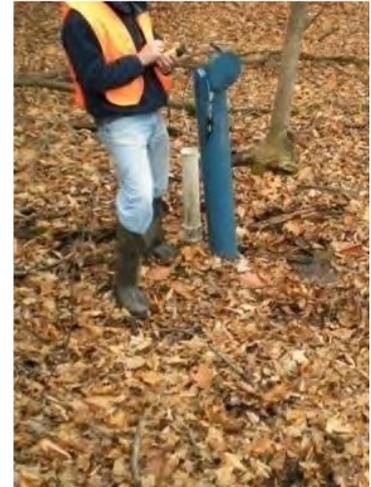
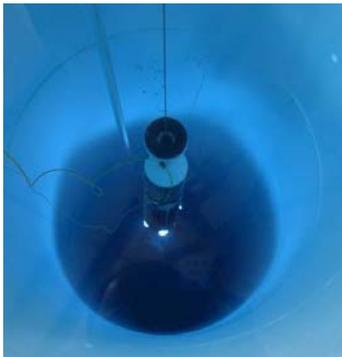
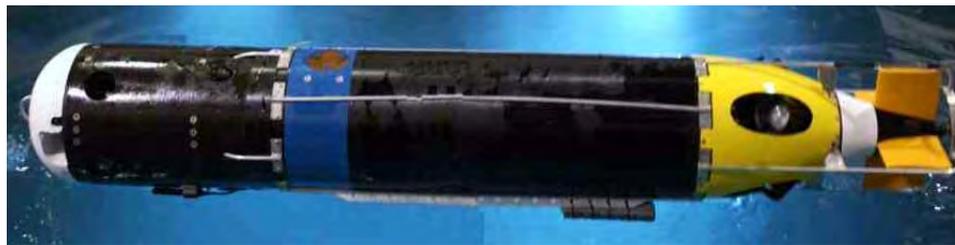
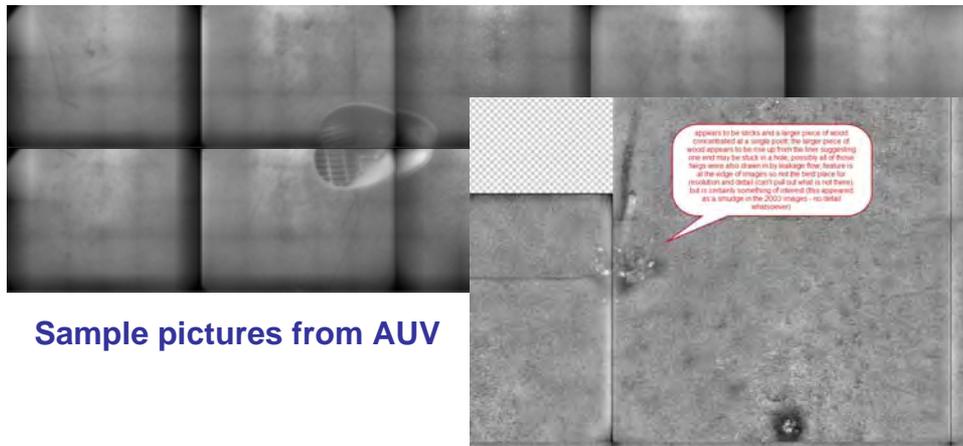
Sample pictures from AUV

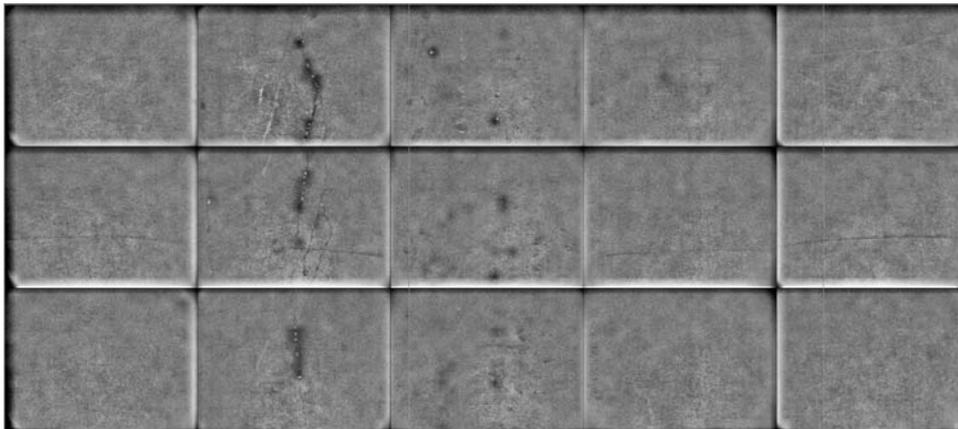
- ❖ 5,200 linear feet of cracking in Roseton; 485 linear feet of cracking in Wawarsing
- ❖ Cracking located in deepest segment of tunnel at EL -600
- ❖ Largest percentage of leakage as indicated in AUV investigations and backflow tests

Example of Cracking in Roseton area

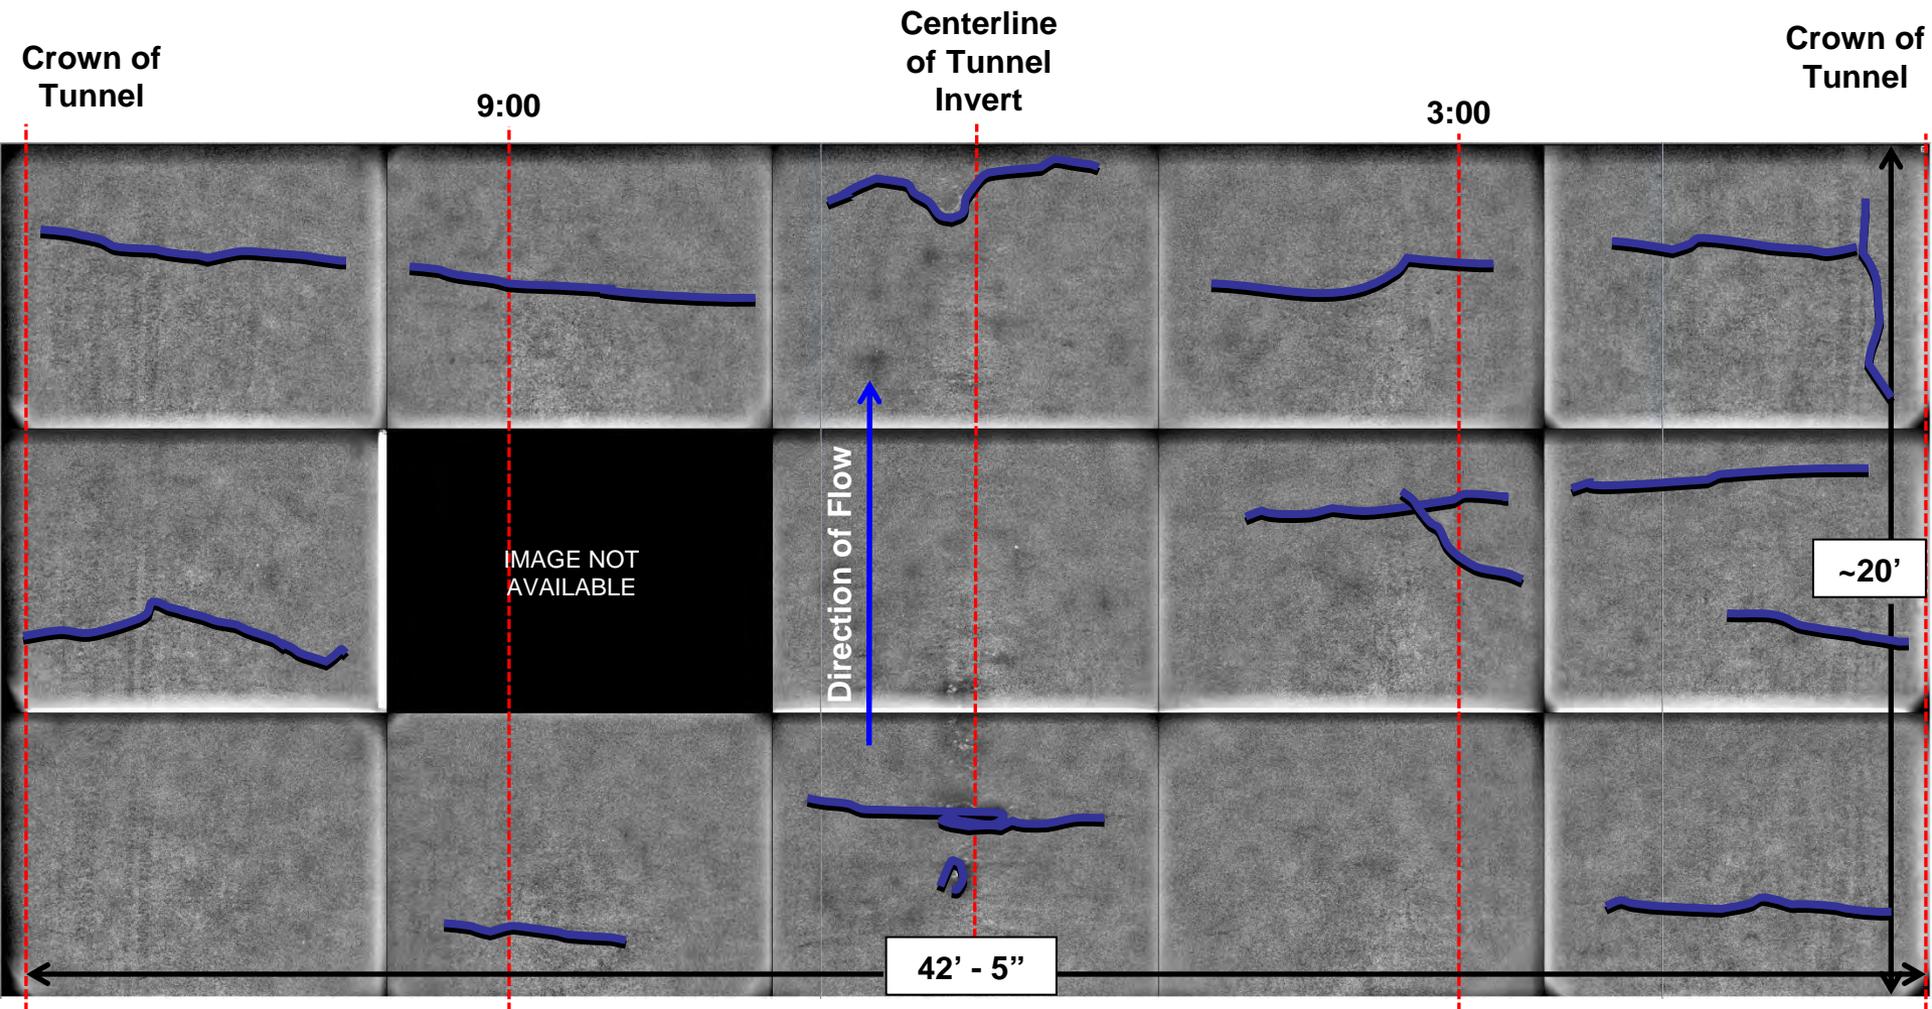
Sta. 281+88 (1.3 miles south along tunnel from Shaft 2)

- ❖ 485 linear feet of cracking in Wawarsing
- ❖ Cracking located in areas of poorest geology (i.e. limestone)

Wawarsing AUV Images

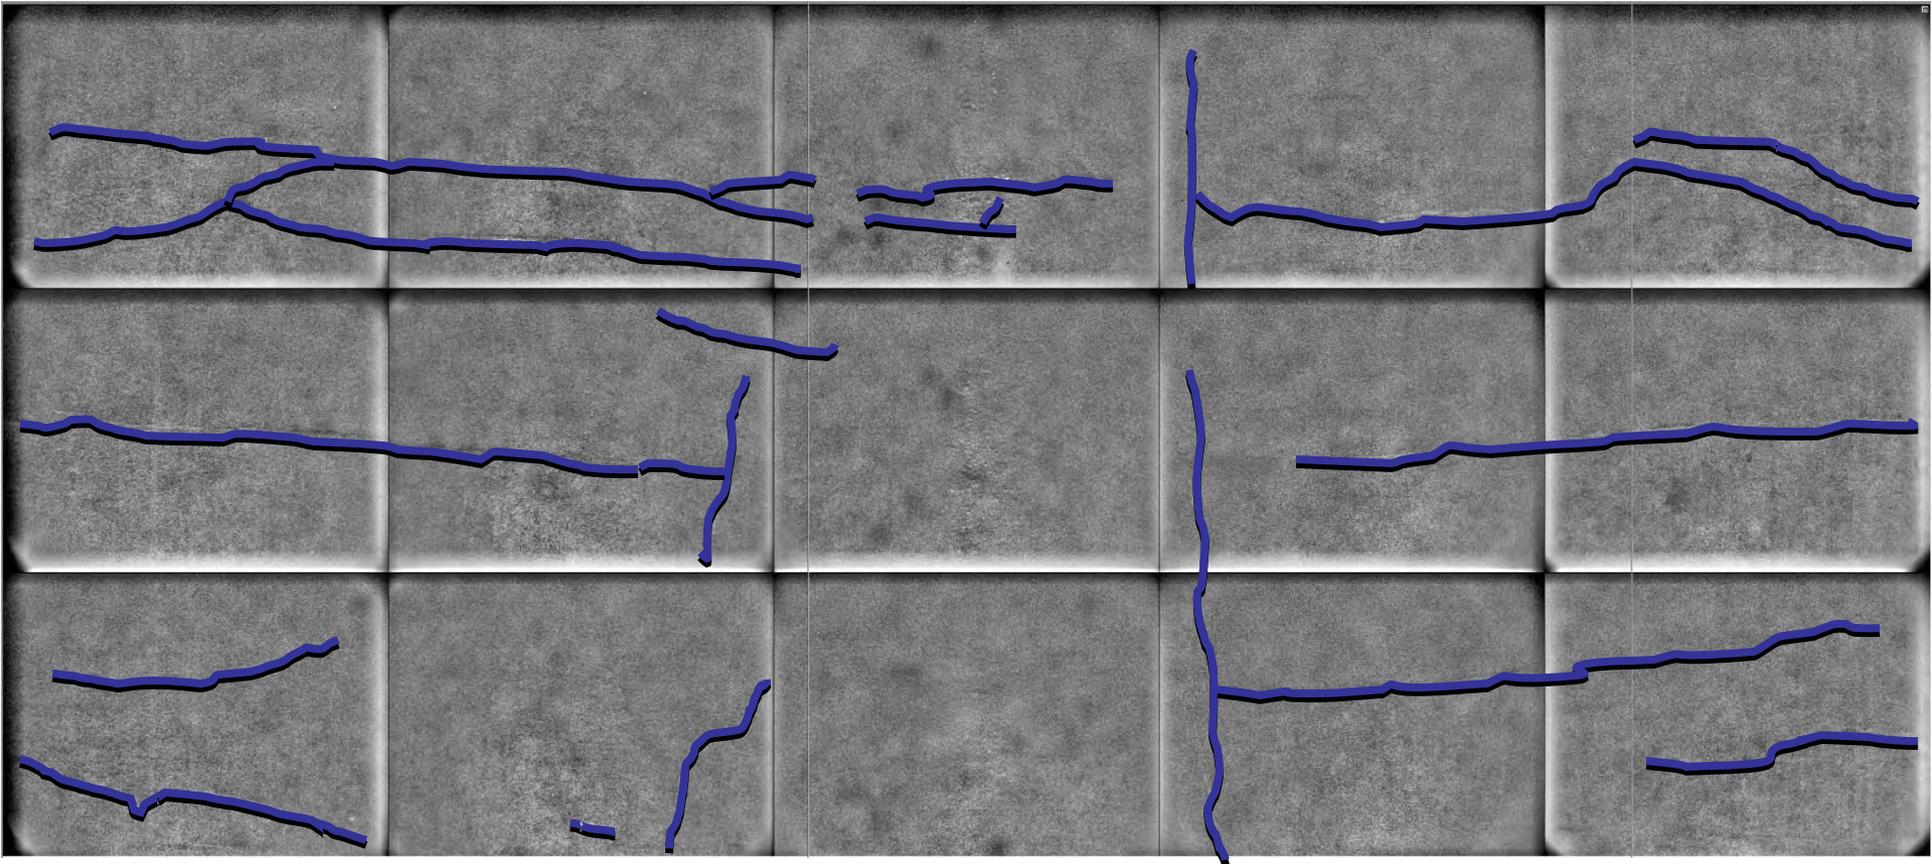
Sta. 282+60 (1.3 miles south along tunnel from Shaft 2)

Wawarsing AUV Images
