Safe Streets for Seniors

Mott Haven, The Bronx

FINAL REPORT
September, 2011

Safe Streets for Seniors
MOTT HAVEN

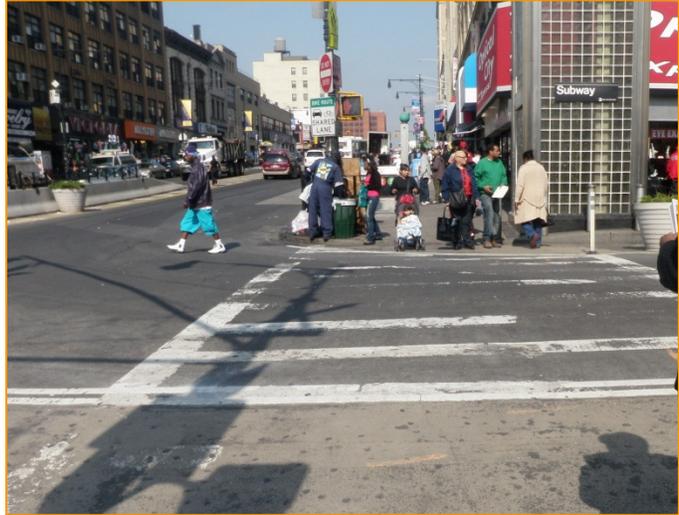
Photo No. 1: E 149th St. & 3rd Ave /Melrose Ave. (looking east)

The Mott Haven Study Area consists of one major north-south corridor, St. Anns Avenue, and two major east-west corridors, Westchester Avenue and East 149th street. The existing street geometry of St. Anns Avenue includes two travel lanes, one in each direction, as well as parking on both sides of the street. The existing geometry of the east-west corridors include, four travel lanes, two in each direction, and parking on both sides of the street. The intersection of East 149th Street, 3rd Avenue and Willis Avenue is a major intersection with heavy vehicular and pedestrian volume, generated from the subway station for the 2 and the 5 line as well as several bus stops for four bus lines (Photo No. 1).

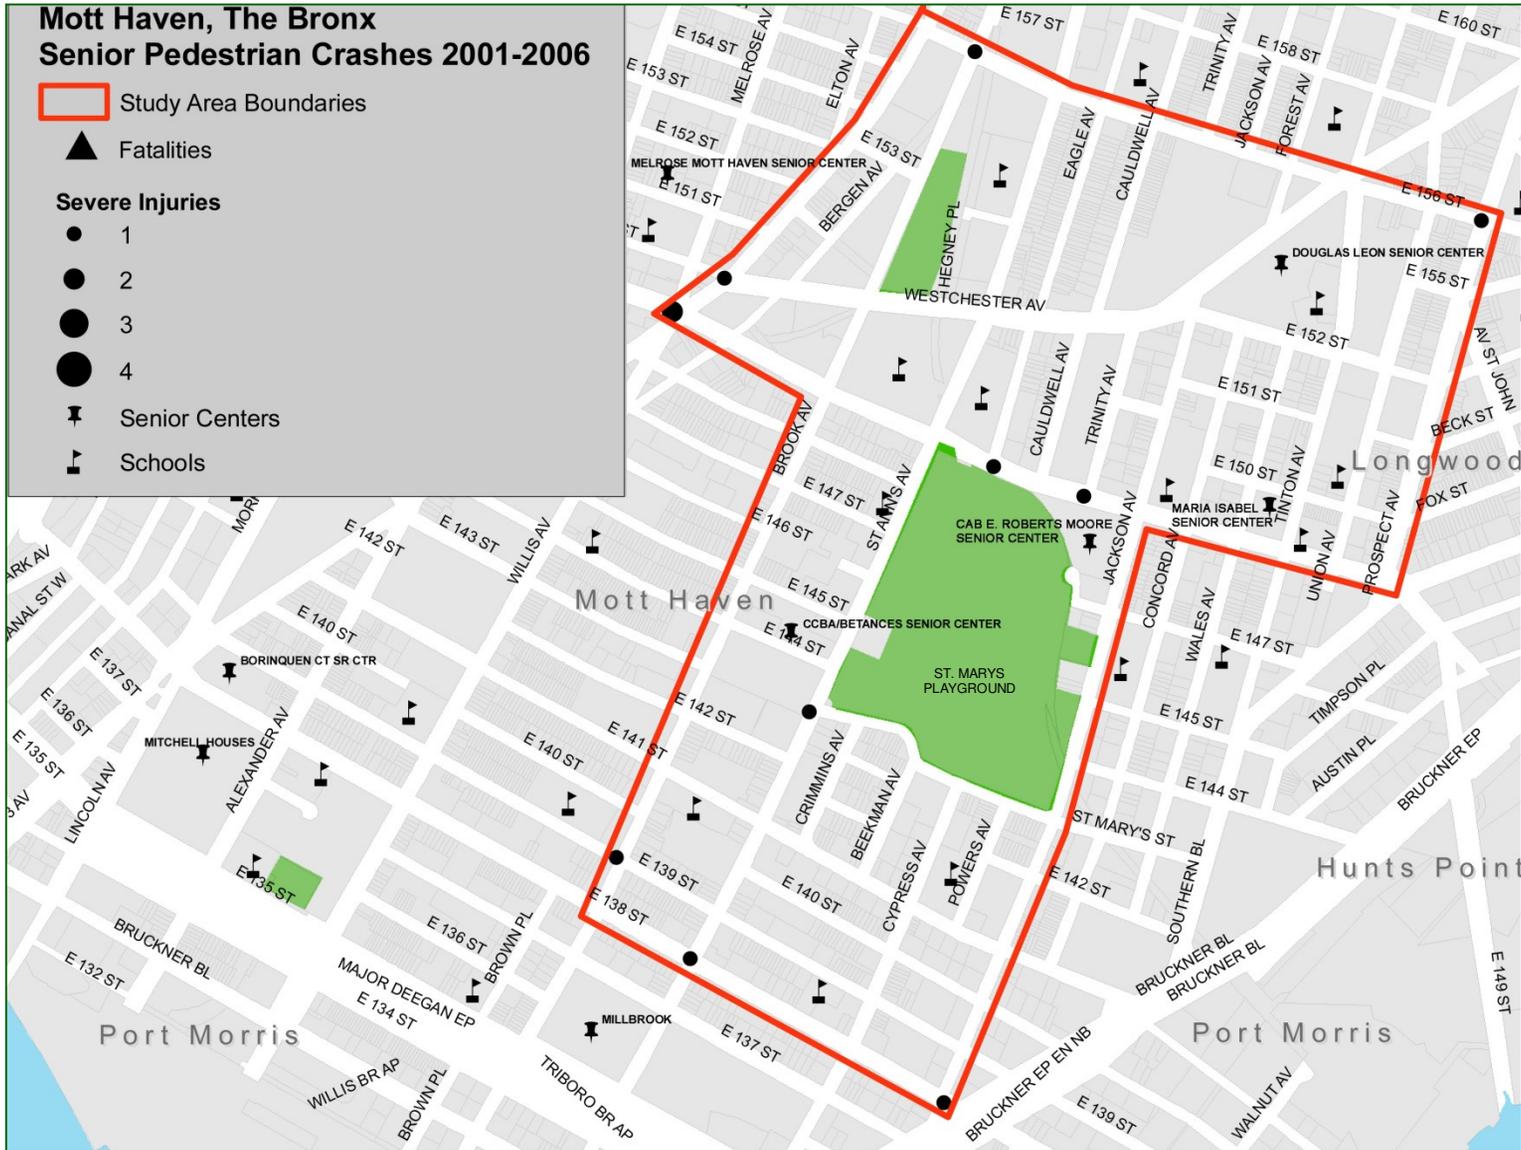
EXHIBIT 5 – PEDESTRIAN CRASH STATISTICS (2001-2006)

Crash data was obtained from the New York City Department of Transportation (NYCDOT) in the Mott Haven Study Area from 2001 through 2006. This data provides some detail relating to the circumstances and cause of each crash. Table 1 and Exhibit 5 show a summary of crashes.

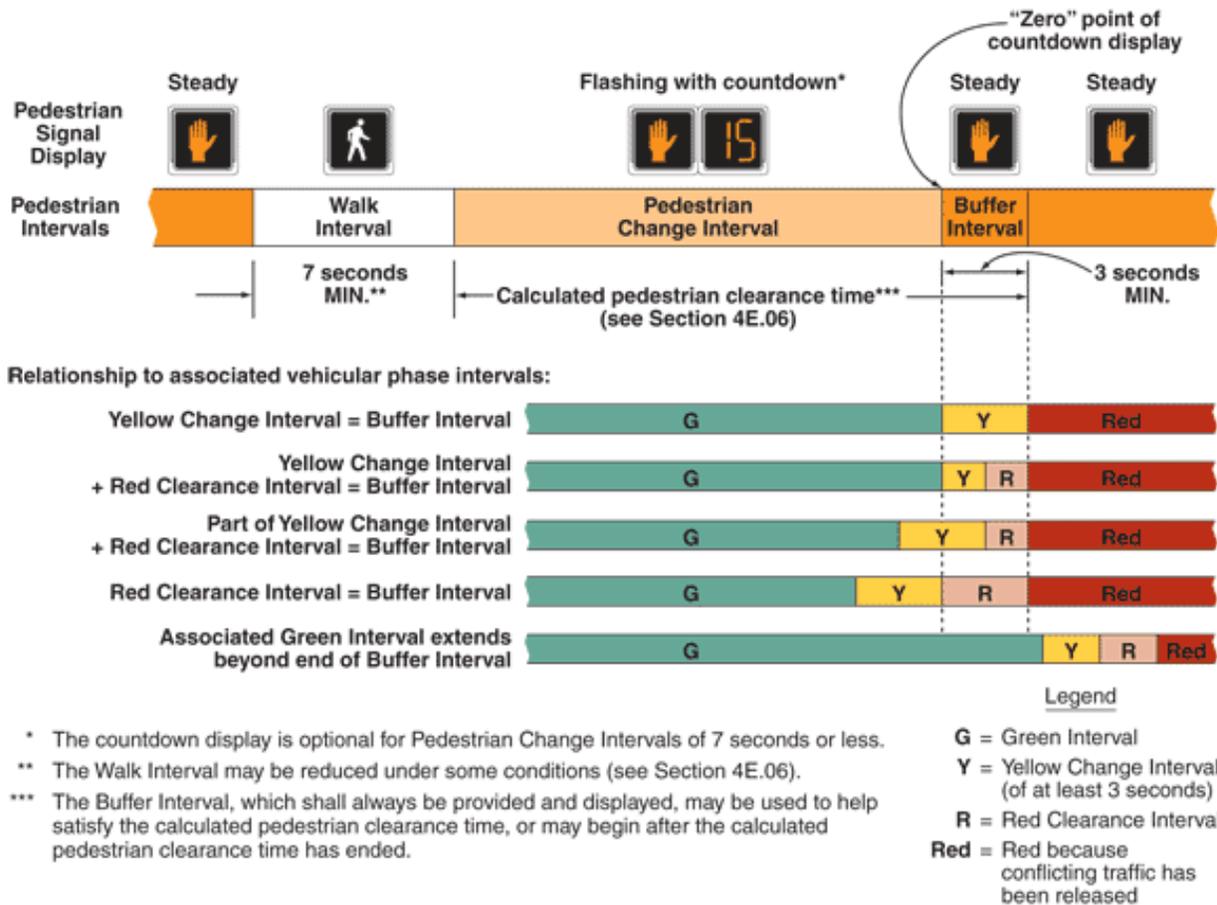
Figure No. 1: Pedestrian Intervals from MUTCD 2009

According to MUTCD 2009 (Manual on Uniform Traffic Control Devices) Section 4E.06, a minimum of seven (7) seconds is allocated for a walk interval, in addition to a pedestrian clearance time based on a walking speed of 3.5 feet per second. All signalized intersections in the study area were modified to provide a clearance interval of 3 feet per second to accommodate slower walking speeds.

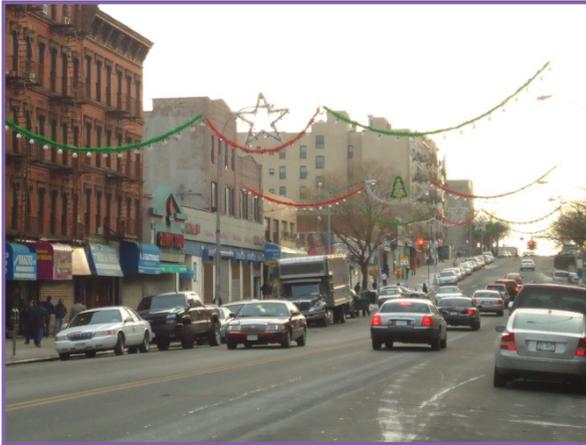
Photo No. 2: E 138th St. btw Brook Ave. & St. Anns Ave.

East 138th Street is a 48-foot wide corridor with one moving lane in each direction with parking on both sides. (Photo No. 2).

Thirteen-foot parking lane striping for both sides of the corridor from Third Avenue to Jackson Avenue is recommended. This measure will narrow the travel lanes and calm vehicular traffic.

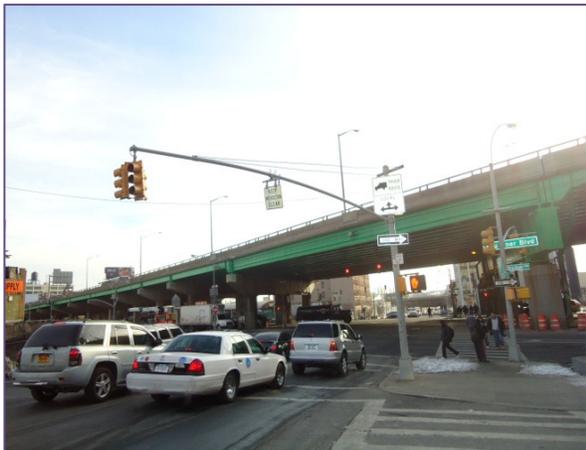
Photo No. 3: Jackson Ave. & E 138th St.

The intersections of East 138th Street, Jackson Avenue and Bruckner Boulevard have heavy vehicular volume (Photo No. 3). Many seniors indicated they do not feel safe crossing the streets at this intersection and there is a history of pedestrian injuries at this location. Turning movement counts and pedestrian counts were collected in June of 2010. Traffic analysis was conducted to determine if the existing Greenstreet triangle can be turned into a pedestrian plaza by closing off Jackson Avenue from East 138th Street to Bruckner Boulevard. The closure would result in expansion of The Greenstreet (Gouverneur Morris Triangle), addition of right turn bay along East 138th Street between Jackson Avenue and Bruckner Boulevard (Photo No. 4) and an eight-foot concrete median along East 138th Street between Jackson Avenue and Bruckner Boulevard with 11-foot travel lanes. The analysis showed that Jackson Avenue can be closed with adjustments made to the signal timing at East 138th Street and

Jackson Avenue. The detailed results are presented in Appendices B, C and the Technical Supplement. A tapered striped median is recommended for the west leg of East 138th Street

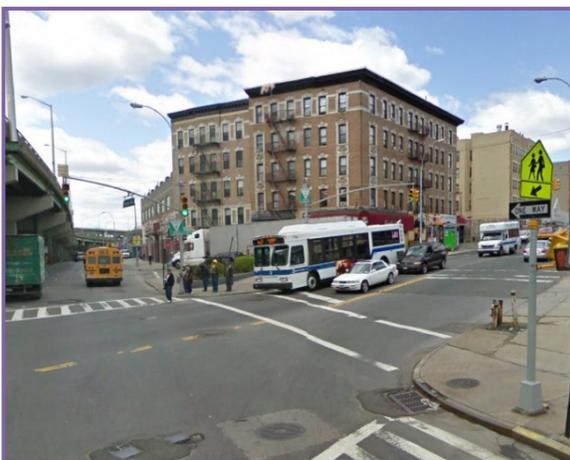
Photo No. 4: E 138th St. & Bruckner Blvd.

and Jackson Avenue to keep moving traffic in-line. The northwest and southwest corners of East 138th Street and Bruckner Boulevard are missing pedestrian ramps and new NYCDOT standard pedestrian ramp and ADA safety surface are recommended for both locations. All improvements can be found in Exhibit 8.

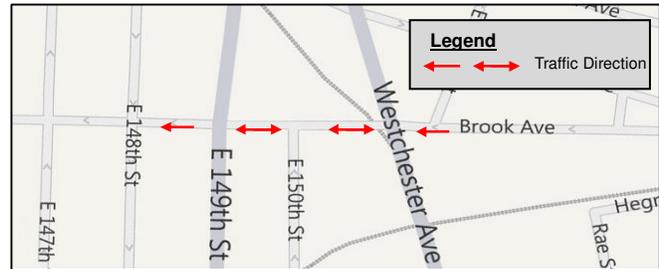
Figure No. 2: Brook Avenue Traffic Pattern

Brook Avenue is a 42-foot wide southbound corridor with two moving lanes and parking on both sides. It is a two-way corridor between East 149th Street and Westchester Avenue with parking along the east side of Brook Avenue.

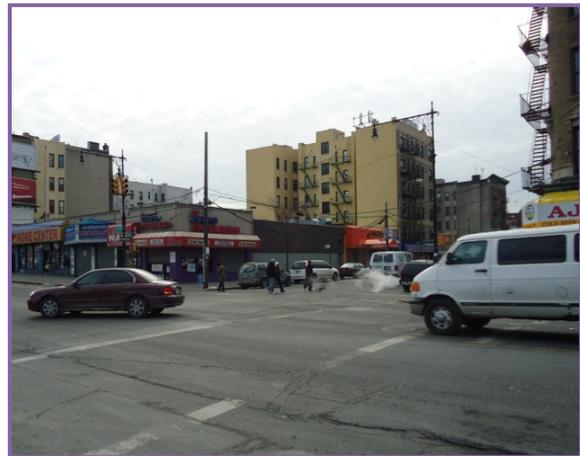
Photo No. 5: Brook Ave. & E 149th St. (looking west)

- North and south legs of East 143rd Street and Brook Avenue
- All four legs of East 149th Street and Brook Avenue (Photo No. 5)
- North and south legs of East 156th Street and Brook Avenue

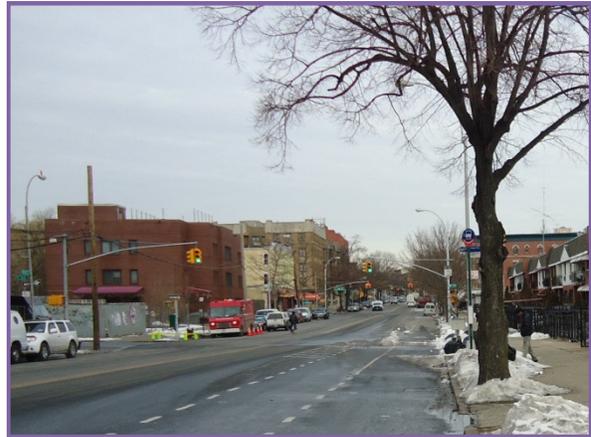
Photo No. 6: Prospect Ave. & E 168th St.

- South leg of East 150th Street, East 152nd Street
- North leg of East 155th Street
- South leg of East 161st Street
- North leg of East 162nd Street
- South leg of East 164th Street
- North leg of East 165th Street, Home Street
- South leg of East 168th Street (Photo No. 6), Jennings Street

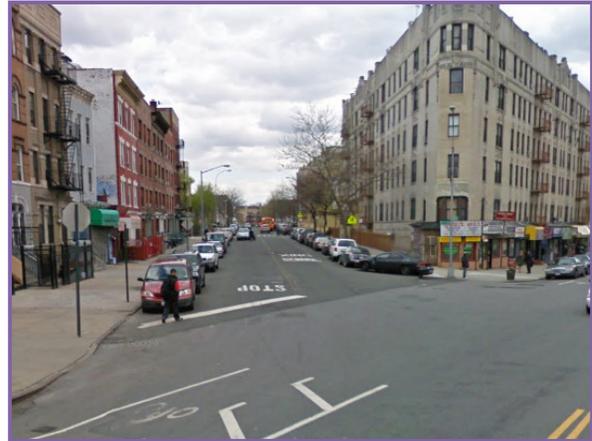
Photo No. 7: Prospect Ave. & Avenue Saint John

On the northeast corner of Prospect Avenue and Avenue Saint John (Photo No. 7), new channelized corner striping is recommended in order to normalize the intersection, narrow the travel lanes and restrict vehicles' turning radius at the intersection. A new corner striping is recommended for the southeast corner of the intersection. These measures will slow turning traffic and shorten the crossing distance for pedestrians. Autoturn for this intersection is shown in Appendix D.

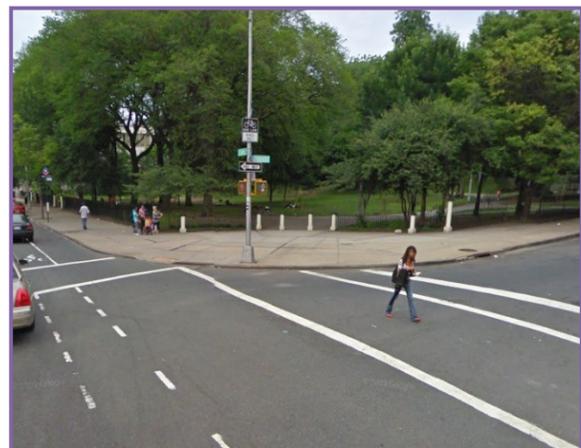
Photo No. 8: St. Anns Ave. & E 143rd St.

St. Anns Avenue is a 42-foot wide corridor with one moving lane in each direction with bike lanes and parking on both sides. It borders the west side of St. Marys Playground which is located in the center of the study area. There is heavy pedestrian volume at the southwest corner of St. Anns Avenue and East 143rd Street. The volumes are generated from the bus stop at the north leg of the intersection and the playground entrance. The existing corner quadrant has a 30-foot radius (Photo No. 8) making the crossing distance for pedestrian excessive. To provide additional sidewalk width, improve pedestrian-vehicle visibility and shorten the crossing distance, a new corner with a 12-foot radius is recommended with high visibility cross walks for the north, south and east legs of the intersection. Along East 143rd Street, a neckdown is recommended to further shorten the crossing distance and to slow turning vehicles. All improvements can be found in Exhibit 13.

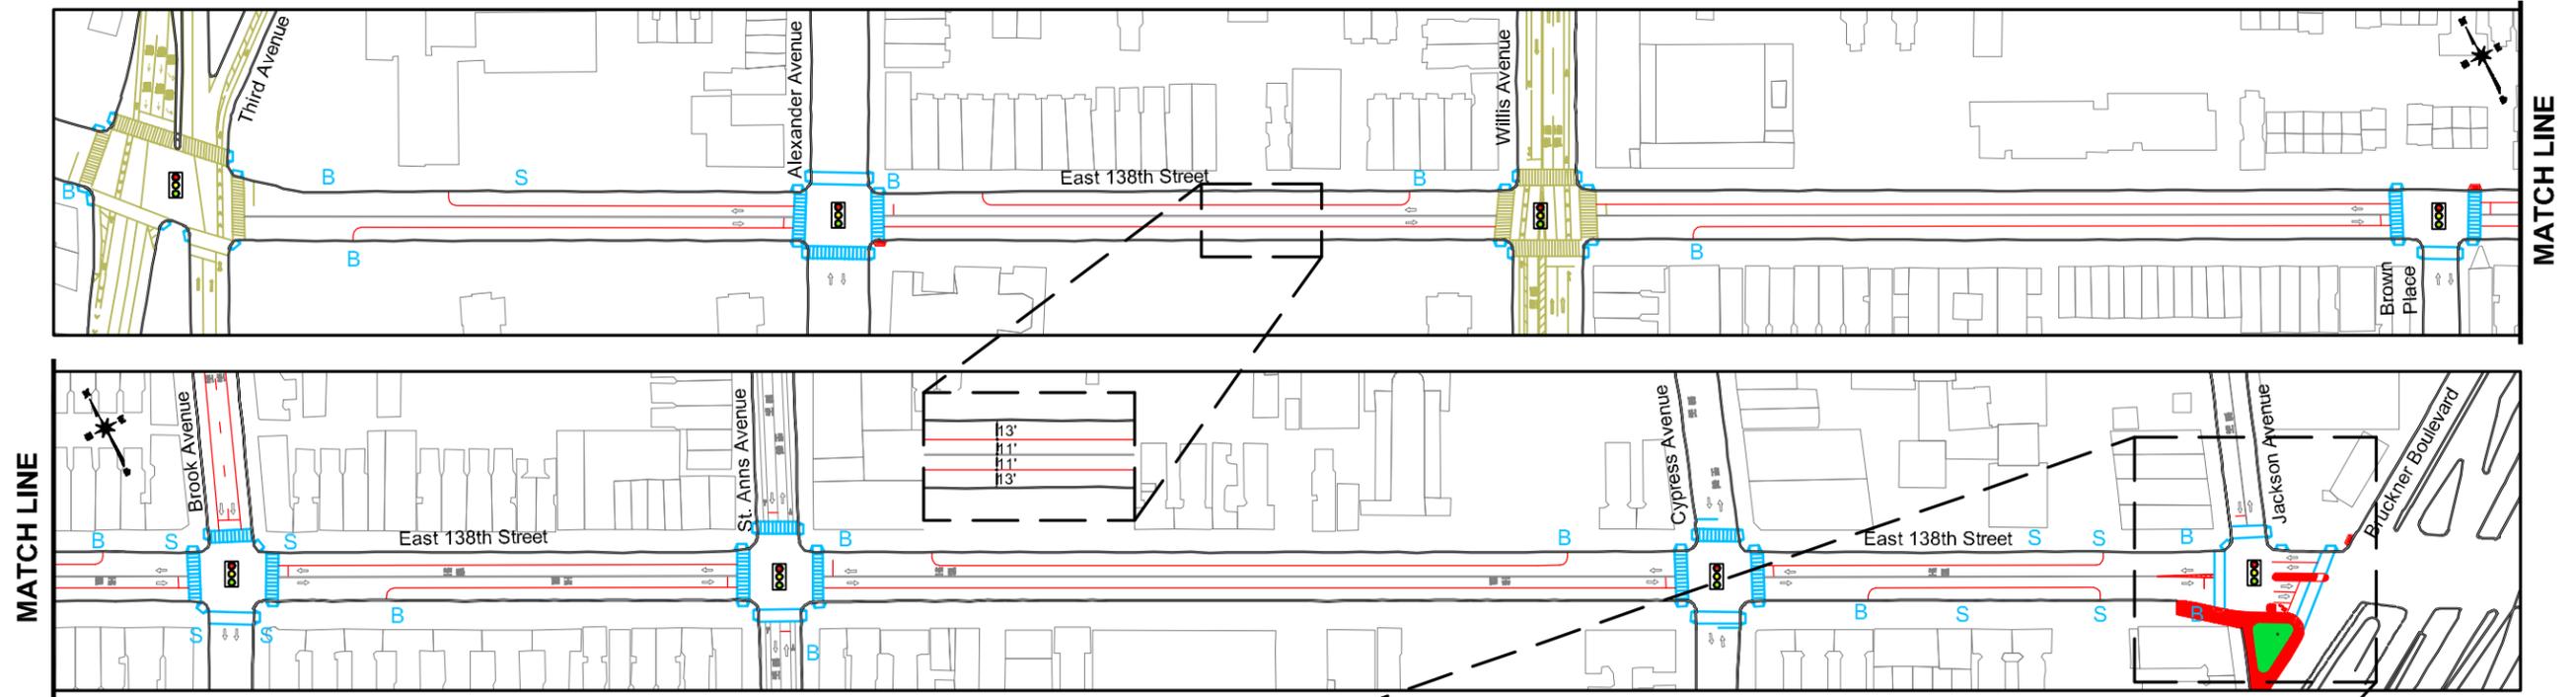
EXHIBIT 8 - East 138th Street

Pedestrian concerns in this area:

- Turning vehicles not yielding to pedestrians
- Signal timing (insufficient crossing time)

Recommended improvements include:

- Time all signals for seniors and where feasible, the crossing time will be extended
- Install new advanced stop bars
- Stripe parking lane along East 138th Street between Third Avenue & Jackson Avenue
- Close off Jackson Avenue from East 138th Street to Bruckner Boulevard by expanding Green Street (Gouverneur Morris Triangle)
- Stripe right-turn bay along East 138th Street between Jackson Avenue & Bruckner Boulevard
- Install an 8-foot concrete median along East 138th Street between Jackson Avenue & Bruckner Boulevard

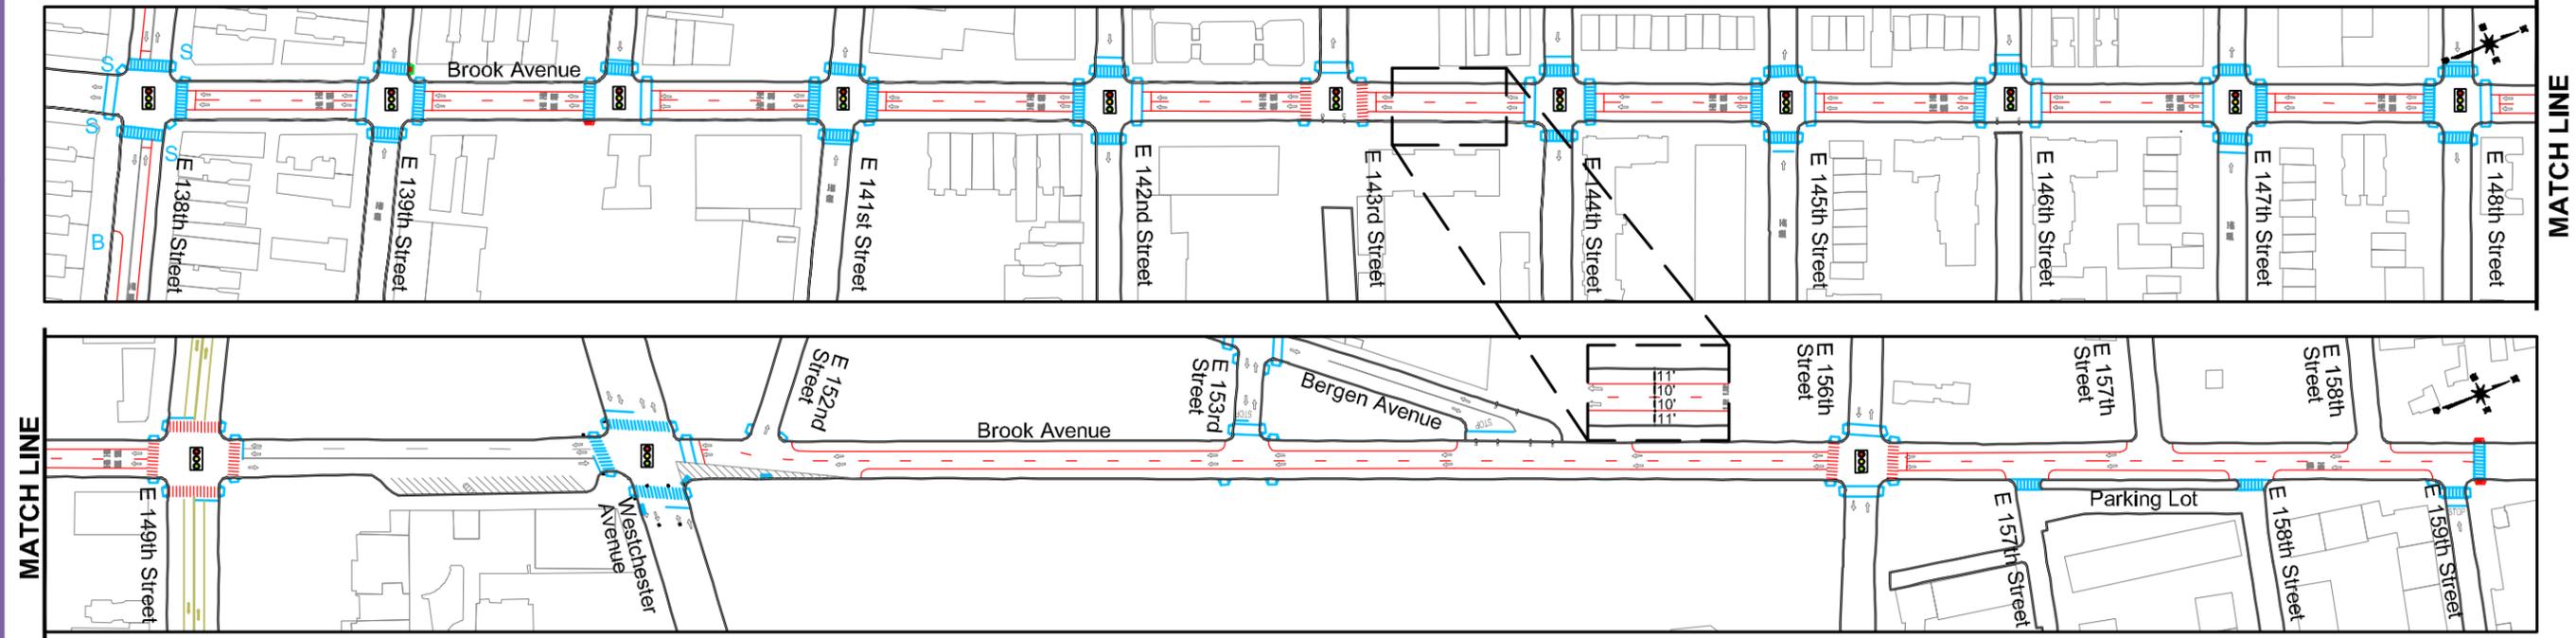
EXHIBIT 9 - Brook Avenue

Pedestrian concerns in this area:

- Turning vehicles not yielding to pedestrians
- Signal timing (insufficient crossing time)

Recommended improvements include:

- Time all signals for seniors and where feasible, the crossing time will be extended
- Install new advanced stop bars
- Stripe parking lane
 - between East 138th Street & East 149th Street
 - between Westchester Avenue & East 159th Street
- Stripe high visibility cross walks
 - north & south legs of Brook Avenue & East 143rd Street
 - Brook Avenue & East 149th Street
 - north & south legs of Brook Avenue & East 156th Street

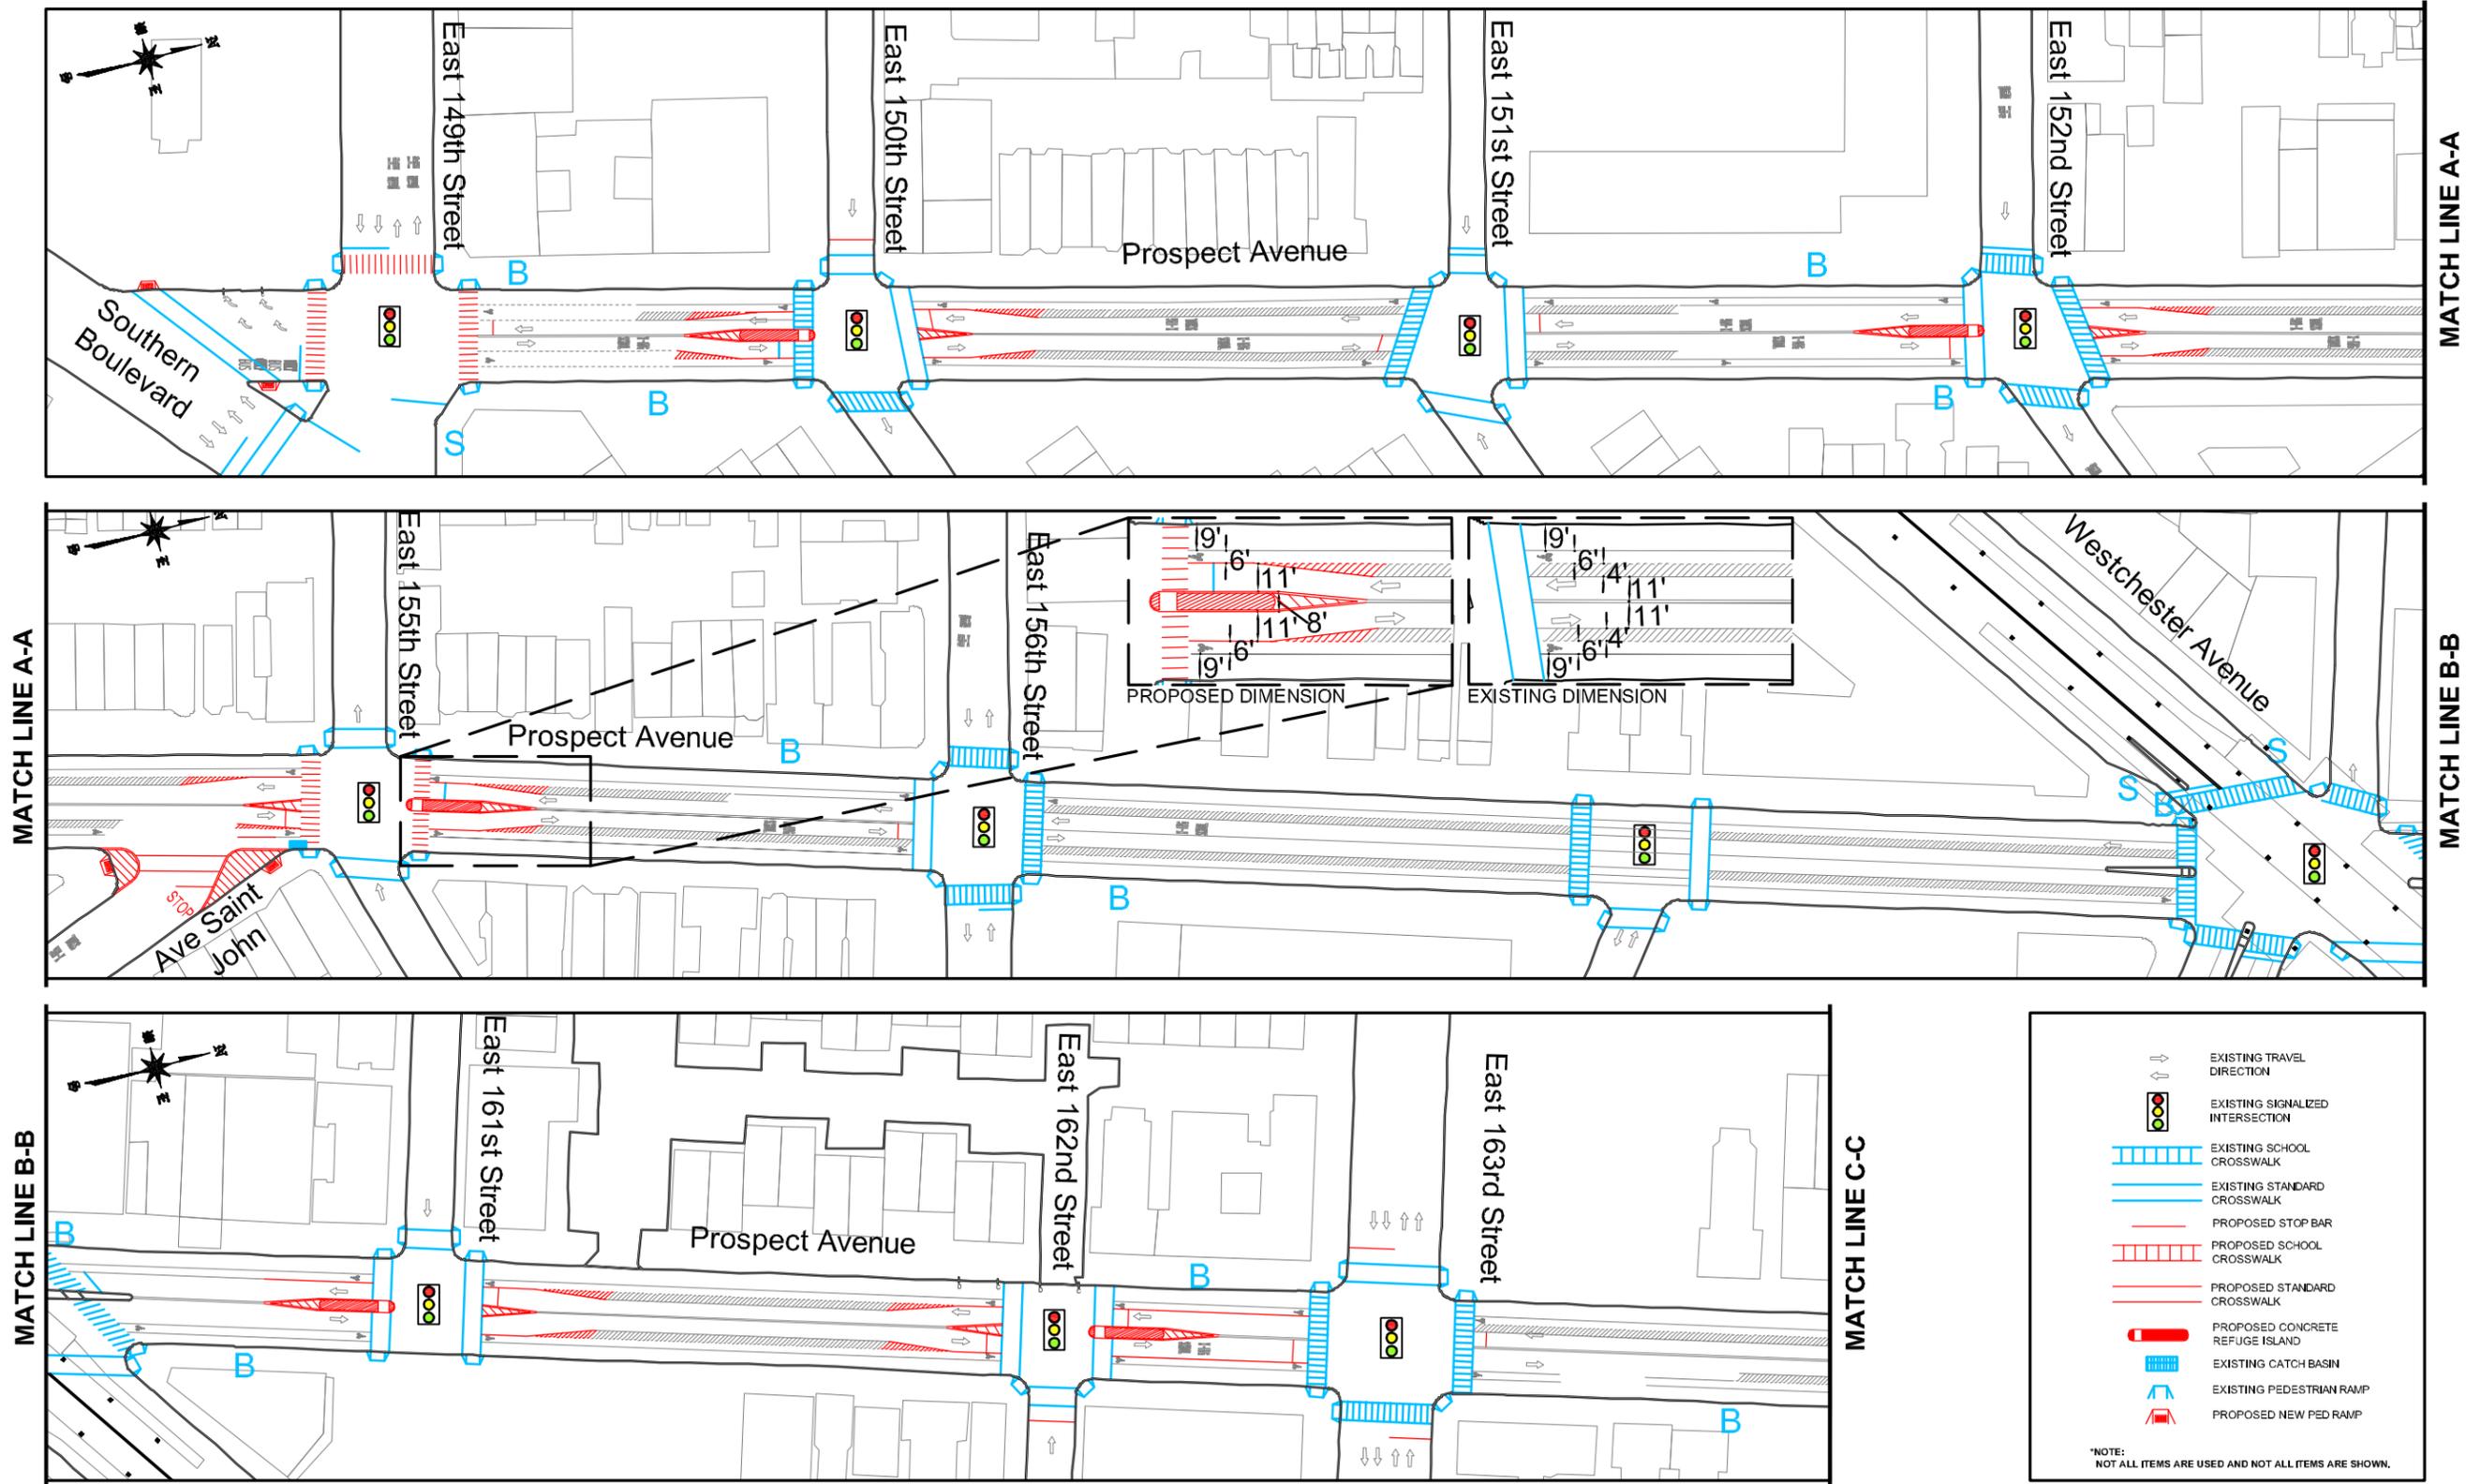
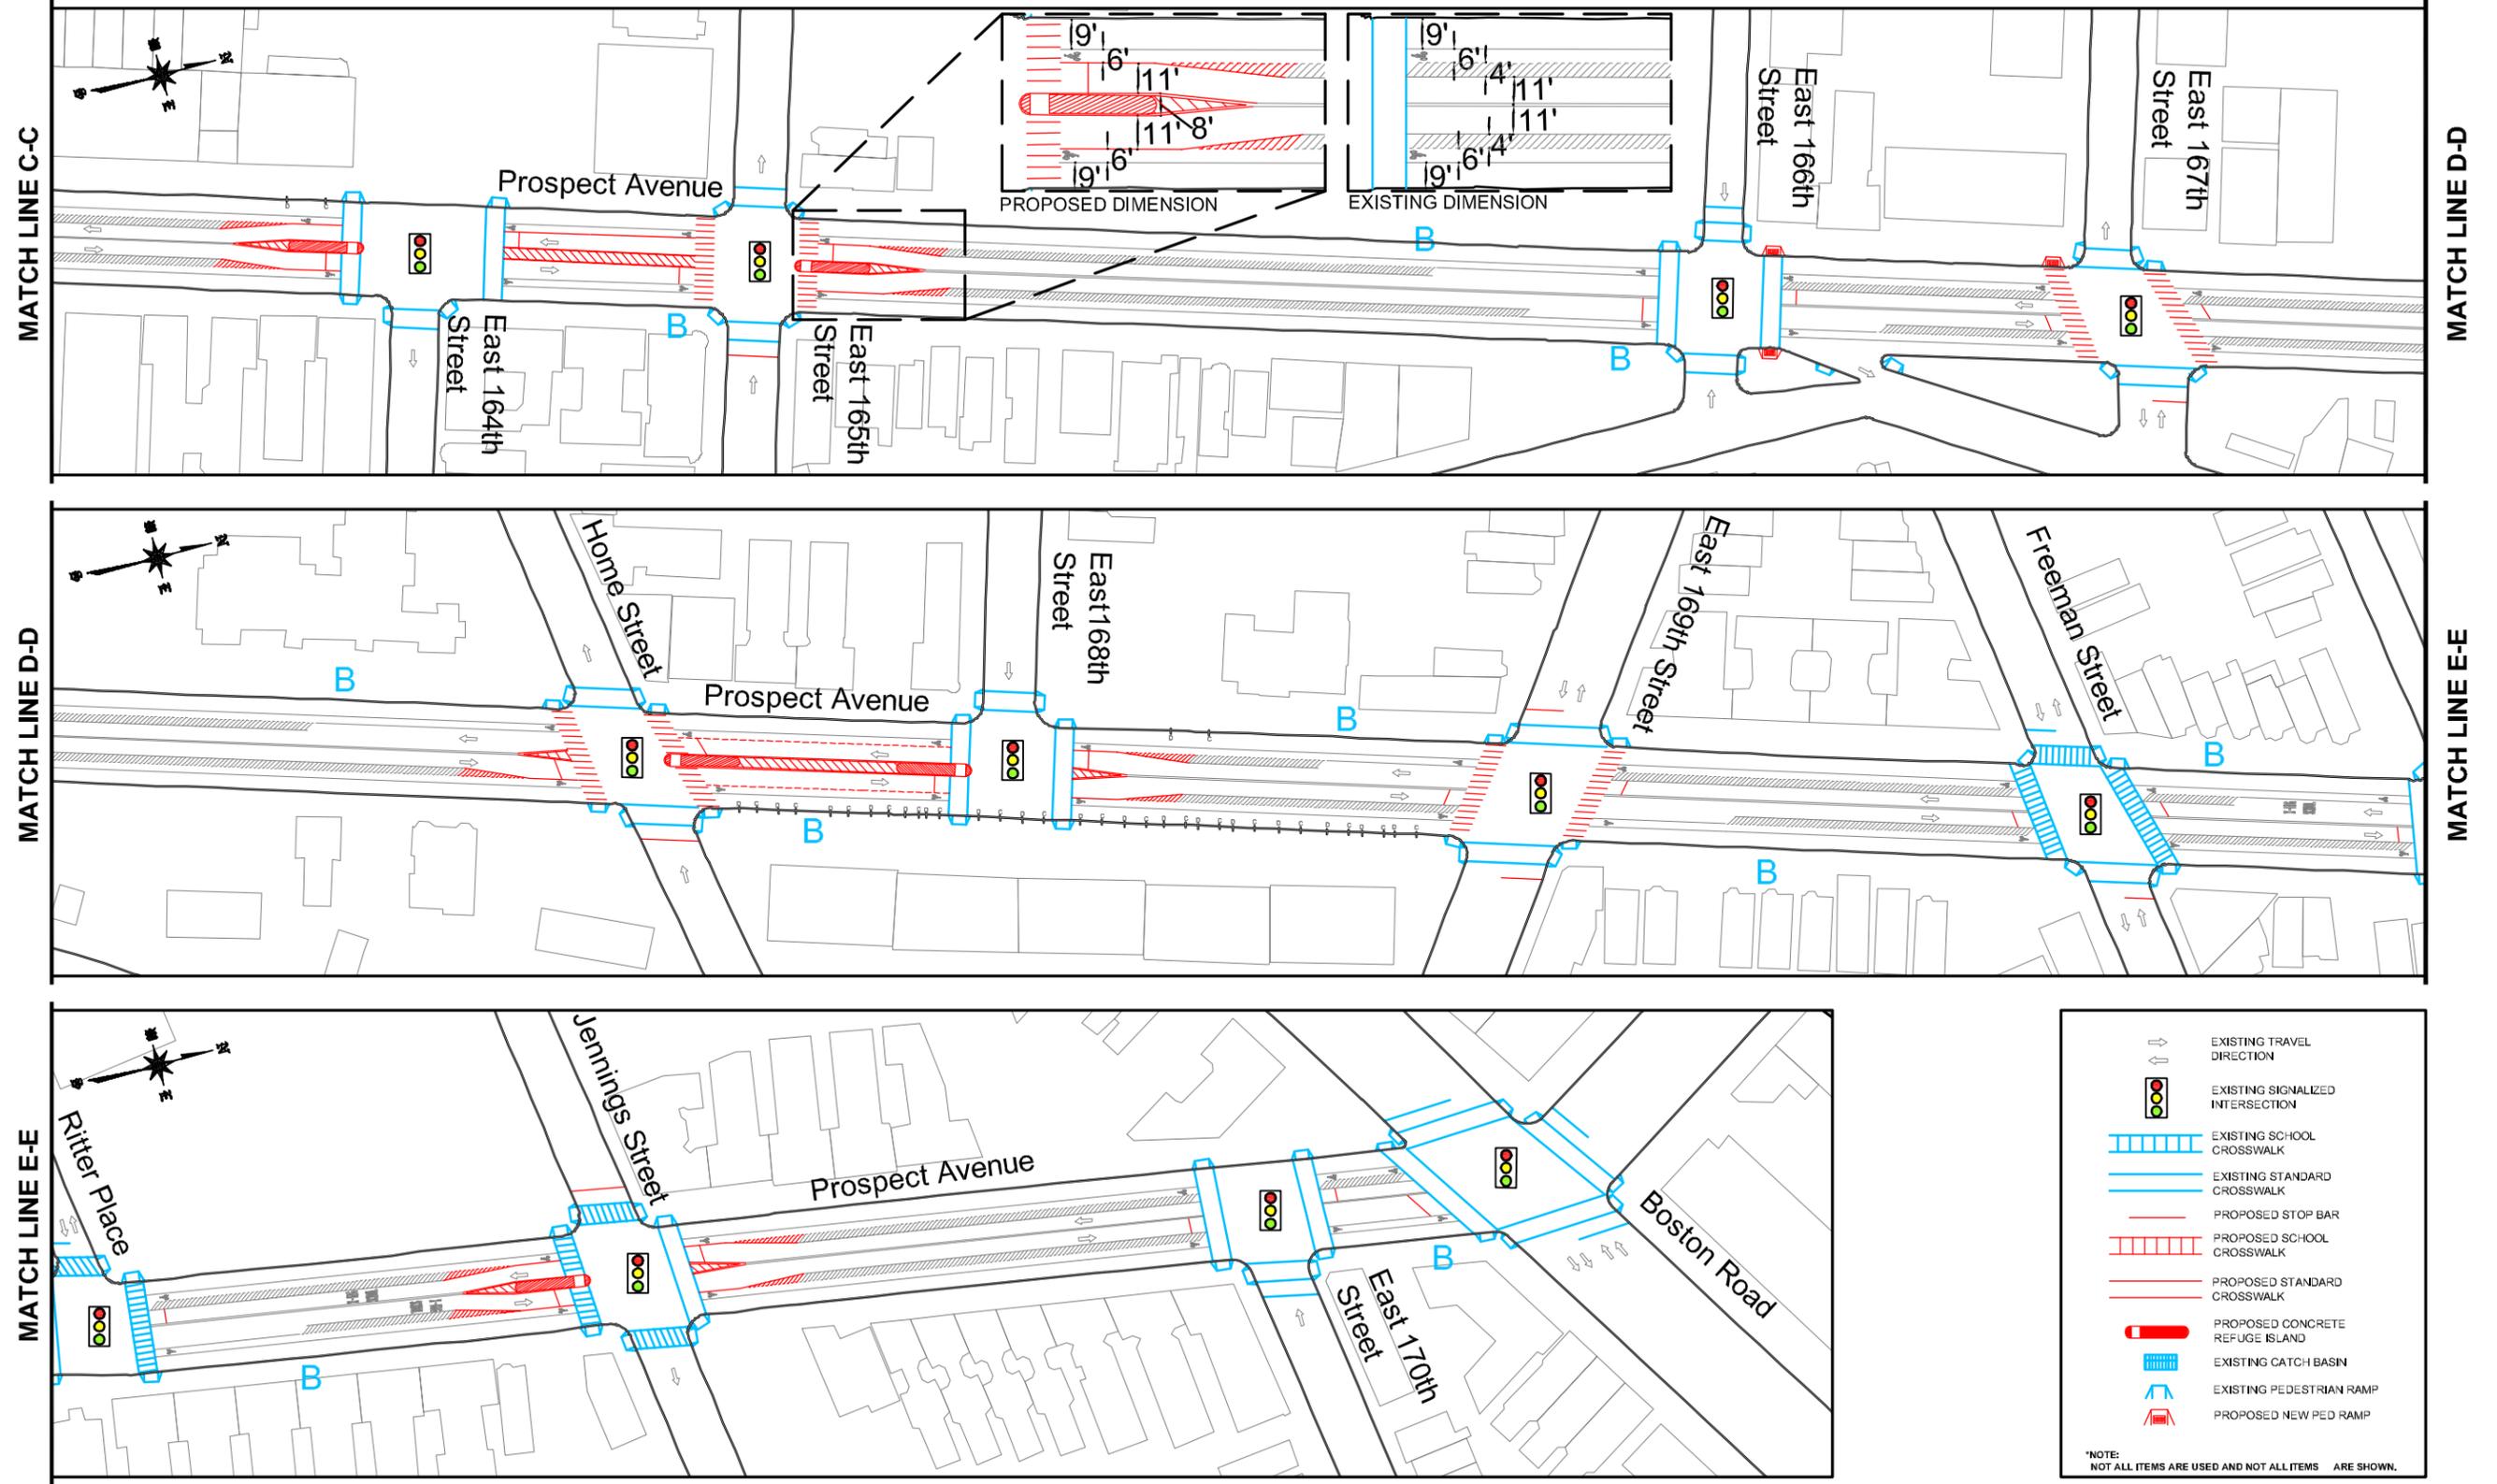
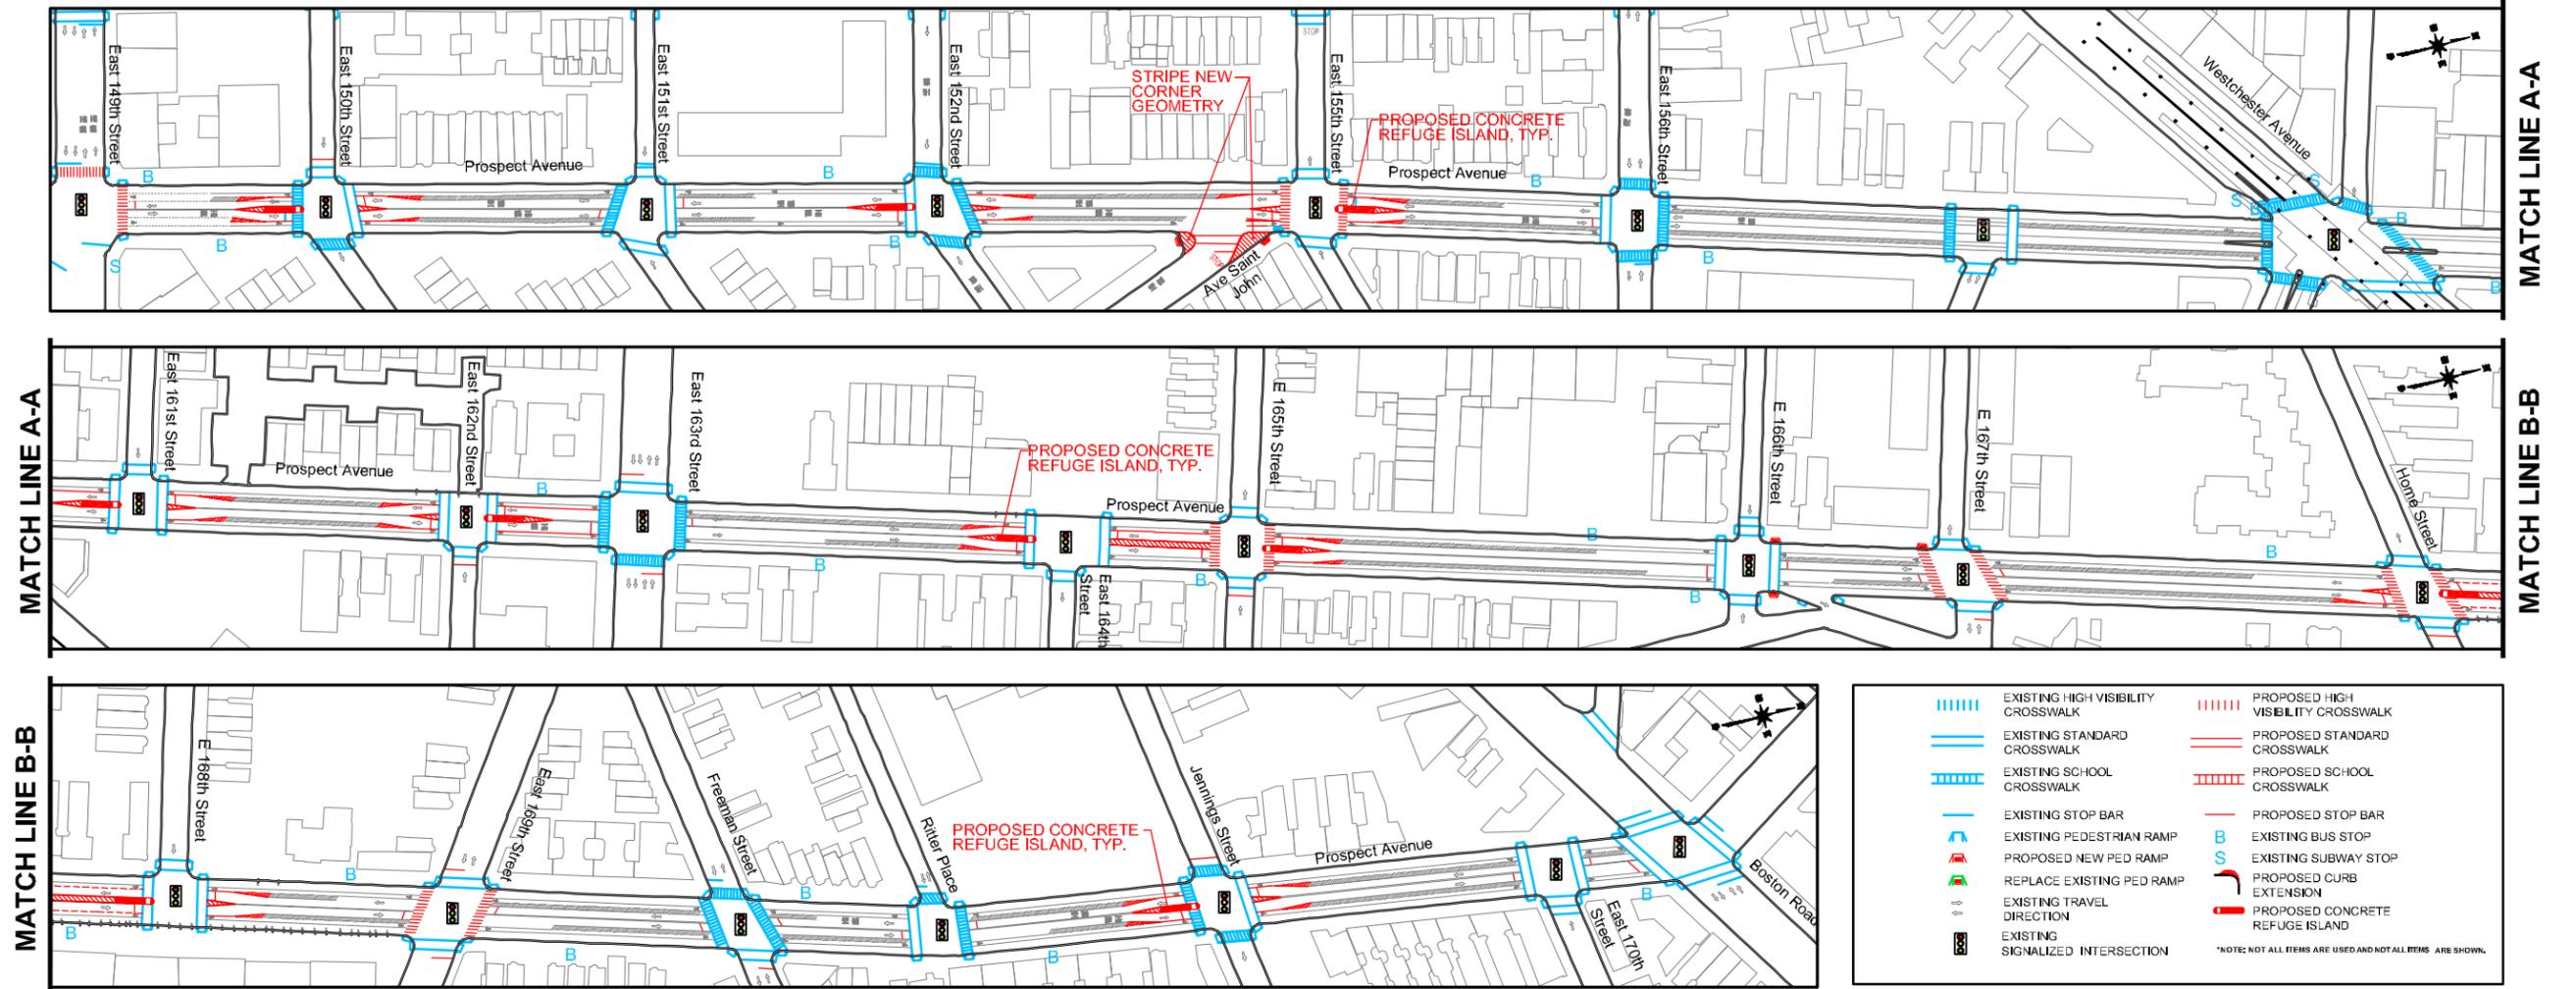
EXHIBIT 10 - Prospect Avenue (From East 149th Street to Boston Road)

Pedestrian concerns in this area:

- Turning vehicles not yielding to pedestrians
- Signal timing (insufficient crossing time)

Recommended improvements include:

- Time all signals for seniors and where feasible, the crossing time will be extended
- Install new advanced stop bars
- Reconfigure buffer striping
 - at East 150th Street
 - at East 152nd Street
 - at East 155th Street
 - at East 161st Street
 - at East 164th Street
 - at East 165th Street
 - at Home Street
 - at East 168th Street
 - at Jennings Street
- Stripe new corner geometry at Avenue Saint John
 - southeast corner
 - northeast corner

- Install a concrete refuge island
 - south leg of East 150th Street, East 152nd Street
 - north leg of East 155th Street
 - south leg of East 161st Street
 - north leg of East 162nd Street
 - south leg of East 164th Street
 - north leg of East 165th Street, Home Street
 - south leg of East 168th Street, Jennings Street
- Stripe high visibility crosswalks
 - north, south, & west legs of East 149th Street
 - north & south legs of East 155th Street
 - north & south legs of East 165th Street
 - north & south legs of East 167th Street
 - north & south legs of Home Street
 - north & south legs of East 169th Street

All improvements can be found in Exhibits 10, 11 and 12.

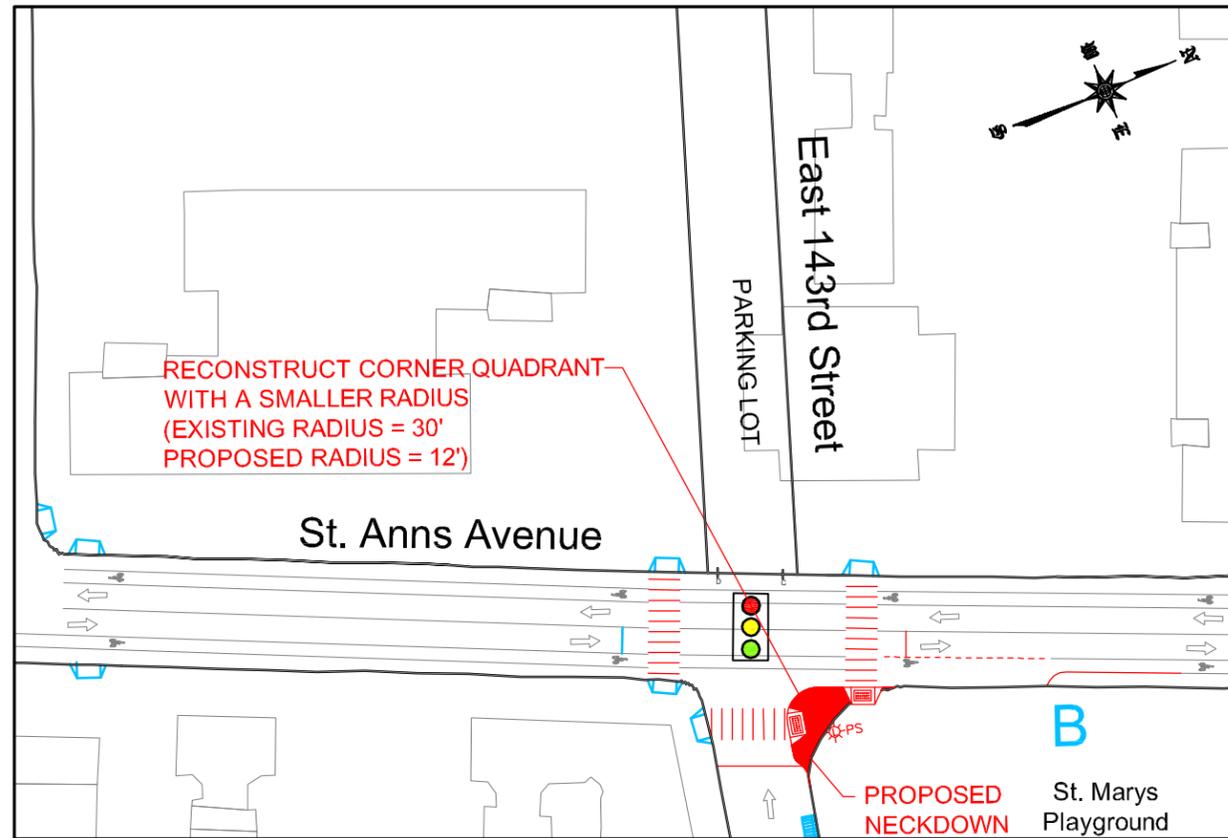
EXHIBIT 13 - St. Anns Avenue & East 143rd Street

Pedestrian concerns in this area:

- Turning vehicles not yielding to pedestrians
- Signal timing (insufficient crossing time)

Recommended improvements include:

- Time all signals for seniors and where feasible, the crossing time will be extended
- Install new advanced stop bars
- Stripe high visibility crosswalks
- Reconstruct northeast corner with a smaller radius
- Install a neckdown
 - at the northeast corner along East 143rd Street
