**New York City Department of Transportation  
Office of School Safety Engineering**

**School Safety Engineering Project**

**FINAL REPORT: I.S. 238 (Susan B. Anthony School), Queens**

**November 17, 2006**

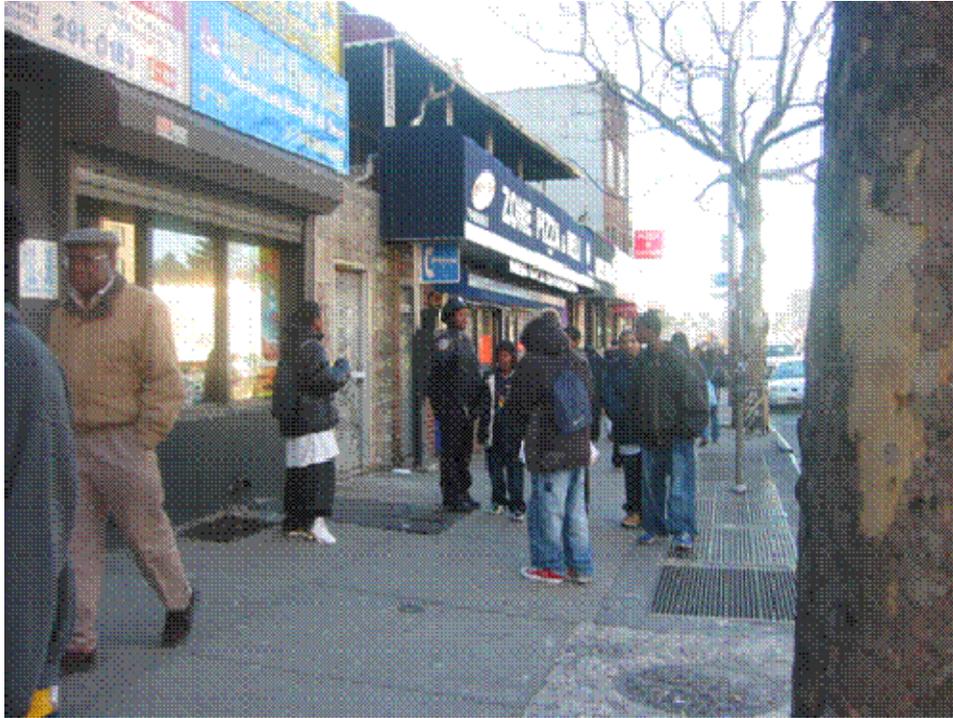
*Figure 3: Following dismissal, students congregate near local stores on the south side of Hillside Avenue, east of I.S. 238*

Hillside Avenue is a major commercial corridor that generates pedestrian and vehicular traffic around the school. In addition, Hillside Avenue is well served by local and express bus service as well as subway service (the “F” line). Following dismissal, I.S. 238 students were observed congregating around the local stores and fast-food restaurants, waiting for buses along Hillside Avenue near the school (see Figures 3 and 4).

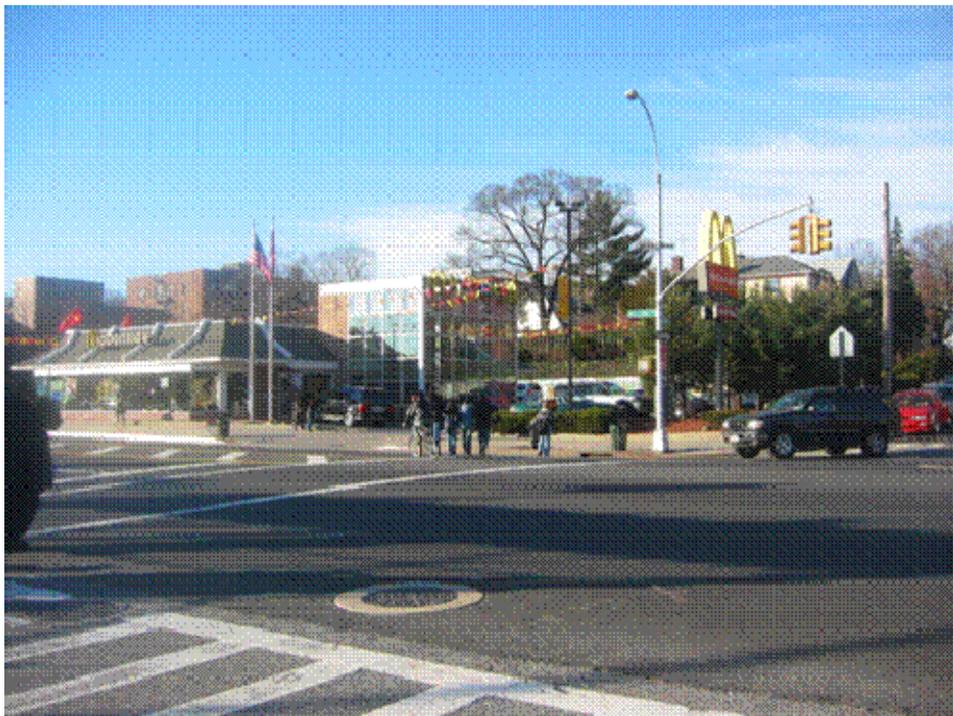
*Figure 4: Following dismissal, students cross Hillside Avenue to patronize a fast-food restaurant located opposite I.S. 238*

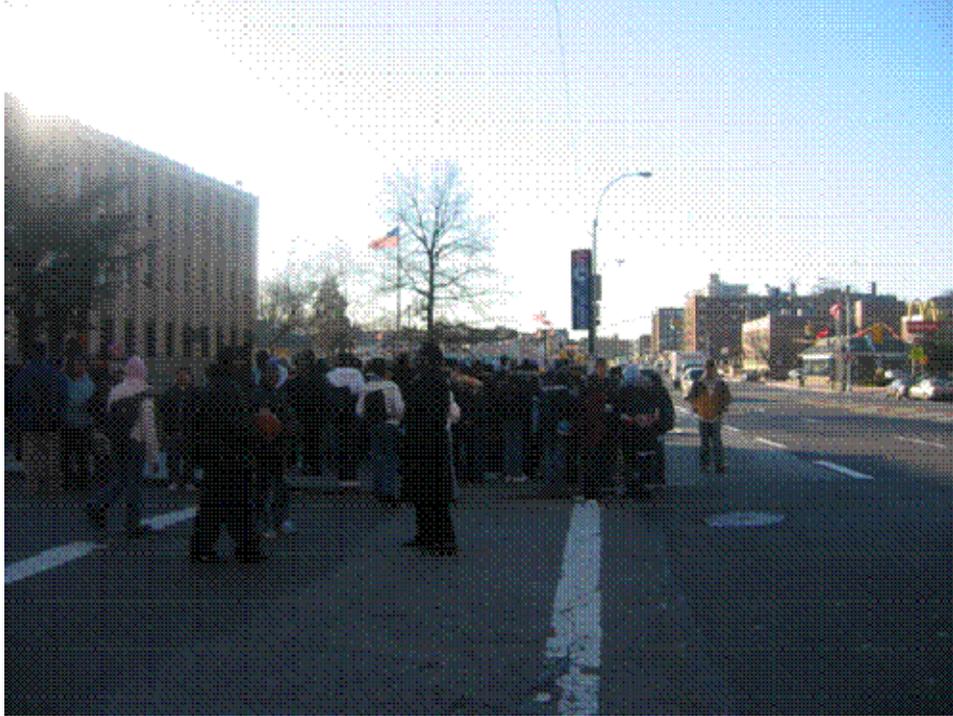
*Figure 5: Following dismissal, students wait for buses on south side of Hillside Avenue at 182<sup>nd</sup> Place (I.S. 238 is shown on the left)*

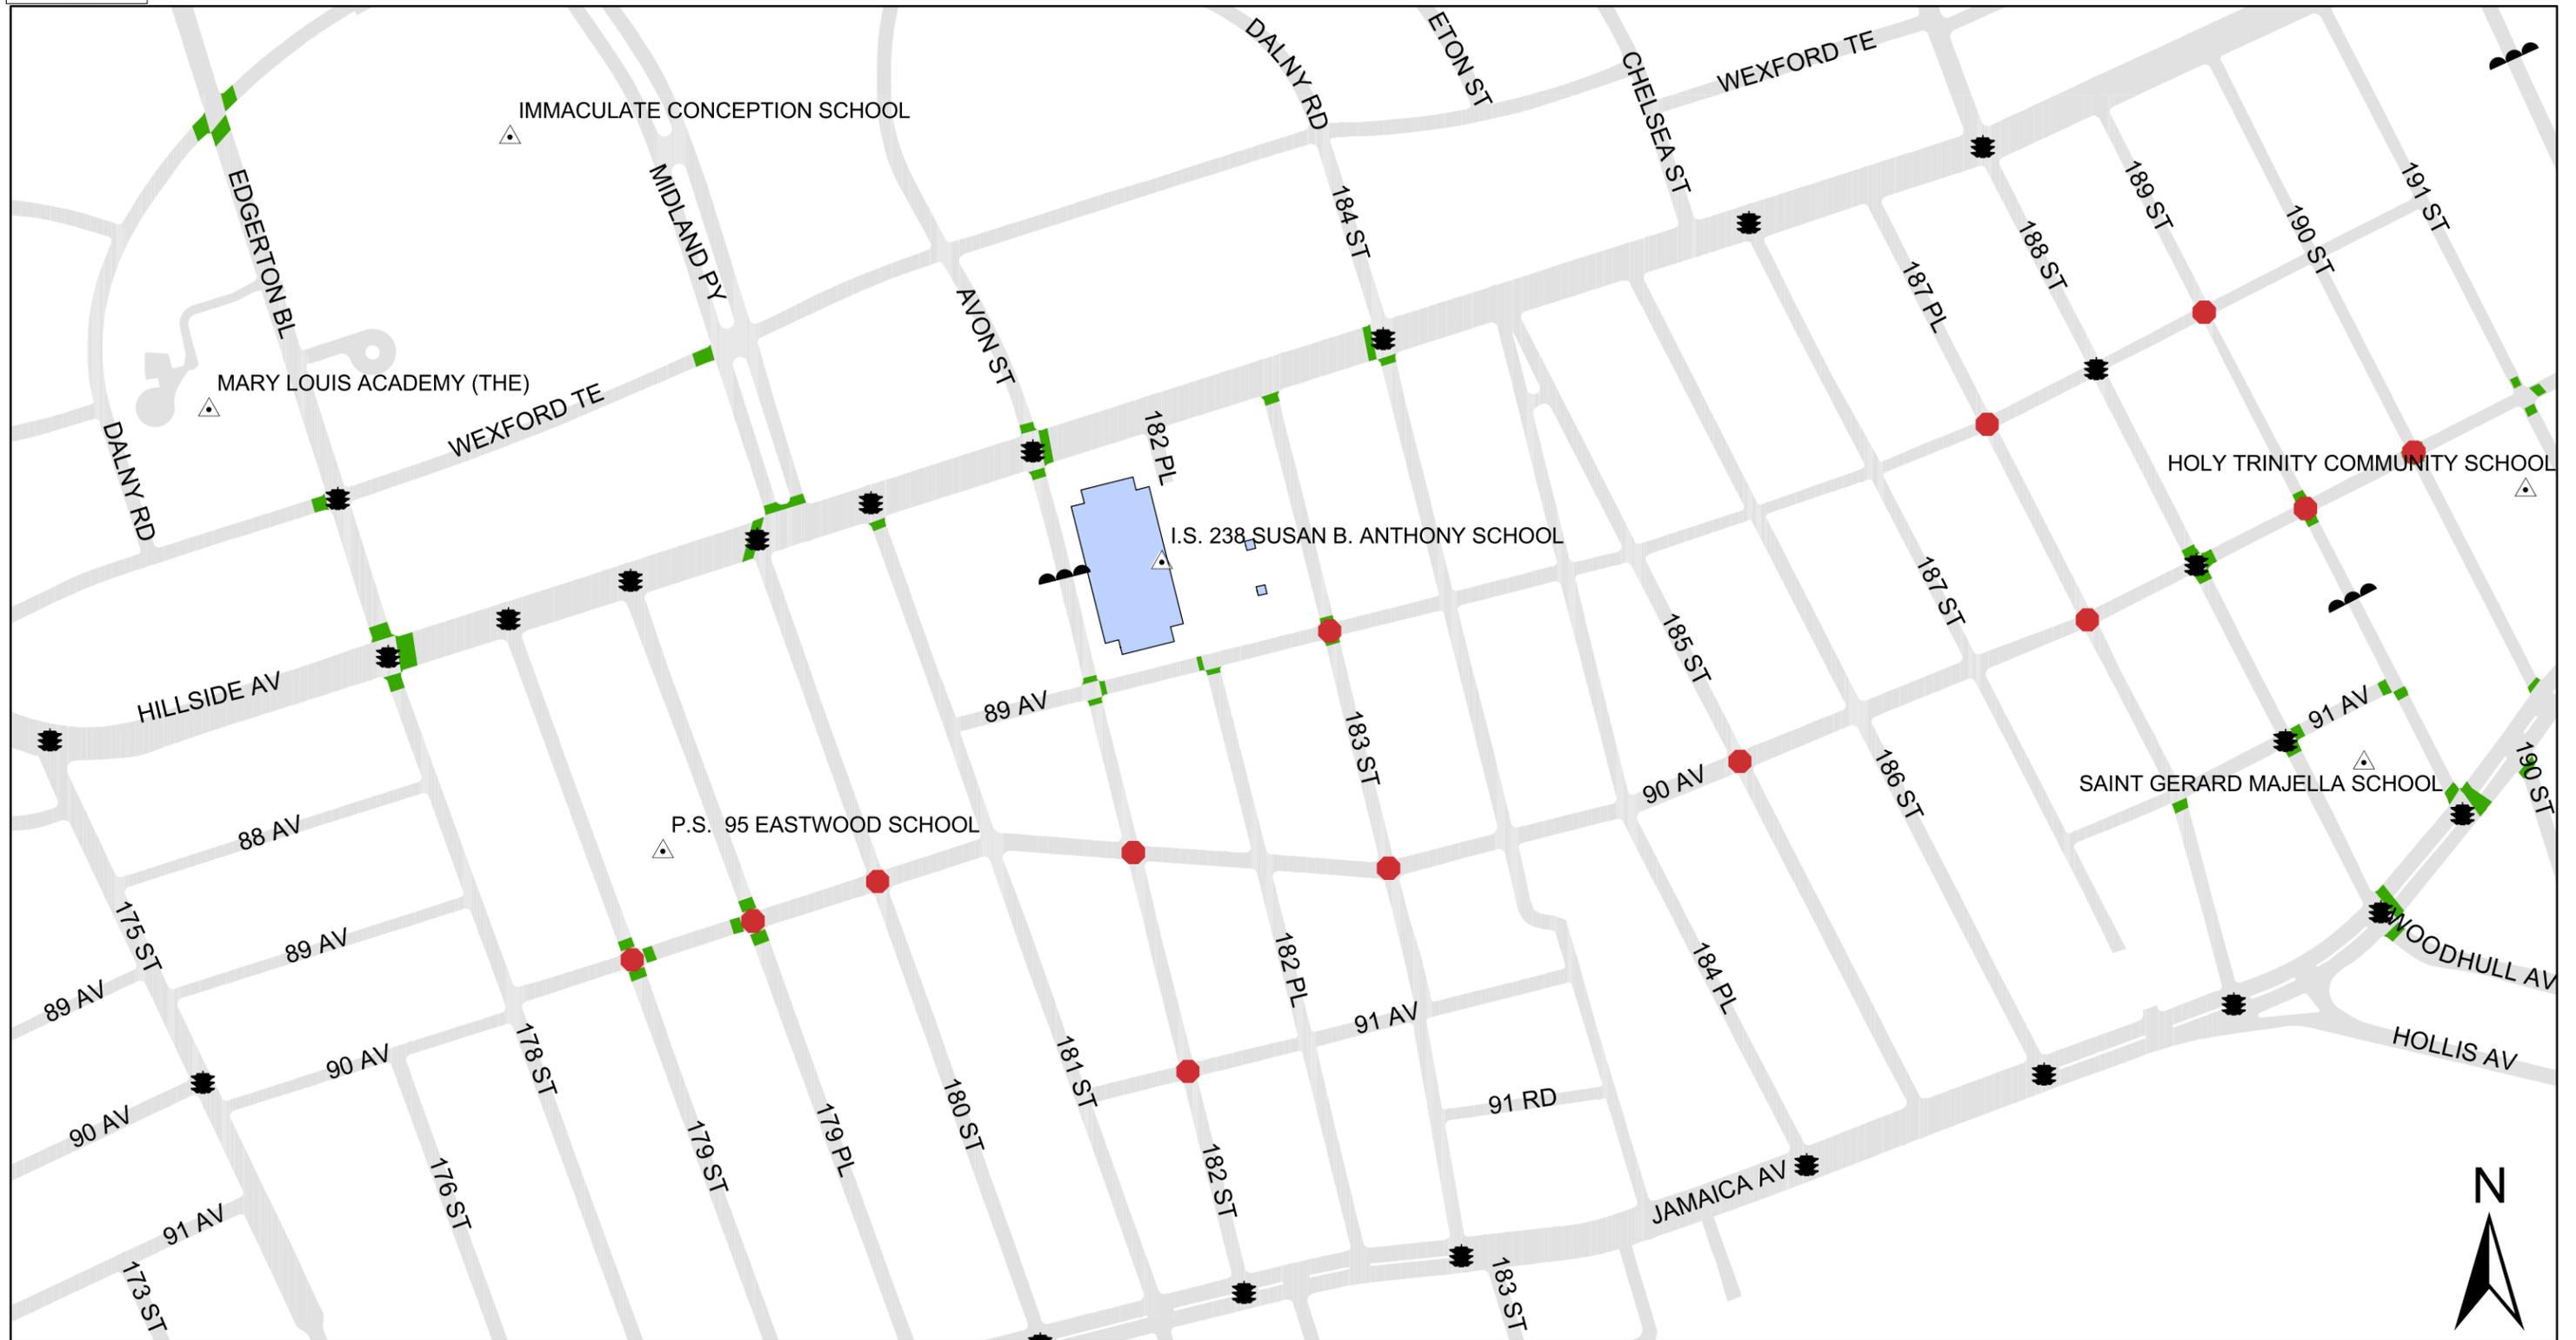
Map created on 11/17/2006 **EXHIBIT 3**

Exhibit 3 shows the existing signals, signs, school crosswalks, and speed reducers in the vicinity of I.S. 238. It should be noted that a citywide signage program is currently underway to upgrade school signage to current Federal Manual on Uniform Traffic Control Devices (MUTCD) standards of fluorescent yellow-green signs accompanied by downward pointing arrows. Signs scheduled to be installed under this program are shown as “existing” in Exhibit 7.

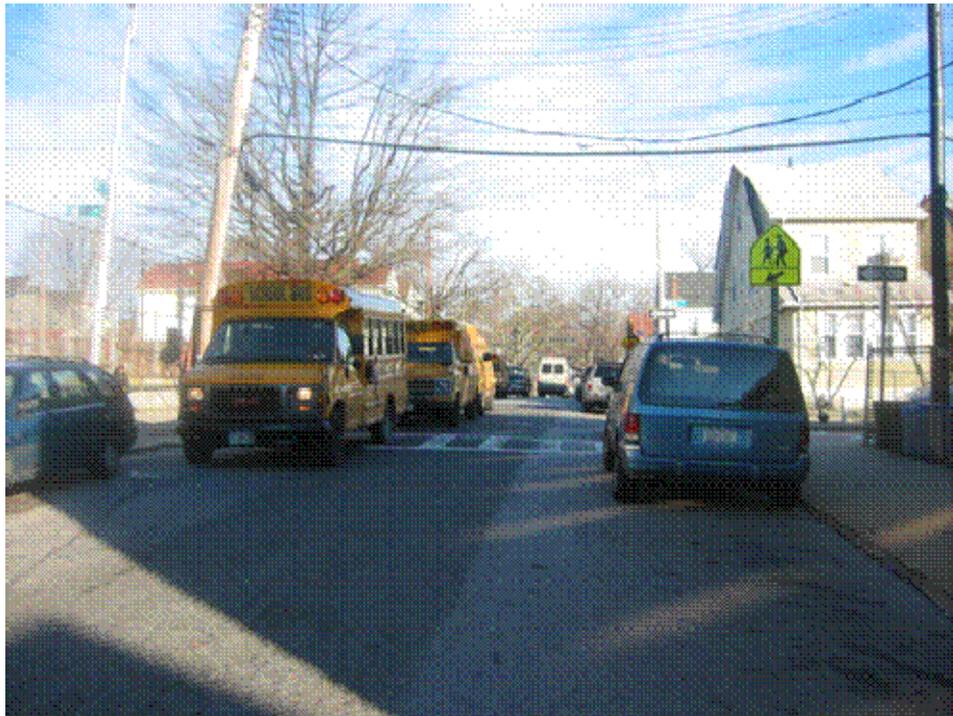
*Figure 6: I.S. 238 students aboard buses along 89<sup>th</sup> Avenue at dismissal time (school bus is shown blocking school crosswalk)*

According to school representatives, approximately 1,500 students take public transportation, including nine MTA buses and subway service running along Hillside Avenue. The F train has stops at East 169<sup>th</sup> Street and East 179<sup>th</sup> Street and the MTA bus stops are at East 182<sup>nd</sup> Street and Dalny Road, all along Hillside Avenue in the vicinity of the school. In addition, approximately 30 students ride a yellow school bus to and from school (see Table 1). Figure 5 through Figure 9 shows bus operations.

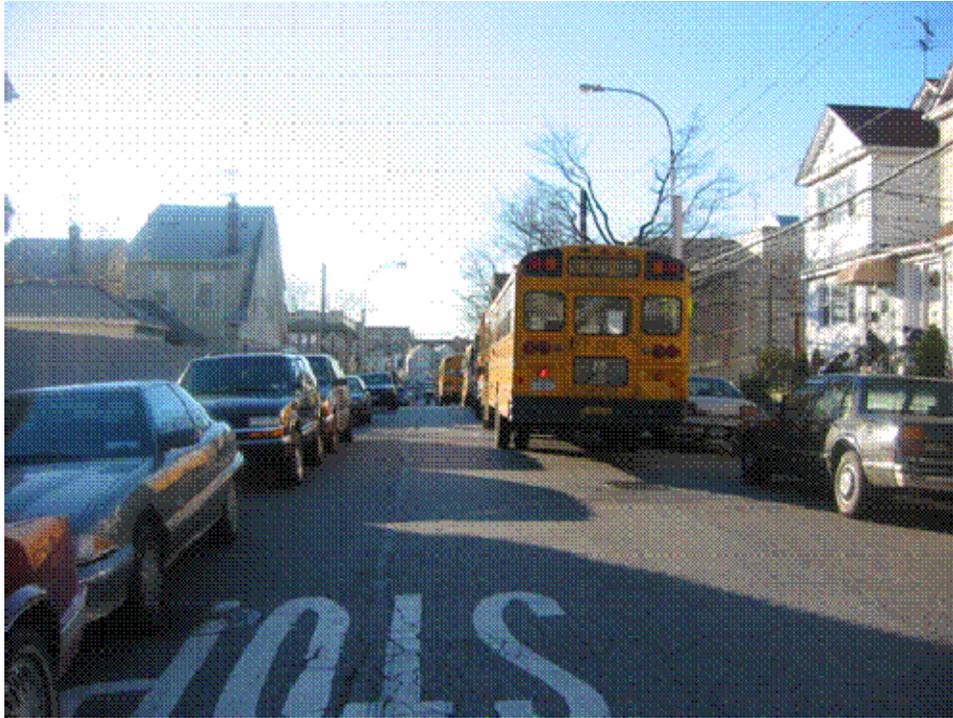
*Figure 7: Due to on-street parking, school buses must double-park along the north side of 89<sup>th</sup> Avenue*

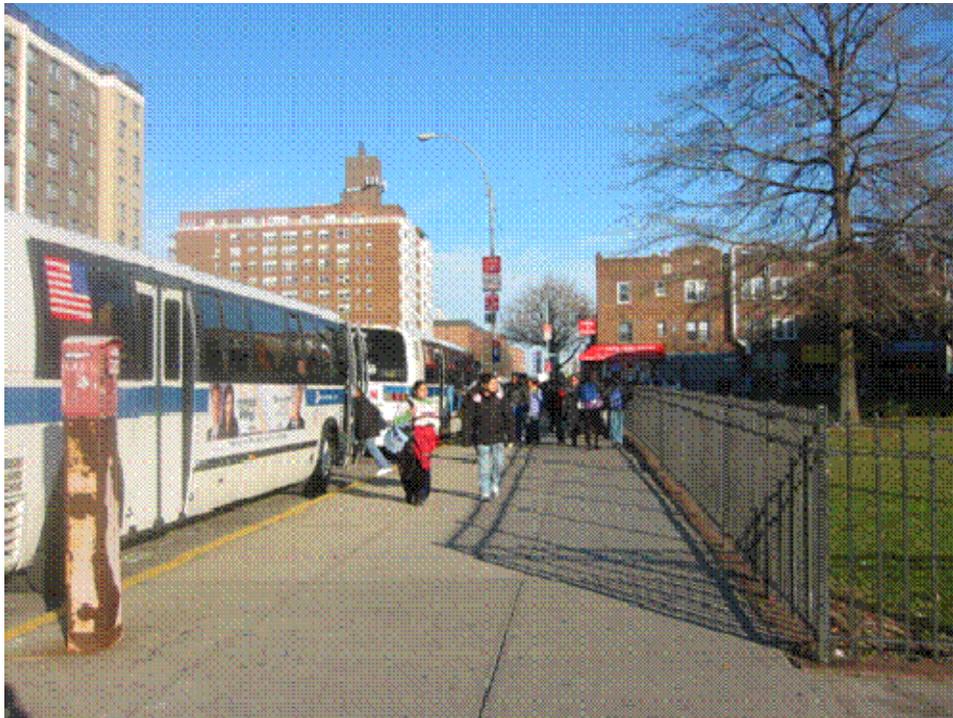
*Figure 8: Queued MTA buses on south side of Hillside Avenue at 182<sup>nd</sup> Place, at dismissal time for I.S. 238*

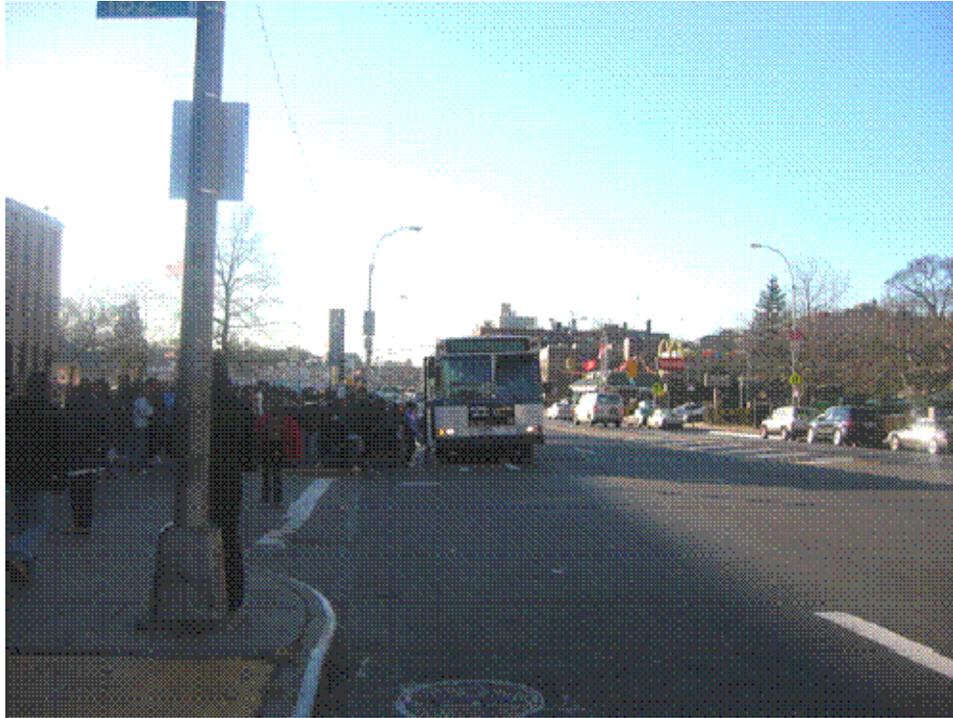
*Figure 9: Following dismissal, I.S. 238 students board MTA buses on the south side of Hillside Avenue at 182<sup>nd</sup> Place*

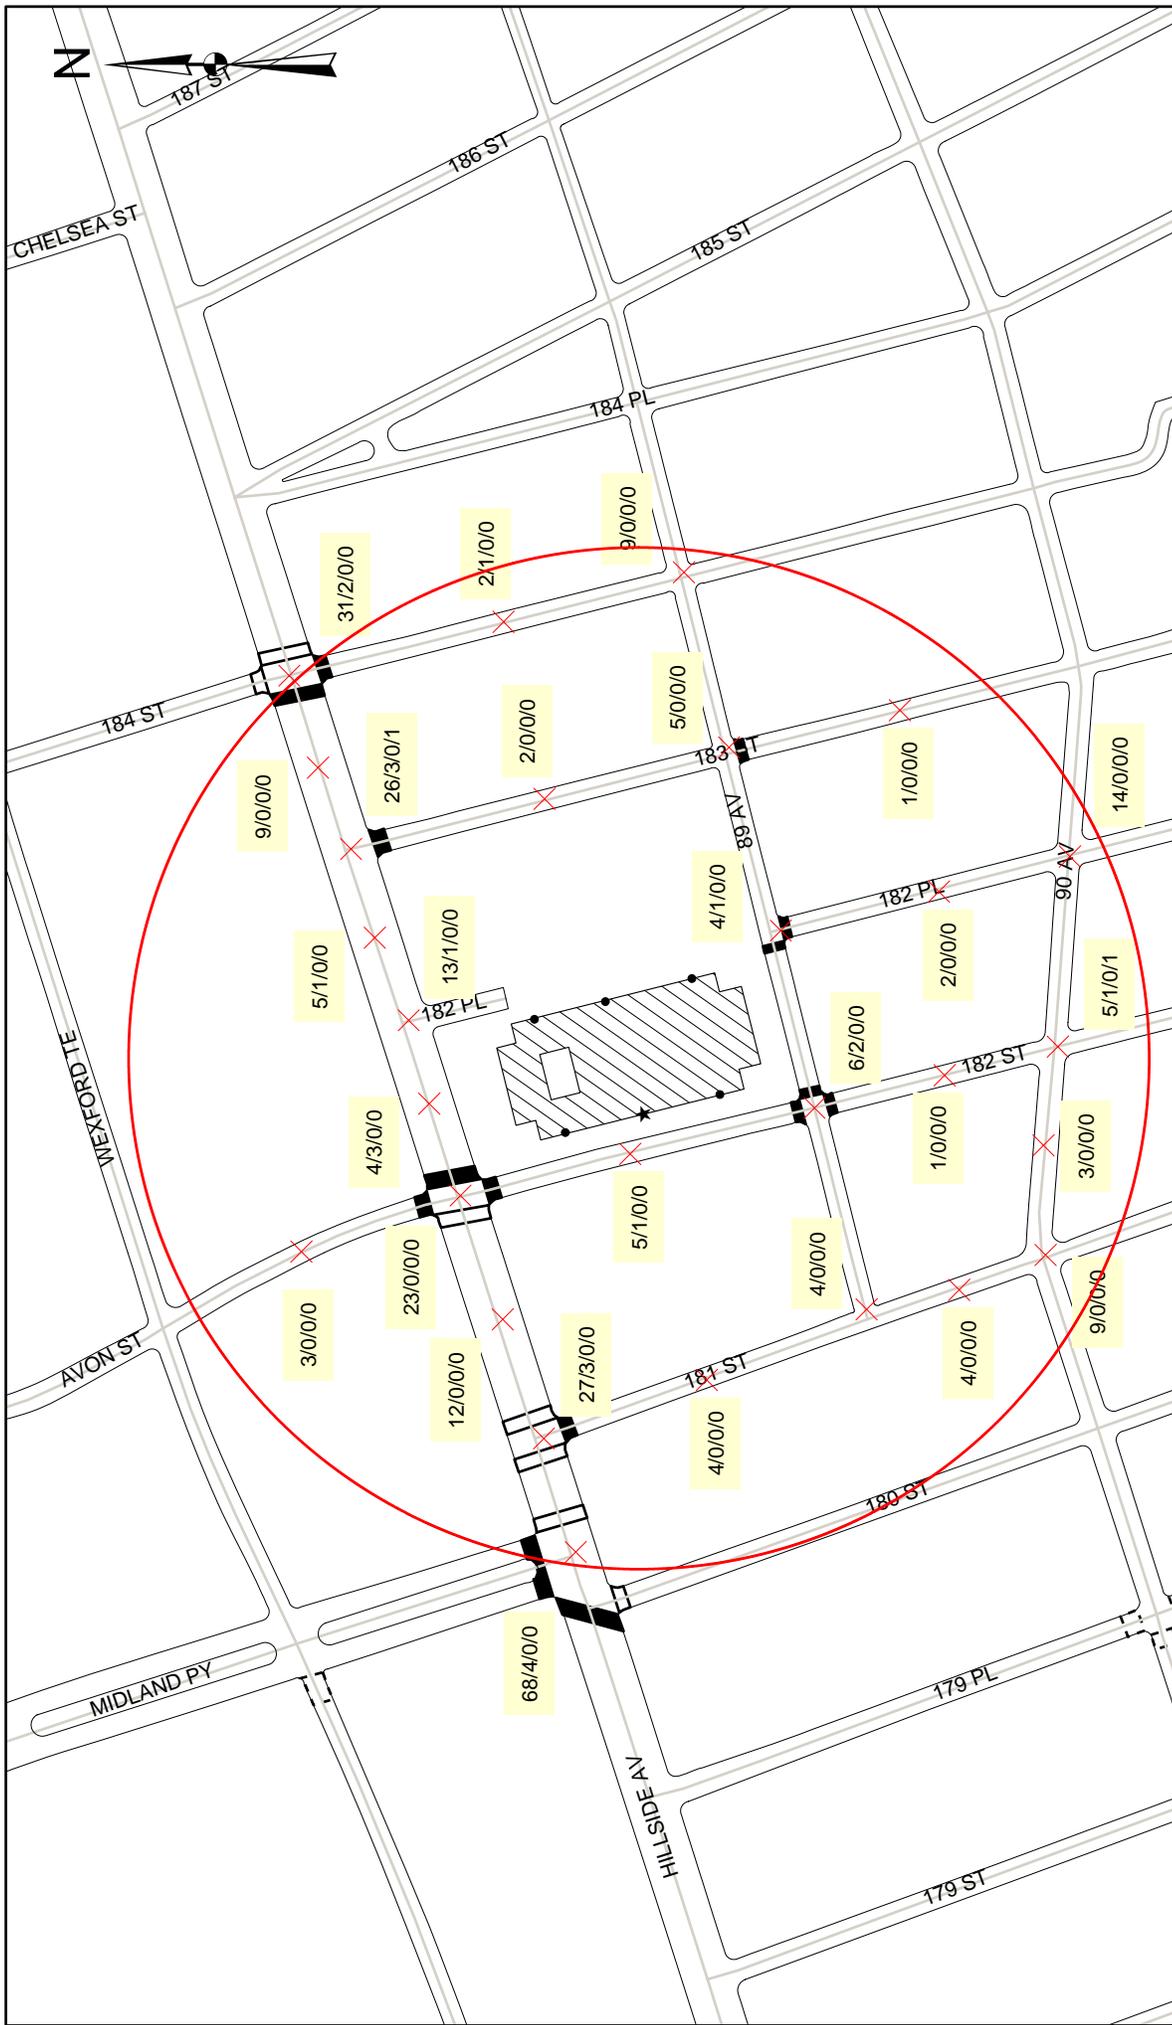
**EXHIBIT 5**  
**I.S. 238 QUEENS**  
**SUSAN B. ANTHONY SCHOOL**  
**ACCIDENT SUMMARY (1998-2000)**

Exhibit 5 and Table 2 show a summary of accidents, as obtained from the New York State Department of Motor Vehicles (DMV), in the vicinity of I.S. 238 for the three-year period from January 1, 1998 through December 31, 2000. The DMV data provides some detail relating to the circumstances and cause of the accident. Table 3 is a summary of more recent accident data obtained from the NYC Police Department (NYPD). Though current through 2004, the NYPD data does not provide the same level of detail as the DMV data.

This report targets intersections closest to the school where the highest concentration of student pedestrians occurs. Intersections farther from the school and locations for which detailed data was not available at the time of this study will be addressed with the ongoing work of DOT's School Safety Engineering Program. DMV accident data is discussed in Section 3.6, Traffic Operations and Issues.

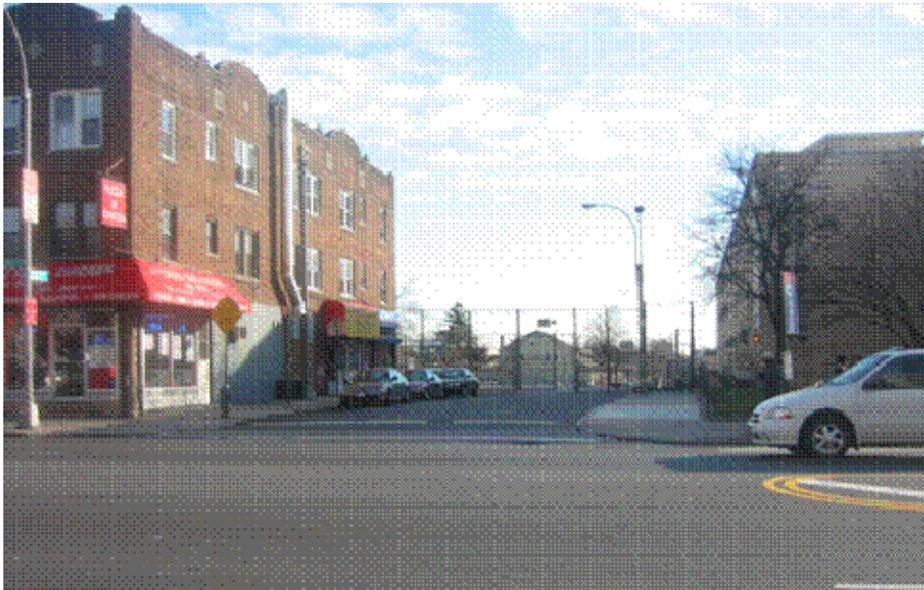
This is an unsignalized T-intersection with no school crosswalks. Hillside Avenue is a two-way street with two traffic lanes and a dedicated bus lane on each side of the roadway, a painted median approximately ten feet wide along the center of the roadway, and dedicated left turn lanes at intersections. Parking is permitted along the curb in the dedicated bus lanes during off-peak hours. 182<sup>nd</sup> Place is situated south of Hillside Avenue and is a two-way street with one traffic lane and on-street parking permitted on both sides of the roadway (see Figure 14). 182<sup>nd</sup> Place extends only approximately 100 feet south of Hillside Avenue. It terminates at a playground/sport fields for I.S. 238. There is a dedicated left turn lane from westbound Hillside Avenue to southbound 182<sup>nd</sup> Place.

There was a total of 13 accidents reported at this intersection between 1998 and 2000 (Table 2). One of these was a pedestrian accident, but was not school-related. There were no pedestrian fatalities reported at this intersection.

*Figure 10: Looking south across Hillside Avenue at 182<sup>nd</sup> Place  
(the school playground/sport fields is located at end of 182nd Place, the school is shown on the right)*

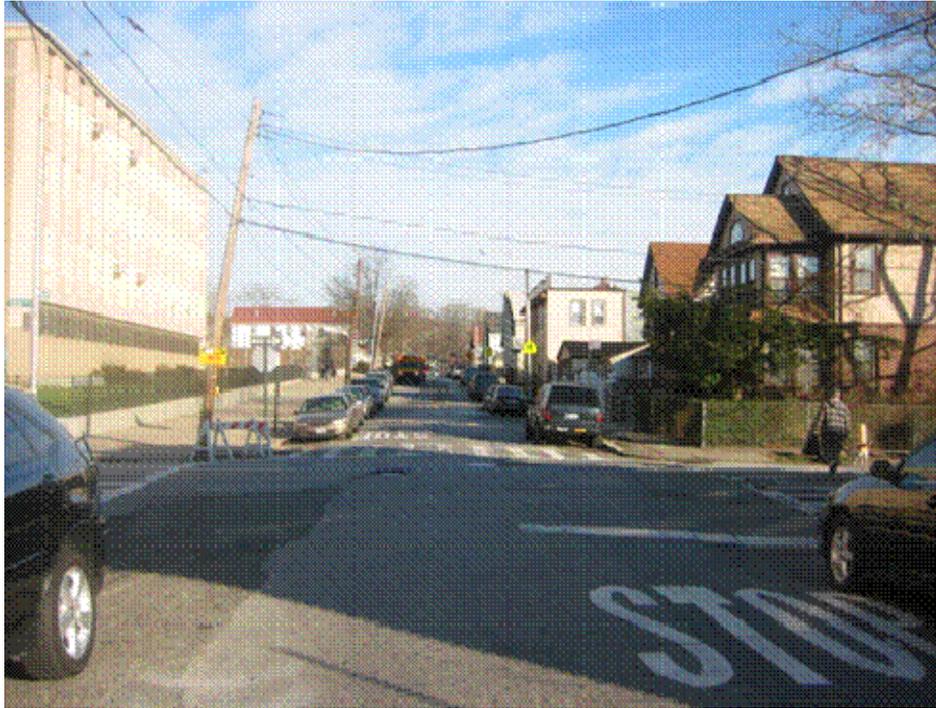
This is an unsignalized four-leg intersection with school crosswalks located across the east leg of 89<sup>th</sup> Avenue, and the north and south legs of 182<sup>nd</sup> Street. 89<sup>th</sup> Avenue is a two-way street with one traffic lane and parking on each side of the roadway. 182<sup>nd</sup> Street is a one-way southbound street with one traffic lane and on-street parking permitted on both sides of the roadway. Traffic movements at both approaches of 182<sup>nd</sup> Street are controlled by stop signs.

There was a total of six accidents reported at this intersection between 1998 and 2000 (Table 2), including two pedestrian accidents, neither of which was school-related. There were no pedestrian fatalities reported at this intersection.

*Figure 11: Looking east on 89th Avenue across 182nd Street (the school is shown on the left)*

Student pedestrians were observed crossing at the uncontrolled school crosswalk of 182<sup>nd</sup> Street at 89<sup>th</sup> Avenue.

It is therefore recommended to:

According to the principal of I.S. 238, students are unsafe crossing the uncontrolled intersections of 182<sup>nd</sup> Street at 89<sup>th</sup> Avenue and 89<sup>th</sup> Avenue at 182<sup>nd</sup> Place. Therefore, the following action is recommended:

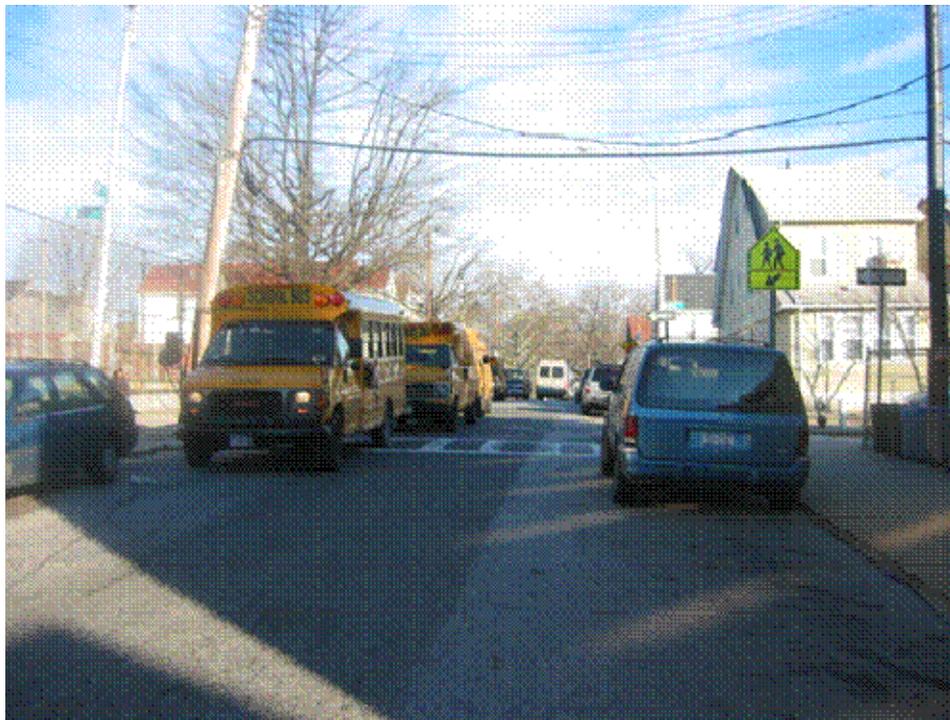
Figure 12: Looking east on 89th Avenue at the 182nd Place intersection (school buses are shown waiting for student dismissal)

There was a total of five accidents reported at this intersection between 1998 and 2000 (Table 2), including one pedestrian accident that was also school-related. This school-related accident occurred at approximately 3:00 pm on April 3, 2000, when a six-year-old pedestrian sustained a “non-incapacitating injury” while crossing at the intersection. The accident occurred under cloudy, daylight conditions, and the road surface was reported as dry. There were no pedestrian fatalities reported at this intersection.

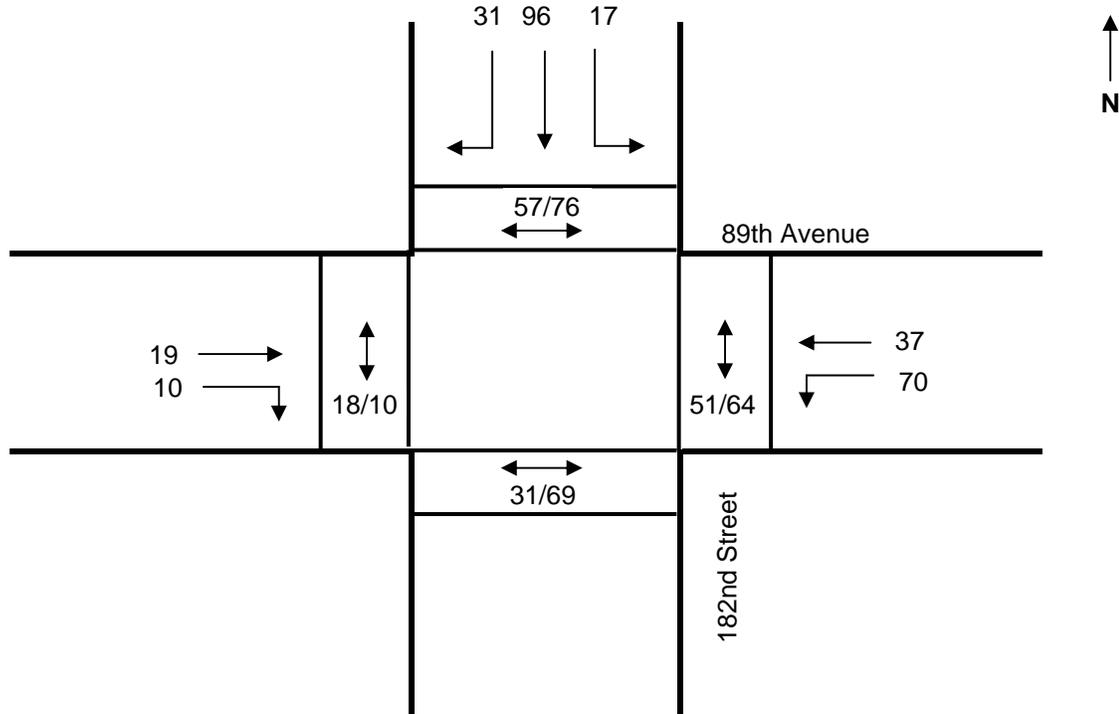
<b>EXHIBIT 6A</b>
<b>I.S. 238 QUEENS</b>
<b>SUSAN B. ANTHONY SCHOOL</b>
<b>TRAFFIC AND PEDESTRIAN COUNTS</b>

In order to determine the appropriate level of traffic control for the school crosswalks, a preliminary traffic signal warrant assessment was performed to assess the traffic situation and determine what type of traffic control devices would be appropriate. A traffic count was conducted at the intersection of 89<sup>th</sup> Avenue and 182<sup>nd</sup> Street, from 7:30 to 9:00 am on Tuesday, June 21, 2005. The results of the peak hour (7:30 to 8:30 am) count are shown in Tables 4 and 5, and in Exhibit 6A at the end of this section.

As shown in Table 5, the pedestrian volume count determined there were 28 pedestrians (18 adults and 10 students) utilizing the school crosswalk located across the west leg of 89<sup>th</sup> Avenue, and 115 pedestrians (51 adults and 64 students) utilizing the pedestrian crosswalk located across the east leg of 89<sup>th</sup> Avenue. This results in a total of 143 pedestrians crossing 89<sup>th</sup> Avenue at 182<sup>nd</sup> Street (69 adults and 74 students) during the 7:30 to 8:30 a.m. time period.

**One Hour Traffic Volumes**  
**Tuesday, June 21st, 2005 7:30am - 8:30m**

**Intersection of 182nd Street and 89th Avenue**

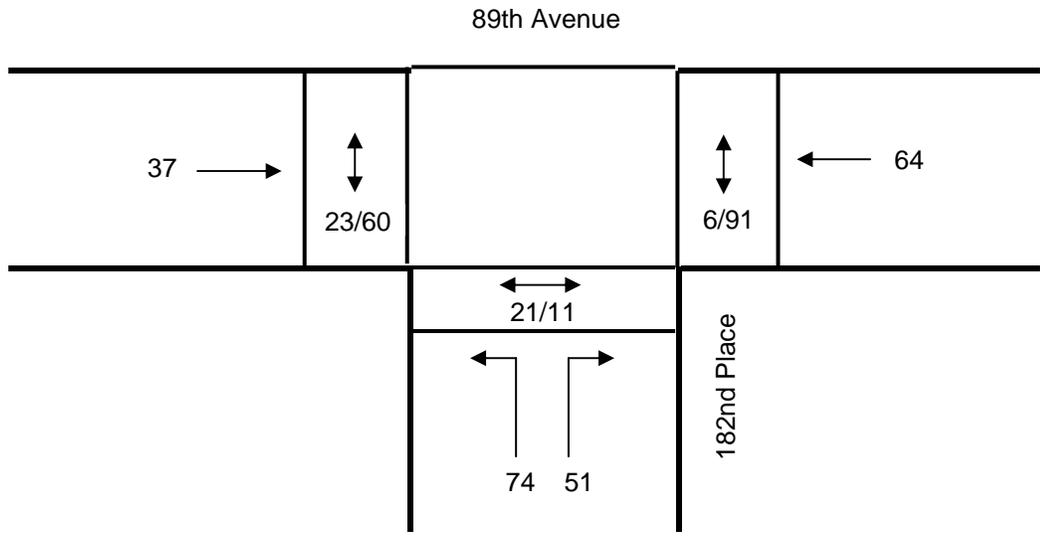
**One Hour Traffic Volumes**  
**Tuesday, September 27th, 2005 7:30 am - 8:30 am**

***Intersection of 182nd Place and 89th Avenue***

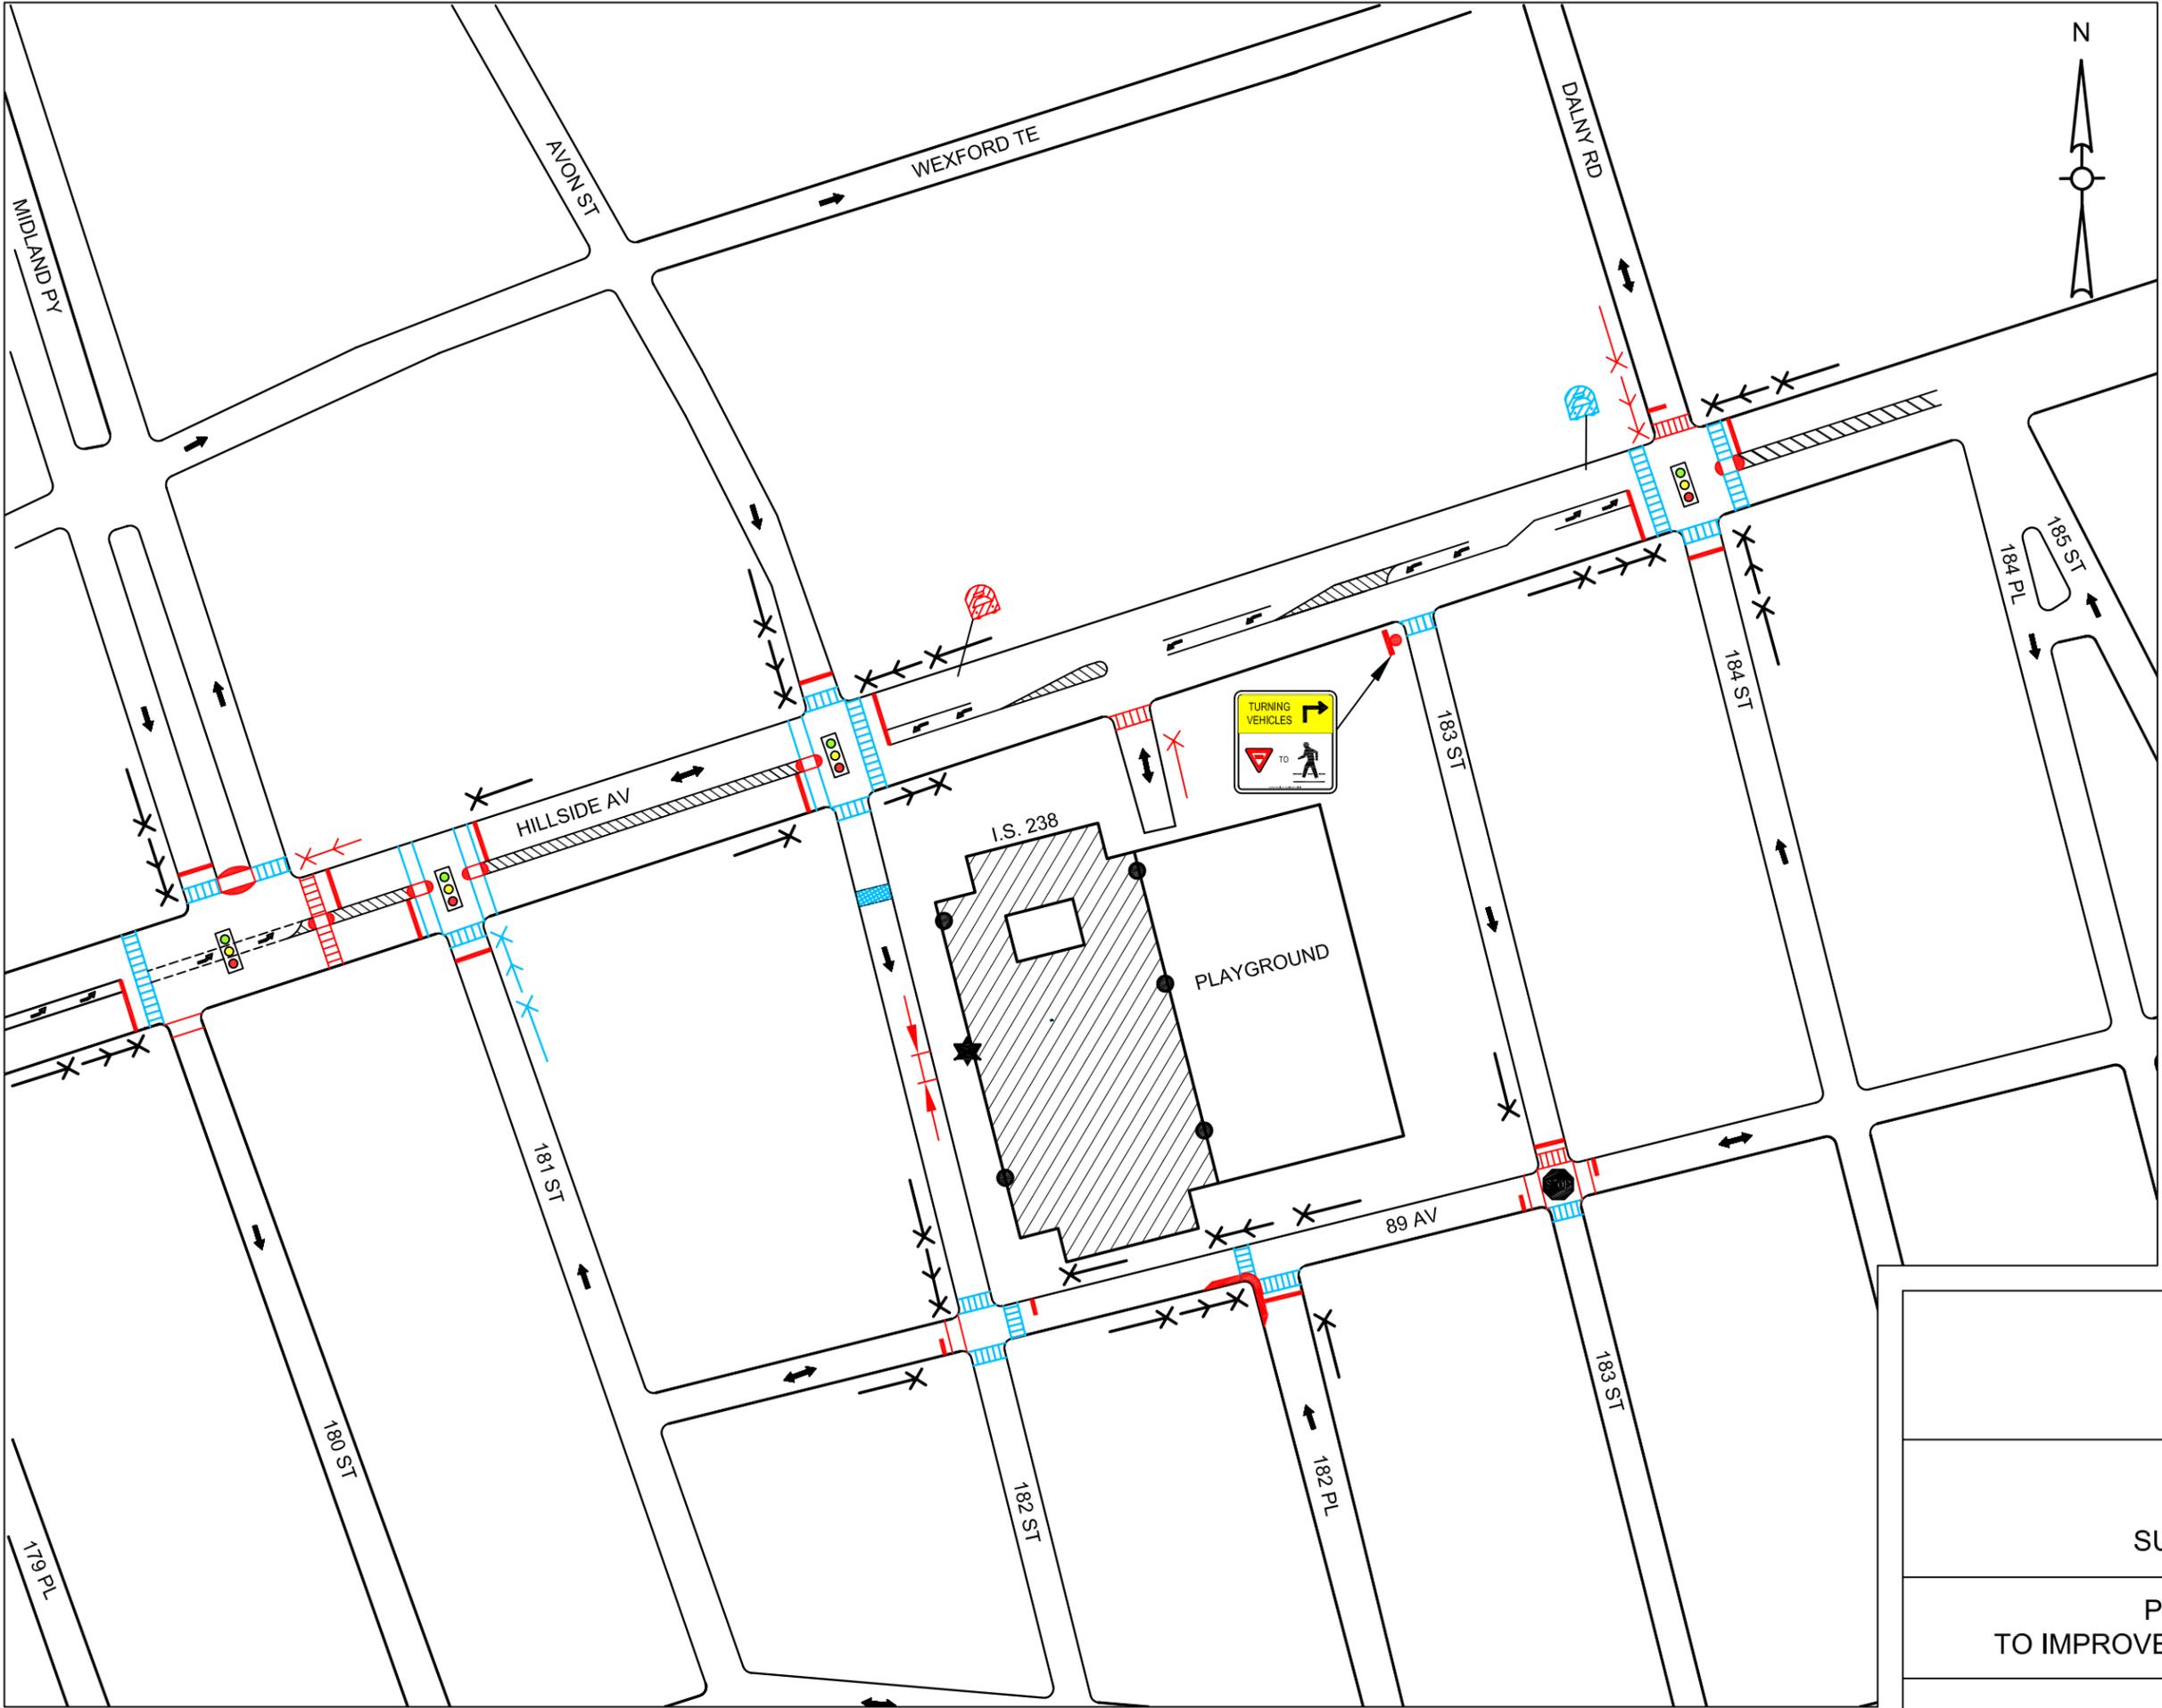
POTENTIAL MEASURES  
TO IMPROVE STUDENT PEDESTRIAN SAFETY

This section describes proposed measures to improve school pedestrian safety around I.S. 238. The proposed recommendations are divided into short-term and long-term measures. Short-term measures are those that potentially can be performed in-house. Long-term measures involve capital improvements. Each of the short- and long-term measures recommended for the I.S. 238 is discussed as follows, and is shown in more detail in Exhibit 7 at the end of this section.

Install “YIELD TO PEDESTRIAN” signs at intersection approaches with substantial vehicle–student pedestrian volumes at intersections assigned to this school. “YIELD TO PEDESTRIAN” signs are recommended on the following approaches of signalized intersections around I.S. 238:

It is therefore recommended to re-designate the following existing pedestrian crosswalks as school crosswalks, and install all appropriate warning devices:

The MUTCD and New York City DOT standard for placement of a stop bar is four feet in advance of a marked crosswalk. At signalized (or stop controlled) crosswalks, the vehicle stop line can be placed farther back from the crosswalk in order to maximize visibility of pedestrians and to minimize the potential for pedestrian/vehicle conflicts. Therefore, it is recommended that stop bars be placed ten feet in advance of all school crosswalks.

Consideration should be given to installing curb extensions at the following locations, provided that the Final Design confirms that construction of the recommended curb extensions would be feasible and not interfere with traffic operations. Final details pertaining to the number, location and geometry of curb extensions will be developed during the Final Design/Contract Document preparation.

There is a striped median along the center of Hillside Avenue, separating eastbound and westbound traffic. It is therefore recommended to:

- Provide a pedestrian refuge island at the east leg of Hillside Avenue at Dalny Road
- Provide a pedestrian refuge island at the west leg of Hillside Avenue at 182<sup>nd</sup> Street
- Provide a pedestrian refuge island at the east and west legs of Hillside Avenue at 181<sup>st</sup> Street
- Provide a pedestrian refuge island at the east leg of Hillside Avenue at Midland Parkway

The islands, as shown in Exhibit 7, will provide a refuge for pedestrians who do not complete the crossing during the flashing “DON’T WALK” indication. The proposed median should be at least five feet wide, should extend beyond the crosswalk, and should have at least five feet at grade cut through section. These medians are not proposed where they would hinder the ability of vehicles to turn. Final details pertaining to proposed refuge islands and curb extensions will be developed during Final Design.
