**New York City Department of Transportation
Office of School Safety Engineering**

School Safety Engineering Project

FINAL REPORT: P.S 96, Queens

**Prepared by
The RBA Group and URBITRAN Associates Inc.**

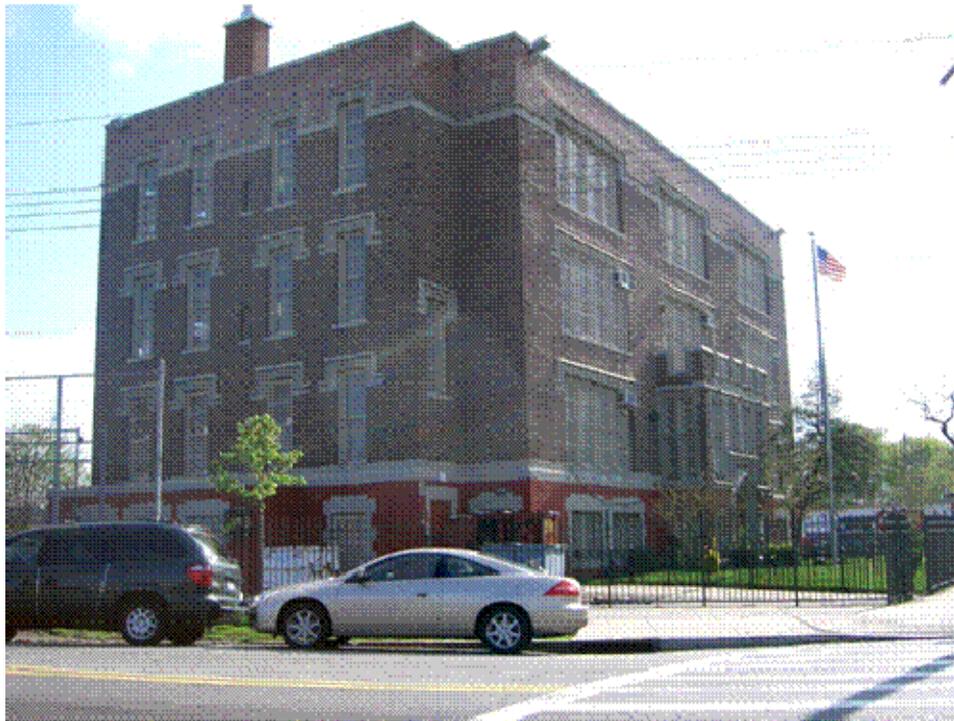
Figure 1: Looking northeast at P.S. 96 from the intersection of Rockaway Boulevard and 130th Street

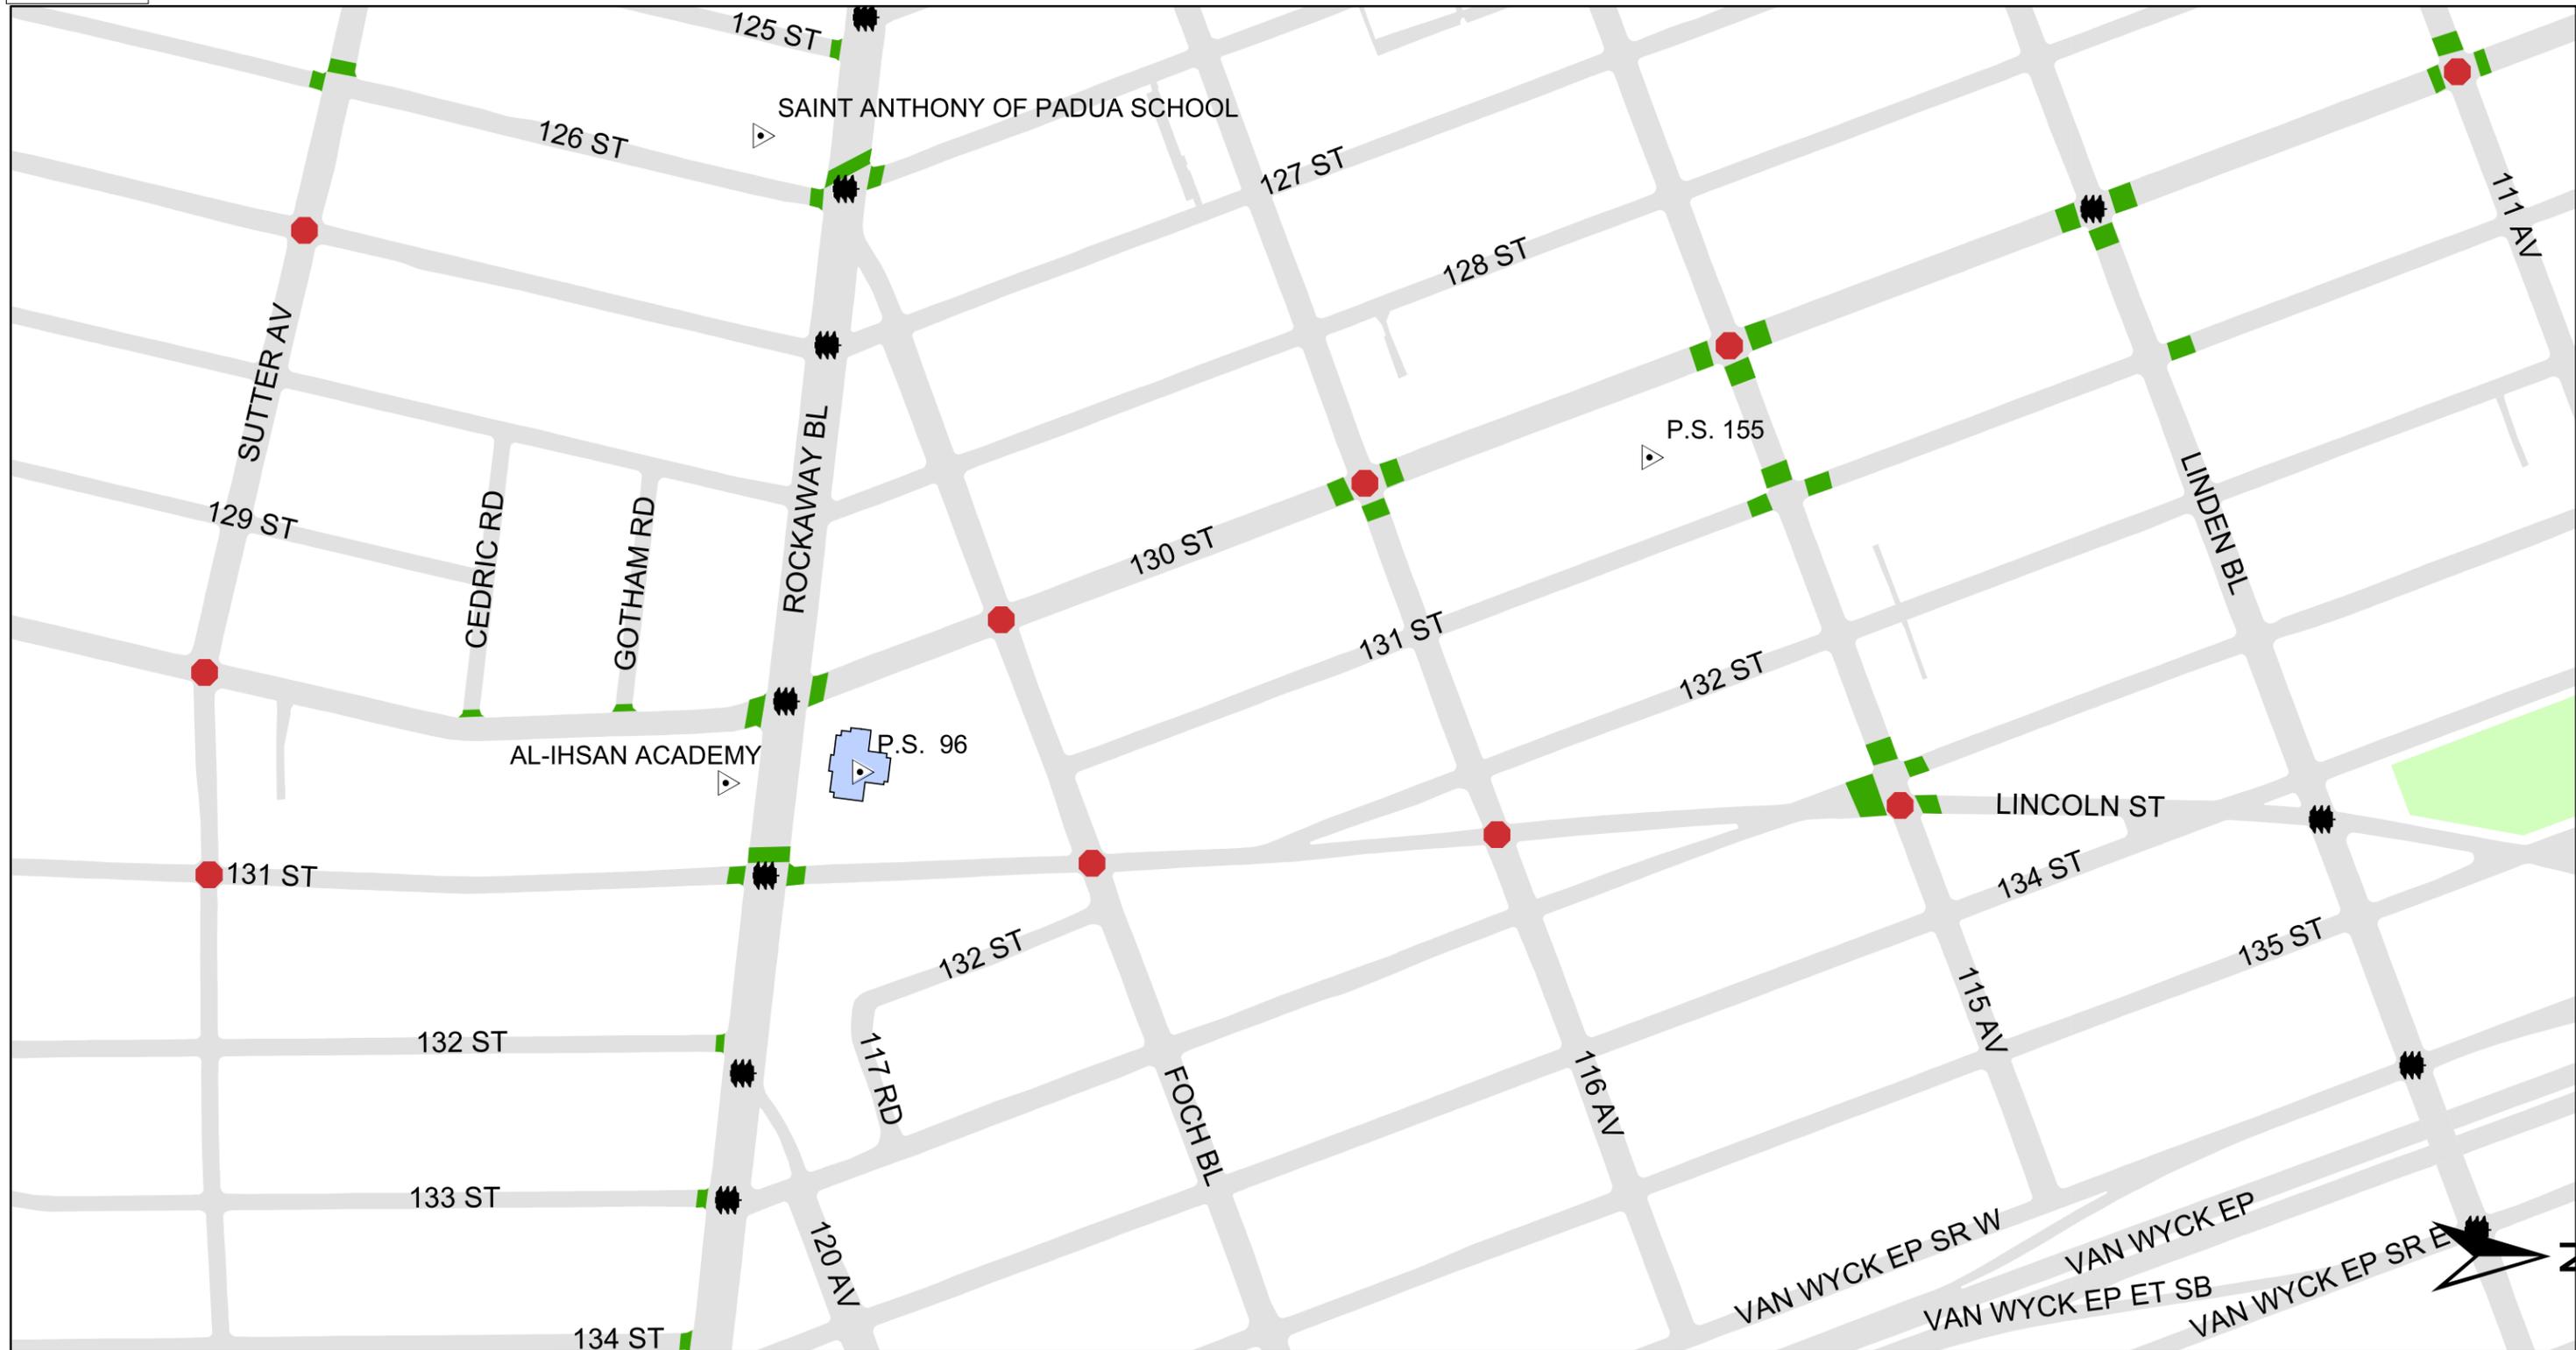
EXHIBIT 3

The School Traffic Safety Map was established to help provide the maximum degree of safety for children going to and from school - by indicating the location of speed reducers, school crosswalks and some traffic control devices. (While virtually all intersections in NYC benefit from traffic control devices - such as stop signs, traffic signals, yield signs, and all way stop signs - this map shows only traffic signals and all way stop signs.) The school crosswalks that are shown are ladder striped and make the crosswalk more visible to drivers and help make the intersection safer. These crosswalks are where school children are recommended to cross.

Exhibit 3 shows the existing signals and school crosswalks in the vicinity of P.S. 96. It should be noted that a citywide signage program is currently underway to upgrade school signage to current Federal Manual on Uniform Traffic Control Devices (MUTCD) standards of fluorescent yellow-green signs accompanied by downward pointing arrows. Signs scheduled to be installed under this program are shown as “existing” in Exhibit 7.

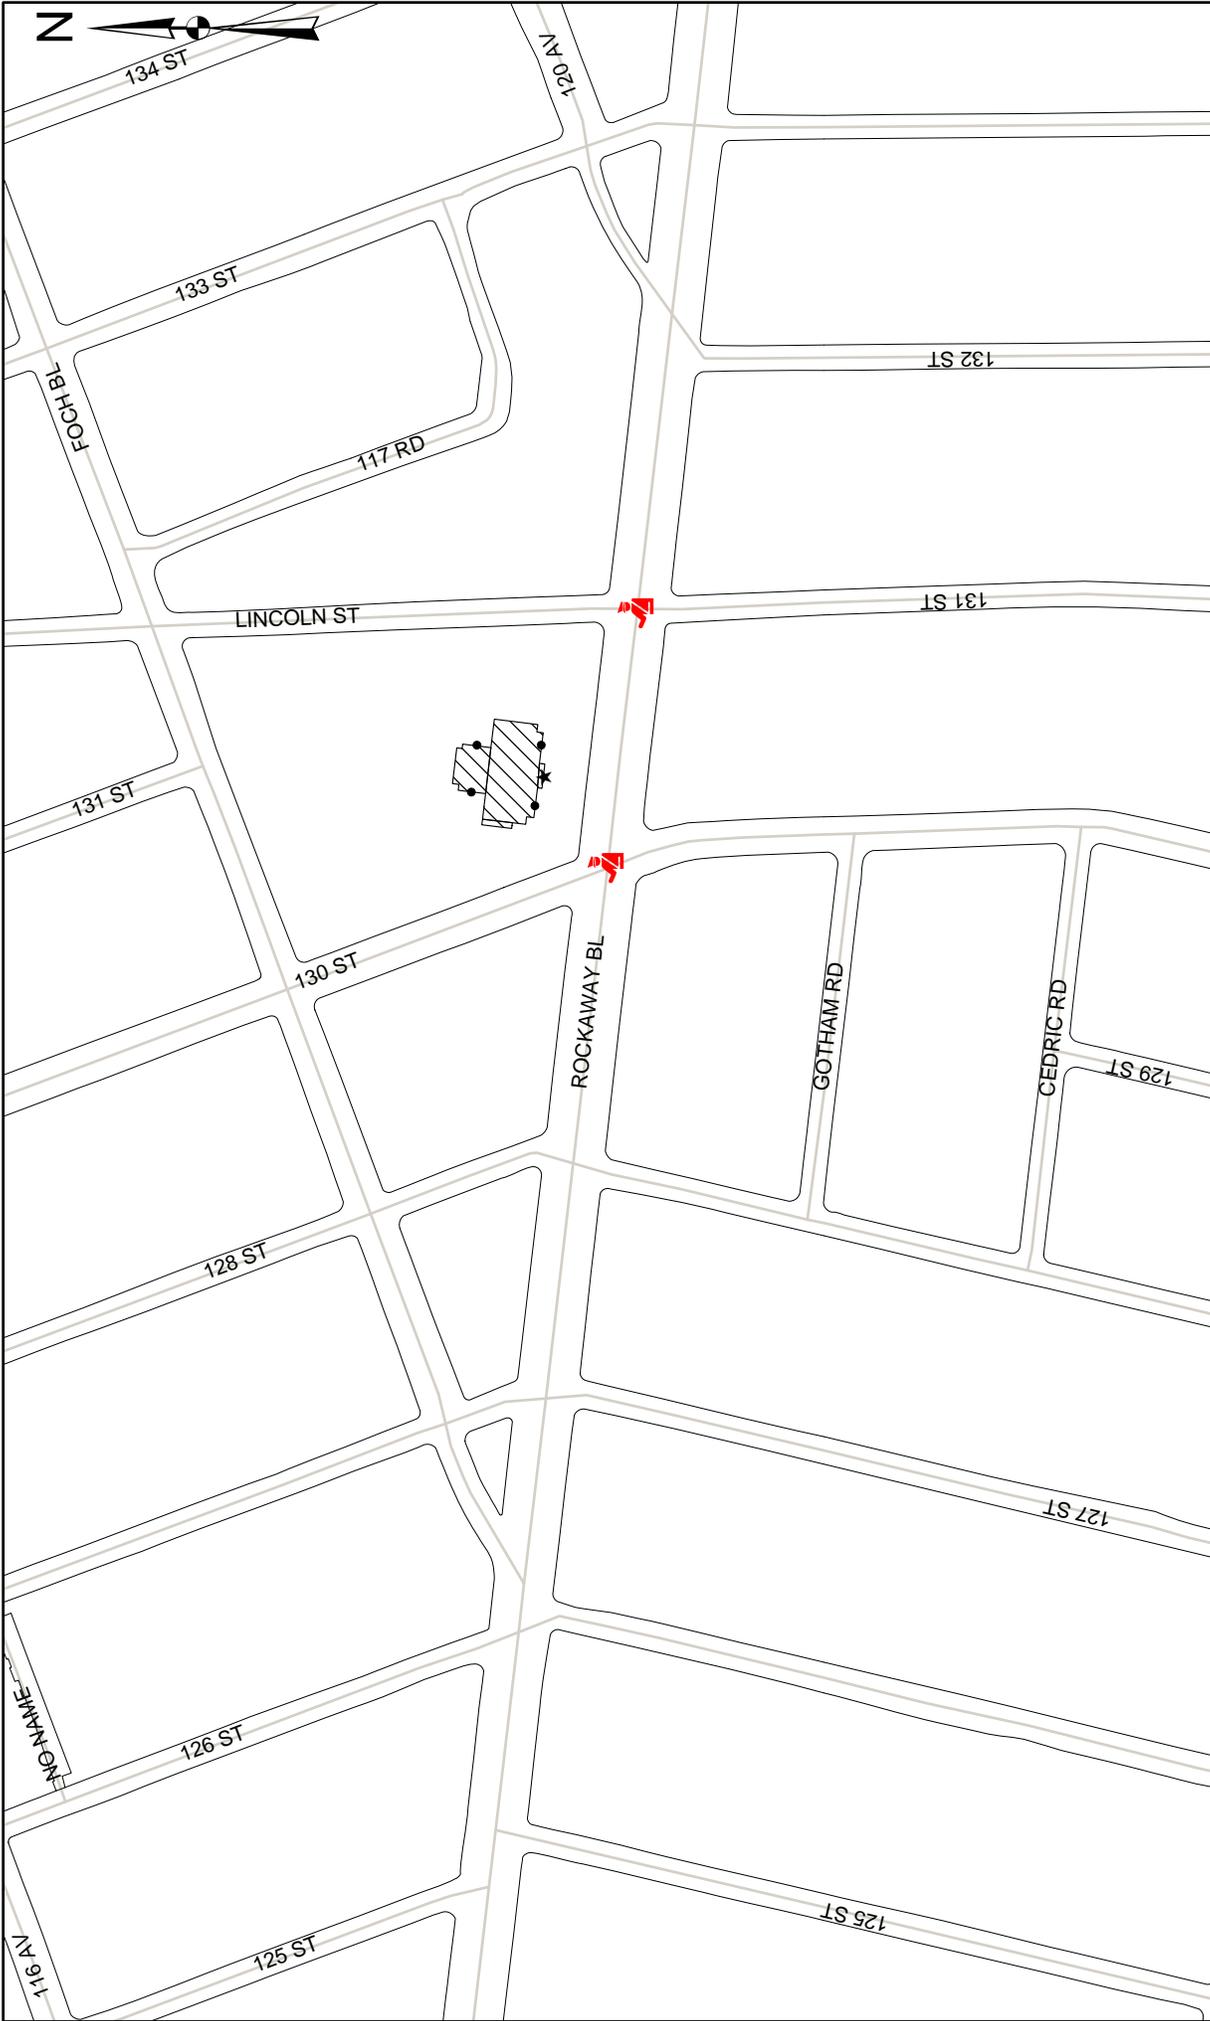
EXHIBIT 4

According to the school representatives, two crossing guards are assigned to P.S. 96. The first crossing guard is stationed at the intersection of Rockaway Boulevard and 130th Street and the second is stationed at the intersection of Rockaway Boulevard and Lincoln Street. The crossing guard locations are shown in Exhibit 4.

CROSSING GUARD LOCATIONS

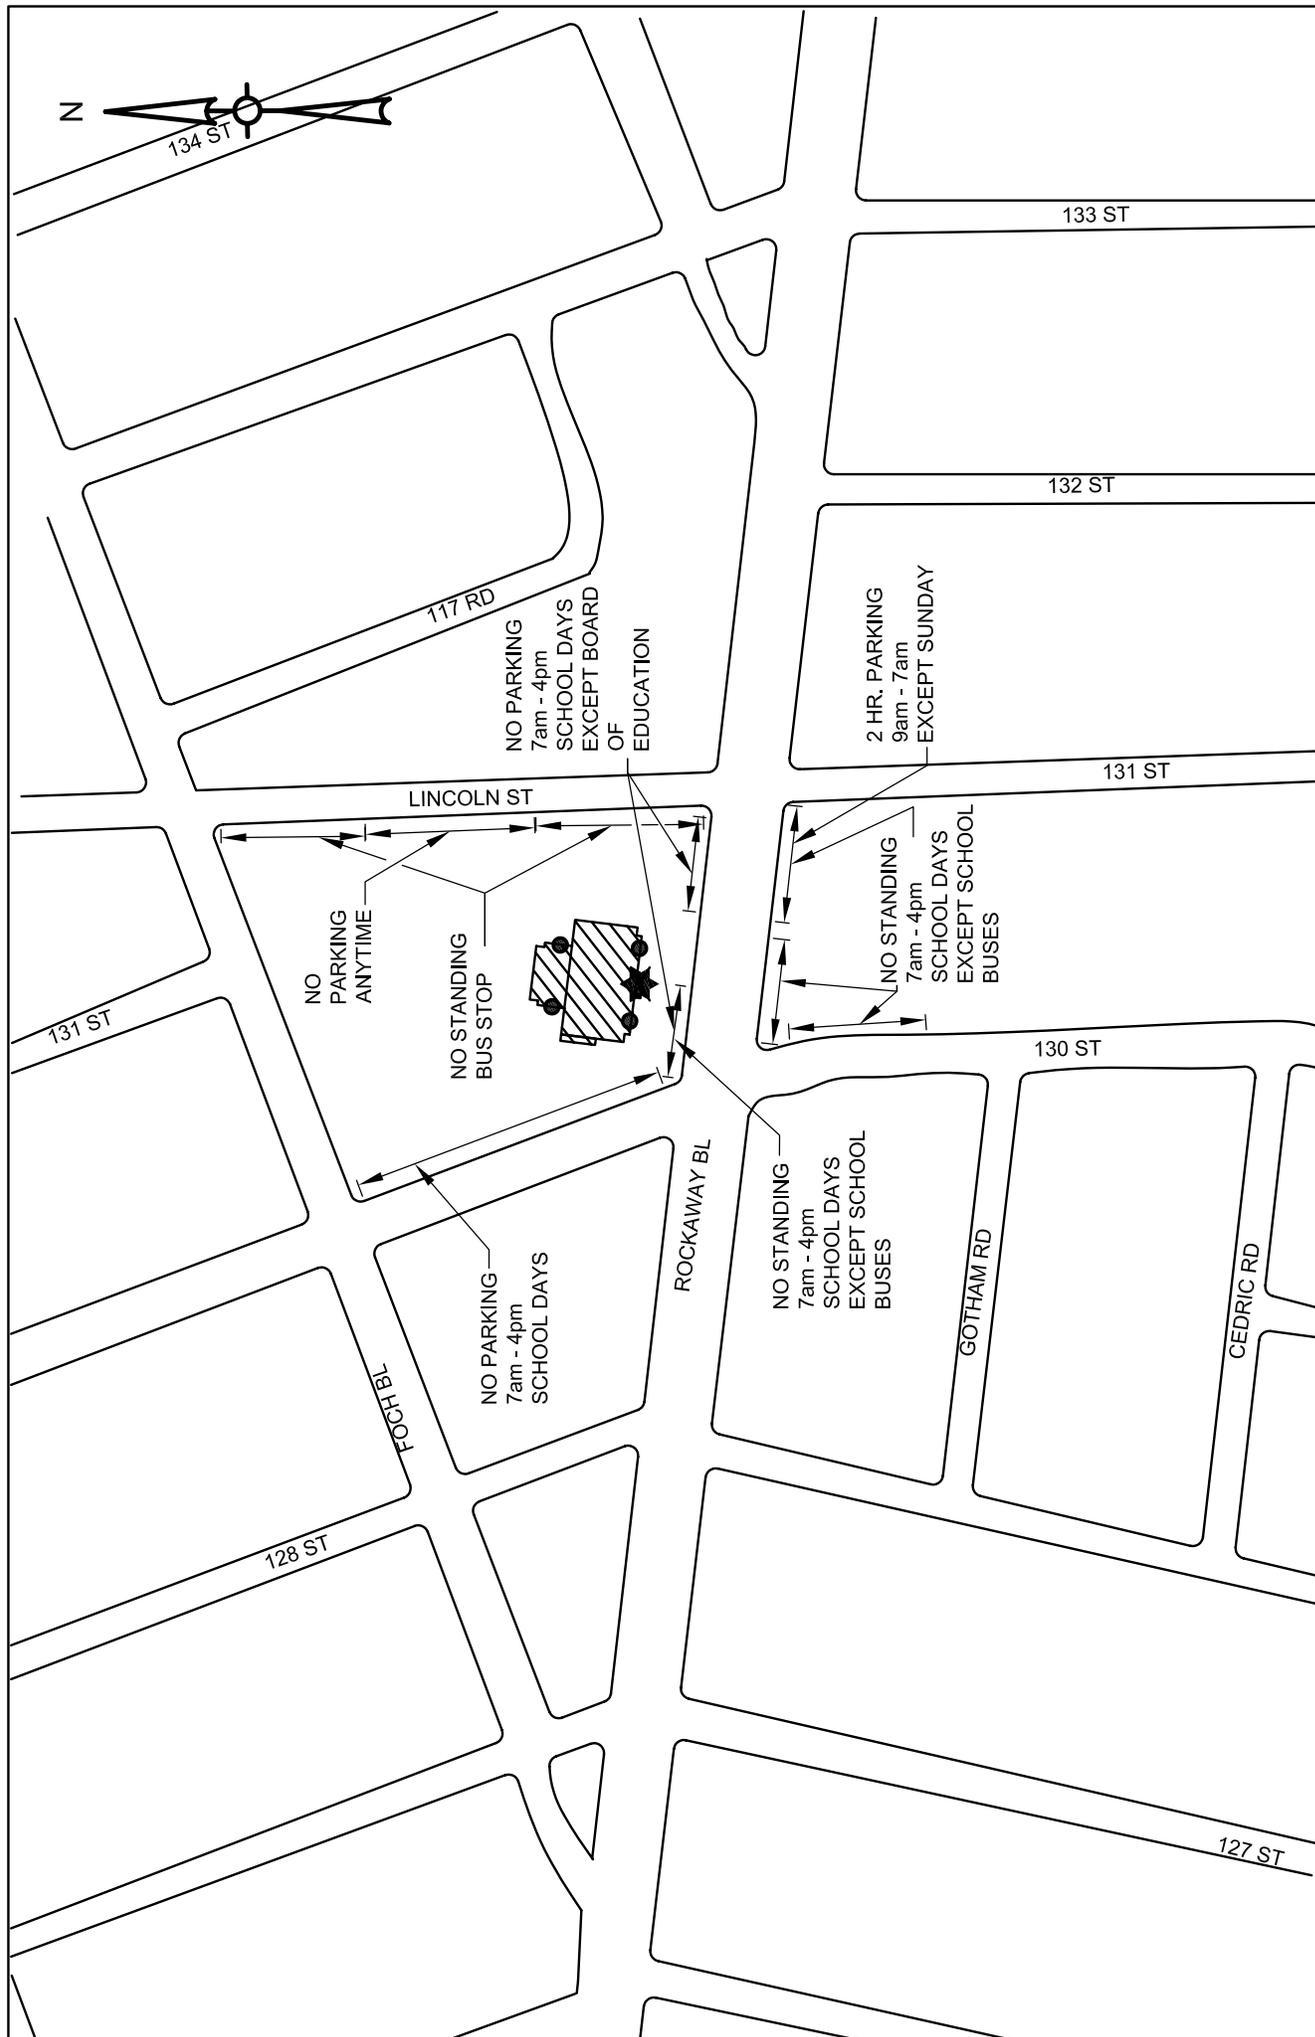
EXHIBIT 5
P.S. 96 QUEENS

Parking regulations in the vicinity of P.S. 96 are shown in Exhibit 5.

EXISTING PARKING REGULATION

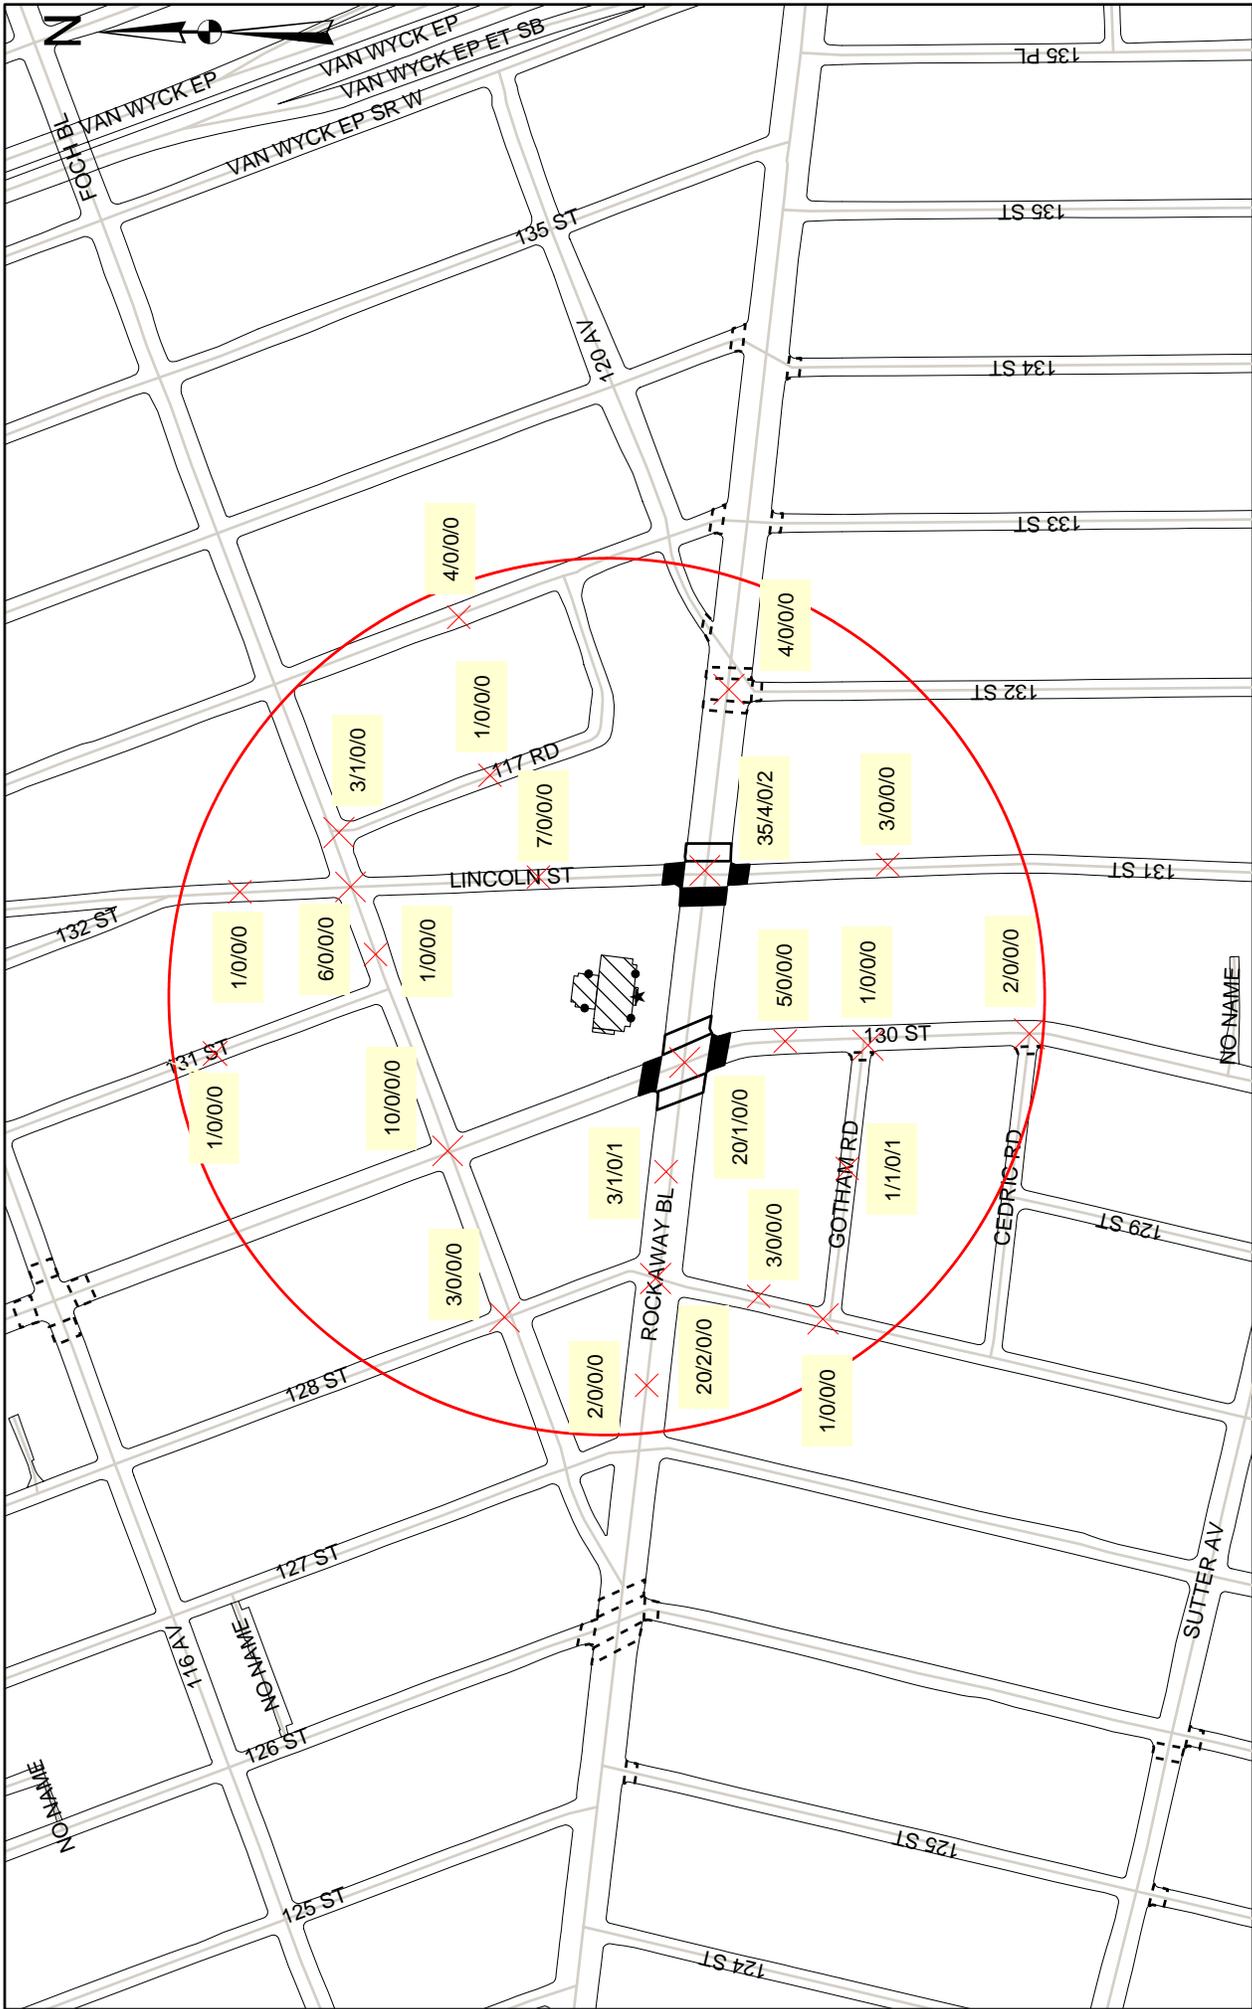
EXHIBIT 6

Exhibit 6 and Table 2 show a summary of accidents, as obtained from the New York State Department of Motor Vehicles (DMV), in the vicinity of P.S. 96 for the three-year period from January 1, 1998 through December 31, 2000. The DMV data provides some detail relating to the circumstances and cause of the accident. Table 3 is a summary of more recent accident data obtained from the NYC Police Department (NYPD). Though current through 2004, the NYPD data does not provide the same level of detail as the DMV data.

ACCIDENT SUMMARY (1998-2000)

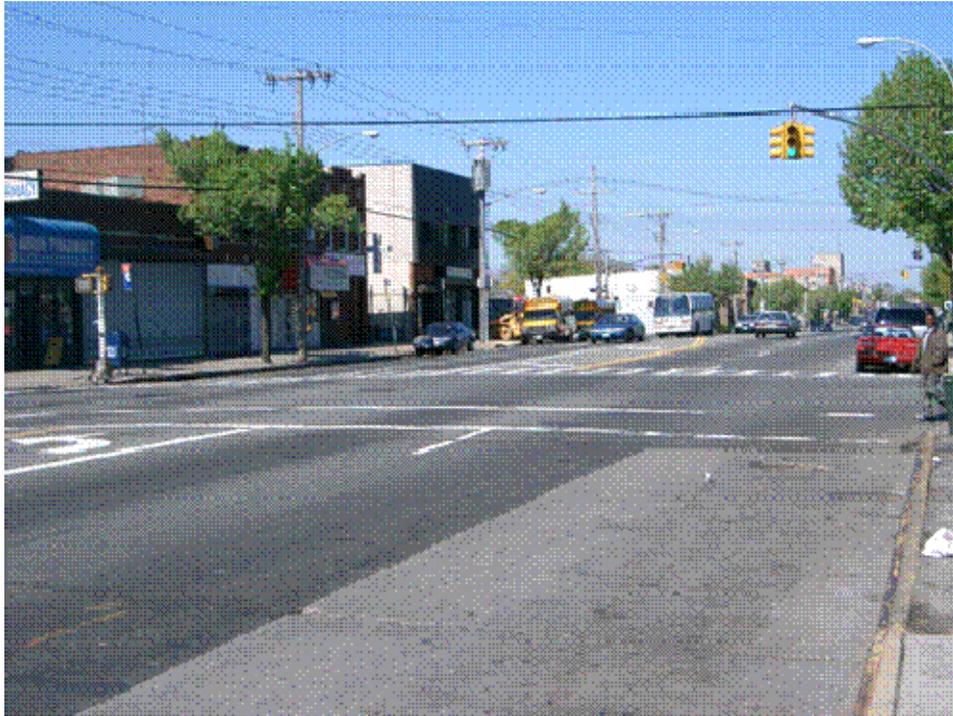
Figure 2: Looking west on Rockaway Boulevard between Lincoln Street and 130th Street

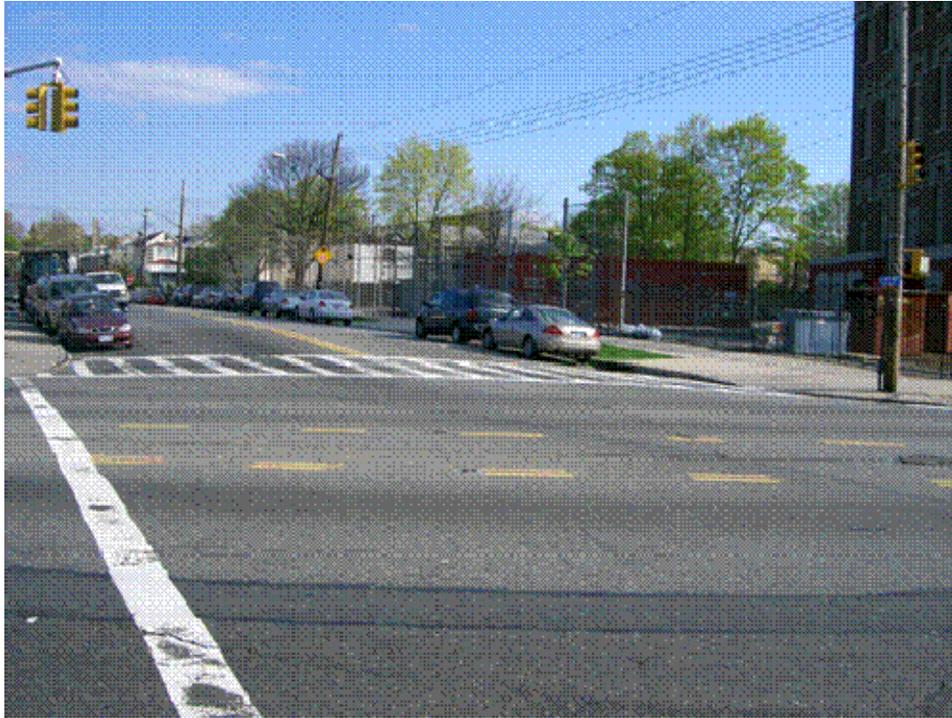
This is a four-leg signalized intersection with school crosswalks located across the north and south legs of 130th Street, and pedestrian crosswalks located across the east and west legs of Rockaway Boulevard. In the vicinity of P.S. 96, Rockaway Boulevard is a two-way east-west arterial roadway with two travel lanes and one on-street parking lane in each direction. In addition, there is a striped center median on Rockaway Boulevard that provides eastbound and westbound left-turn lanes at public street intersections, including 130th Street (see Figure 2). 130th Street is a two-way north-south street with one travel lane and one on-street parking lane in each direction (see Figure 3). A bus stop for the Q7 and Q10 bus lines is located on the south side of Rockaway Boulevard on the east (far) side of its intersection with 130th Street.

Figure 3: Looking north along 130th Street from the intersection with Rockaway Boulevard

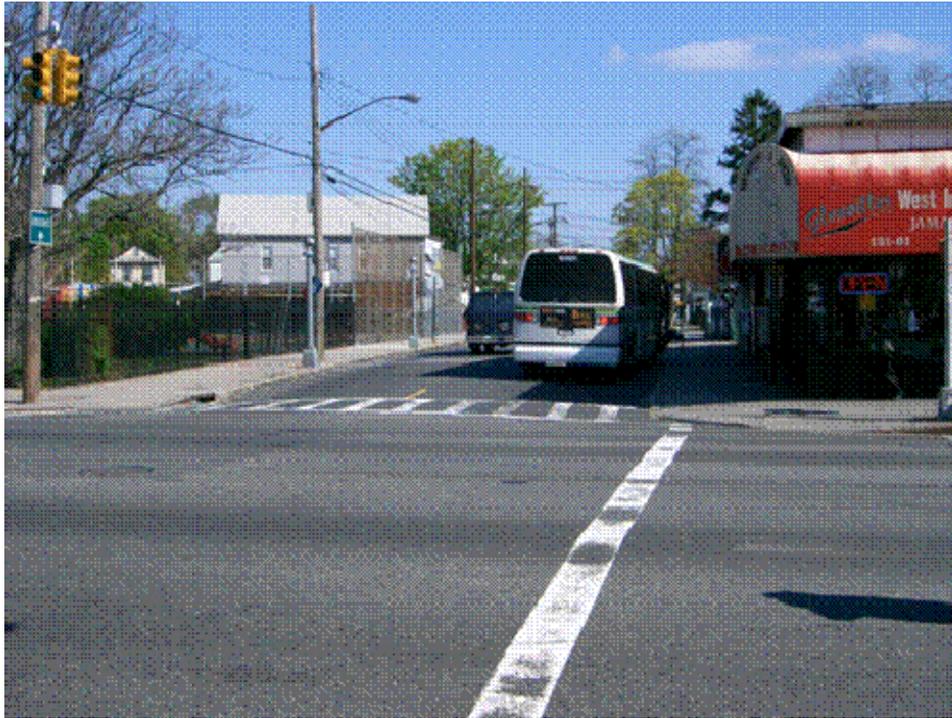
This is a four-leg signalized intersection with school crosswalks located across the north leg of Lincoln Street, the south leg of 131st Street and west leg of Rockaway Boulevard. Rockaway Boulevard is a two-way east-west arterial roadway consisting of two travel lanes and one on-street parking lane in each direction. In addition, there is a striped center median on Rockaway Boulevard that provides eastbound and westbound left-turn lanes at public street intersections, including the intersection with Lincoln Street/131st Street. Lincoln Street (north leg) and 131st Street (south leg) are both two-way north-south streets with one travel lane and one on-street parking lane in each direction (see Figure 4). Bus stops for the Q7, Q9, Q9A and Q10 lines are located on the north side (Q7) and south side (Q10) of Rockaway Boulevard on the near sides of its intersection with Lincoln Street/131st Street, on the east and west sides of Lincoln Street (Q9 and Q9A), north of Rockaway Boulevard, and on the east side (Q10) of 131st Street, south of Rockaway Boulevard.

Figure 4: Looking north along Lincoln Street from the intersection with Rockaway Boulevard

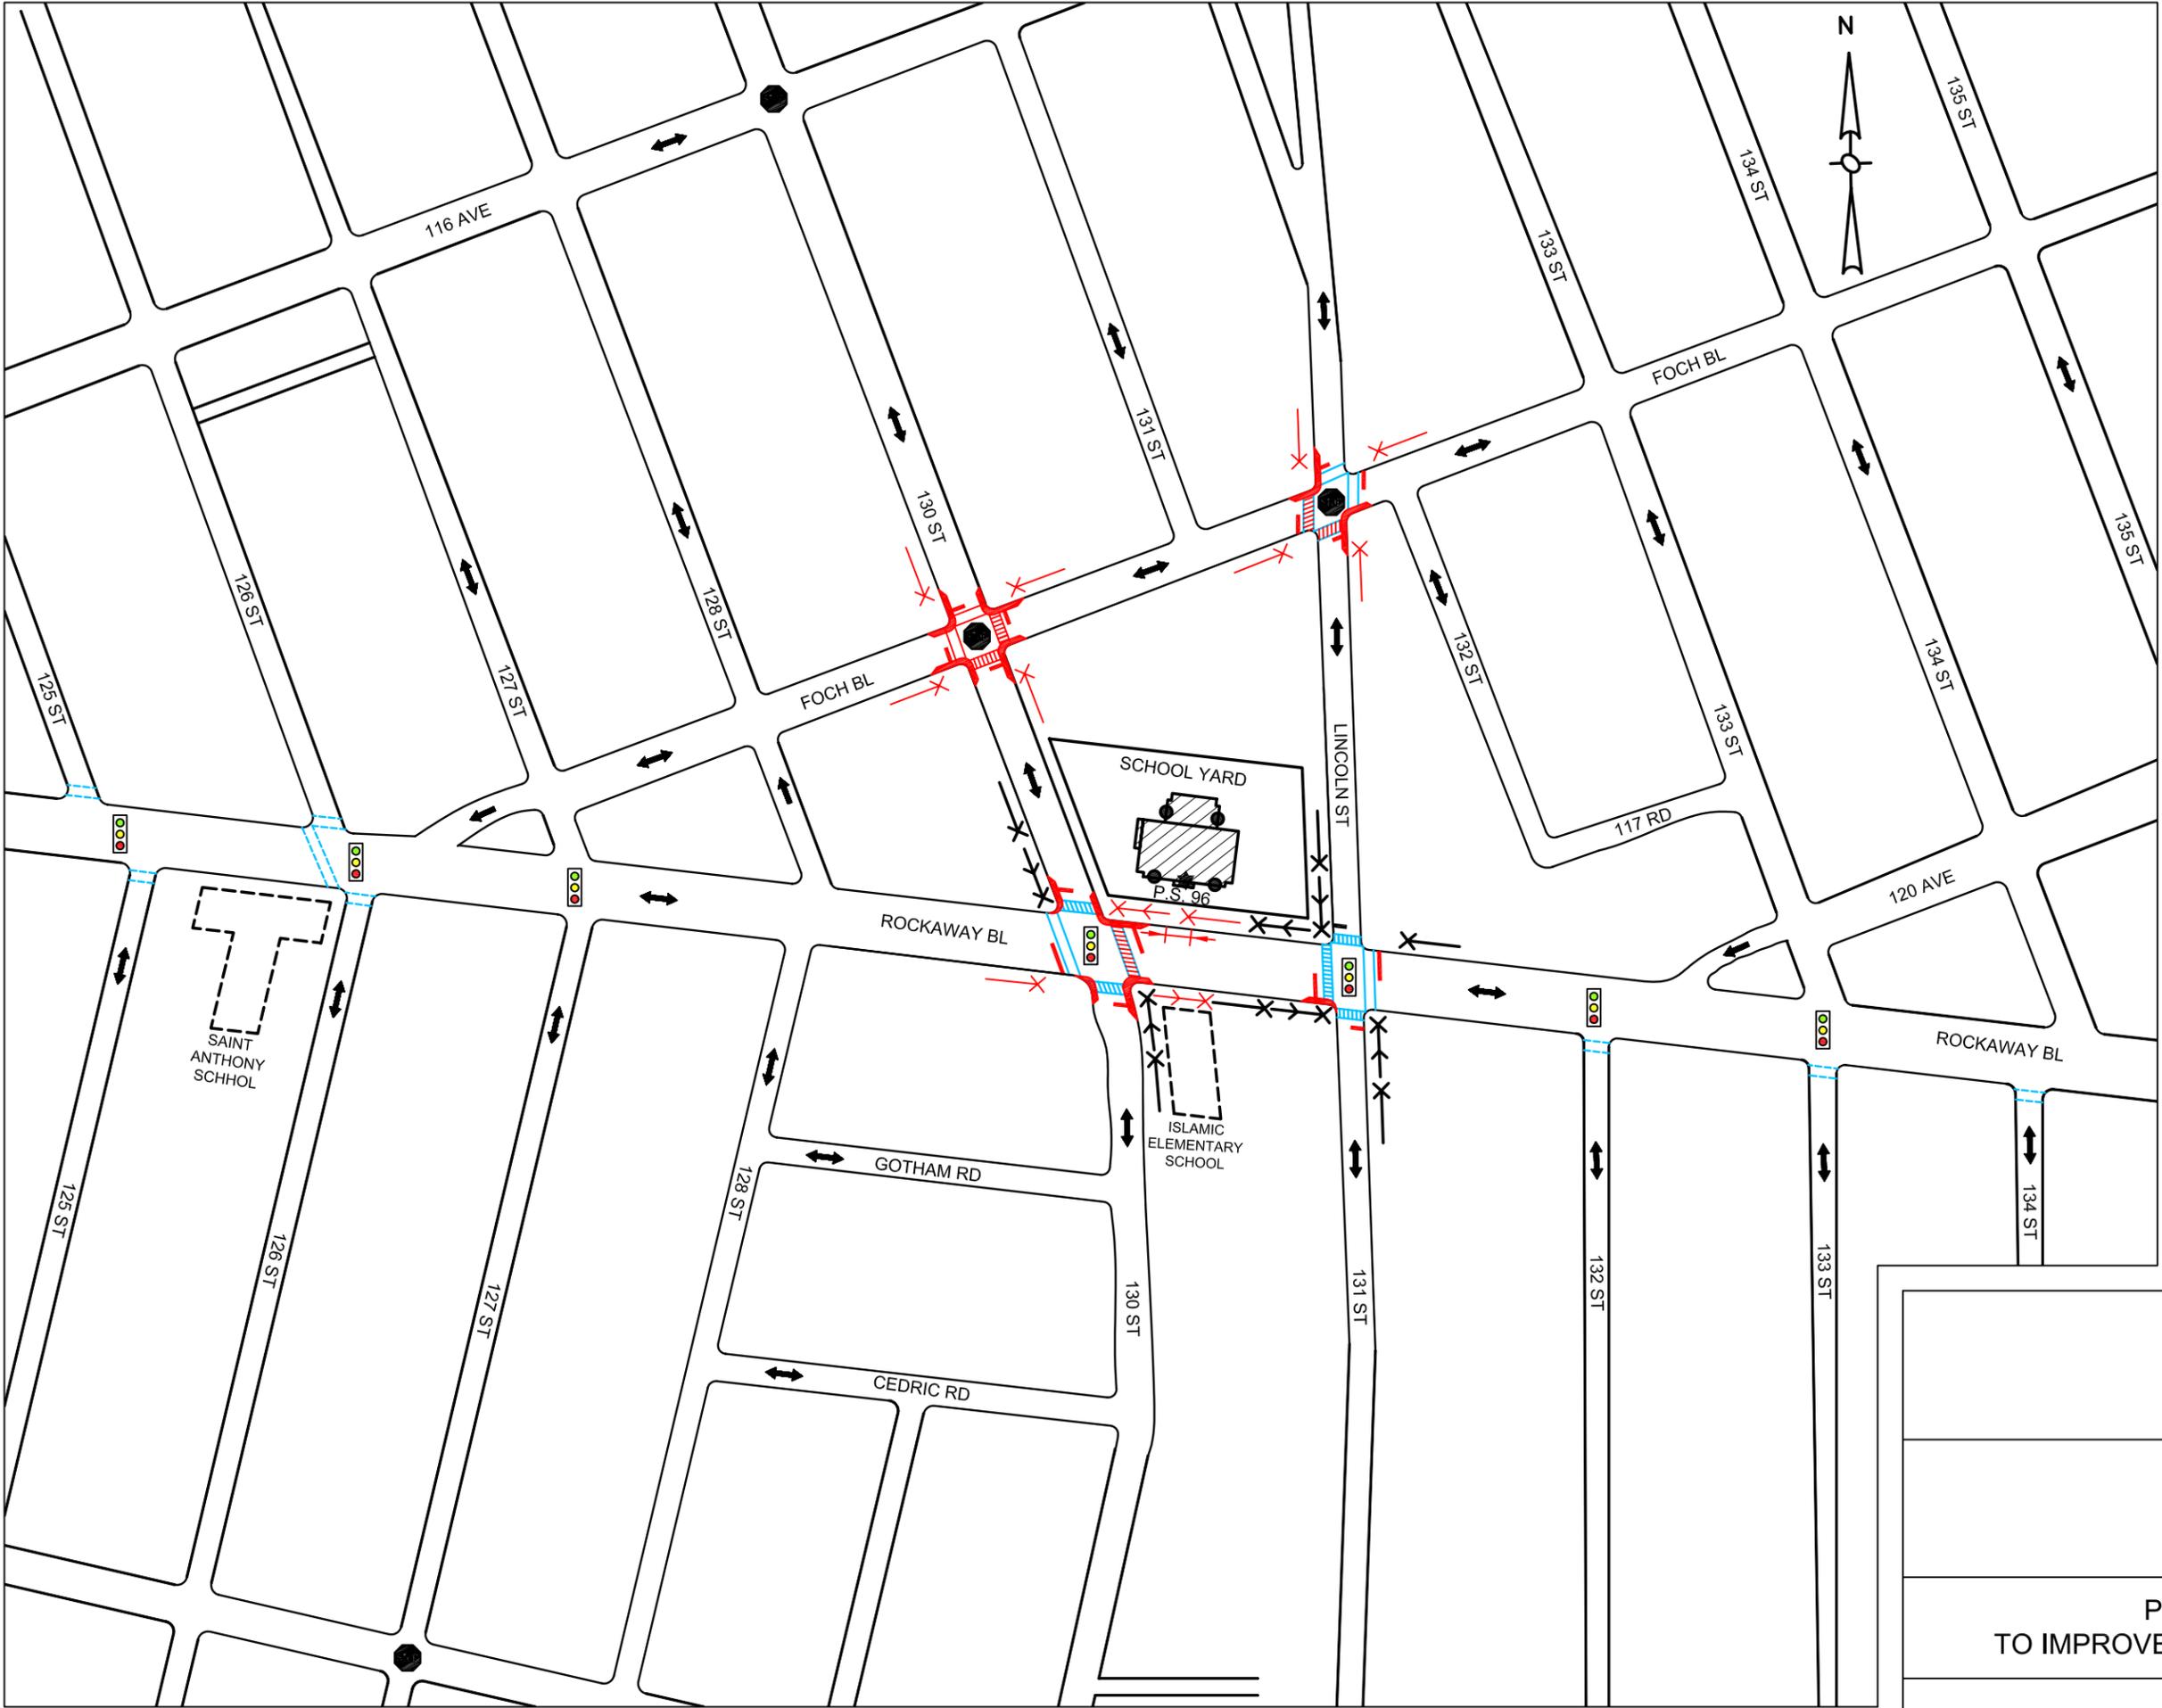
EXHIBIT 7

POTENTIAL MEASURES
TO IMPROVE STUDENT PEDESTRIAN SAFETY

➤ *Install “NO STANDING 7AM-4PM SCHOOL DAYS” signs*

Install “NO STANDING 7AM-4PM SCHOOL DAYS” signs for a distance of 30 feet in front of the main entrance to the school. (This is a typical requirement for all NYC schools in order to provide for emergency access to and from the school.)

➤ *Place stop bars 10 feet in advance of school crosswalks*

The MUTCD and New York City DOT standard for placement of a stop bar is four feet in advance of a marked crosswalk. At signalized (or stop controlled) crosswalks, the vehicle stop line can be placed farther back from the crosswalk in order to maximize visibility of pedestrians and to minimize the potential for pedestrian/vehicle conflicts. Therefore, it is recommended that stop bars be placed ten feet in advance of all school crosswalks.

- Re-designate the existing pedestrian crosswalks located across the west leg and the south leg of the Foch Boulevard and Lincoln Street intersection as school crosswalks, and install all appropriate warning devices.
- Re-designate the existing pedestrian crosswalk located across the east leg of the Rockaway Boulevard and 130th Street intersection as a school crosswalk, and install all appropriate warning devices.

- Install pedestrian crosswalks across the north and west legs of the all-way stop-controlled Foch Boulevard and 130th Street intersection.
- Install school crosswalks across the south and east legs of the all-way stop-controlled Foch Boulevard and 130th Street intersection.

Consideration should be given to installing curb extensions at the following locations, provided that the Final Design confirms that construction of the recommended curb extensions would be feasible and not interfere with traffic operations. Final details pertaining to the number, location and geometry of curb extensions will be developed during the Final Design/Contract Document preparation.

- All four corners of the Foch Boulevard and 130th Street intersection.
- The northwest and southeast corners of the Foch Boulevard and Lincoln Street intersection.
- The northeast and southeast corners of 130th Street and Rockaway Boulevard intersection and the west side of 130th Street, both north and south sides, for the school crosswalks located across the north and south legs of the intersection.
- The south-west side of Rockaway Boulevard, for the school crosswalk located across the south leg of the intersection with Lincoln Street.

The purpose of the curb extensions is to shorten the crossing distance for pedestrians, and to reduce speeds of vehicles approaching and turning at these heavily utilized school crosswalks. These curb extensions would not eliminate or reduce the width of any moving lanes.

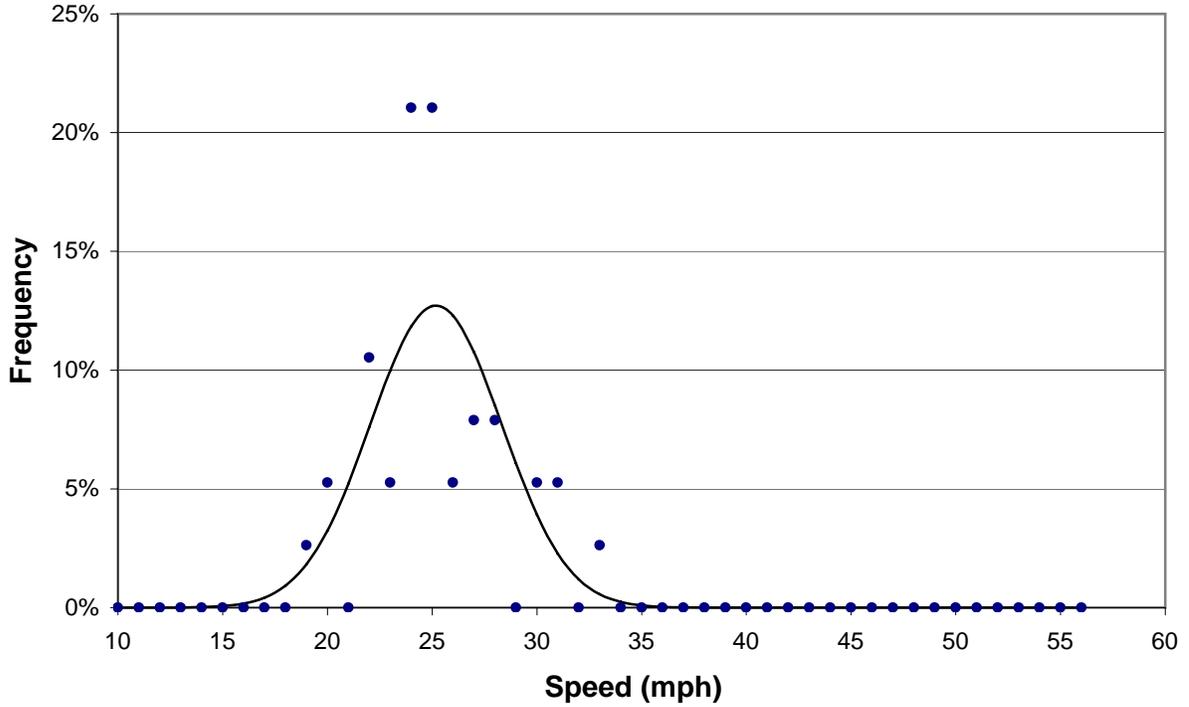
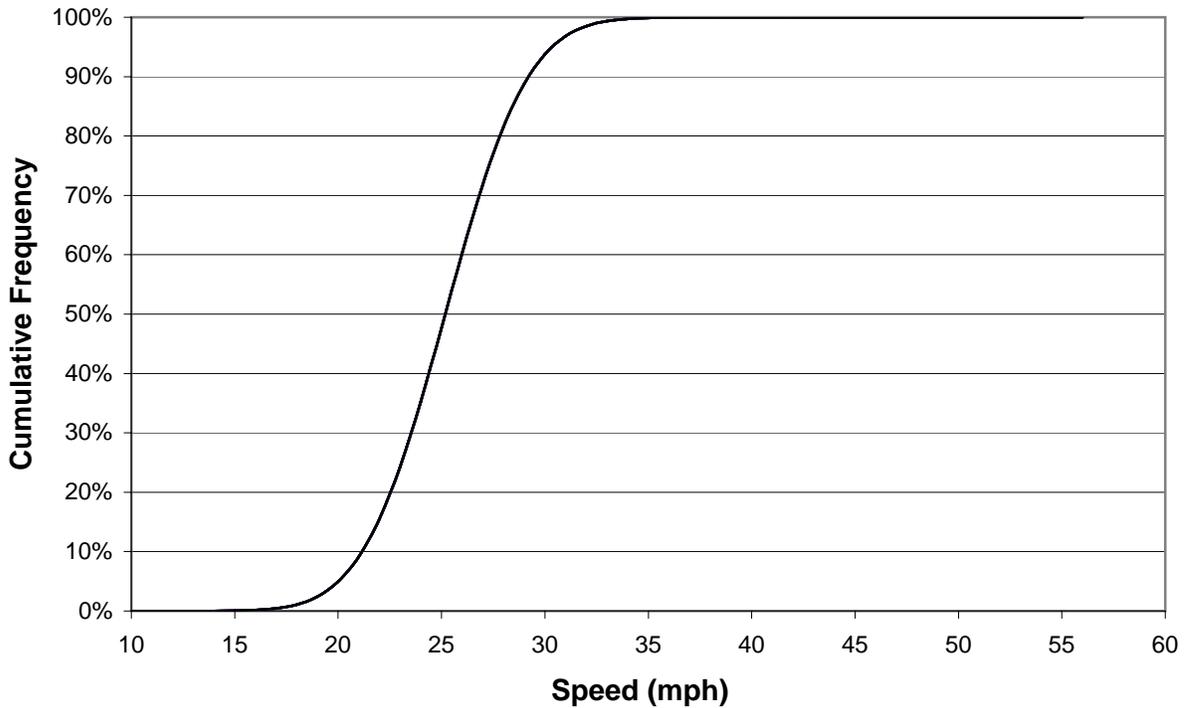
SPOT SPEED STUDY

Date: 10-6-05
Location: 130th Street between Rockaway Blvd & Foch Blvd
Surveyor: R. Calvache/H. Salinas

Mean Speed = 25.2 mph
Standard Deviation = 3.1 mph
Margin of Error (95% Confidence) = ± 1.0 mph

Median Speed = 25.2 mph
15th Percentile Speed = 21.9 mph
85th Percentile Speed = 28.4 mph

The results of the spot speed surveys indicated that vehicles on 130th Street were traveling at an 85th percentile speed of 28 mph in both directions, which is below the threshold speed of 30 mph.
