**New York City Department of Transportation
Office of School Safety Engineering**

School Safety Engineering Project

FINAL REPORT: P.S 96, Queens

**Prepared by
The RBA Group and URBITRAN Associates Inc.**

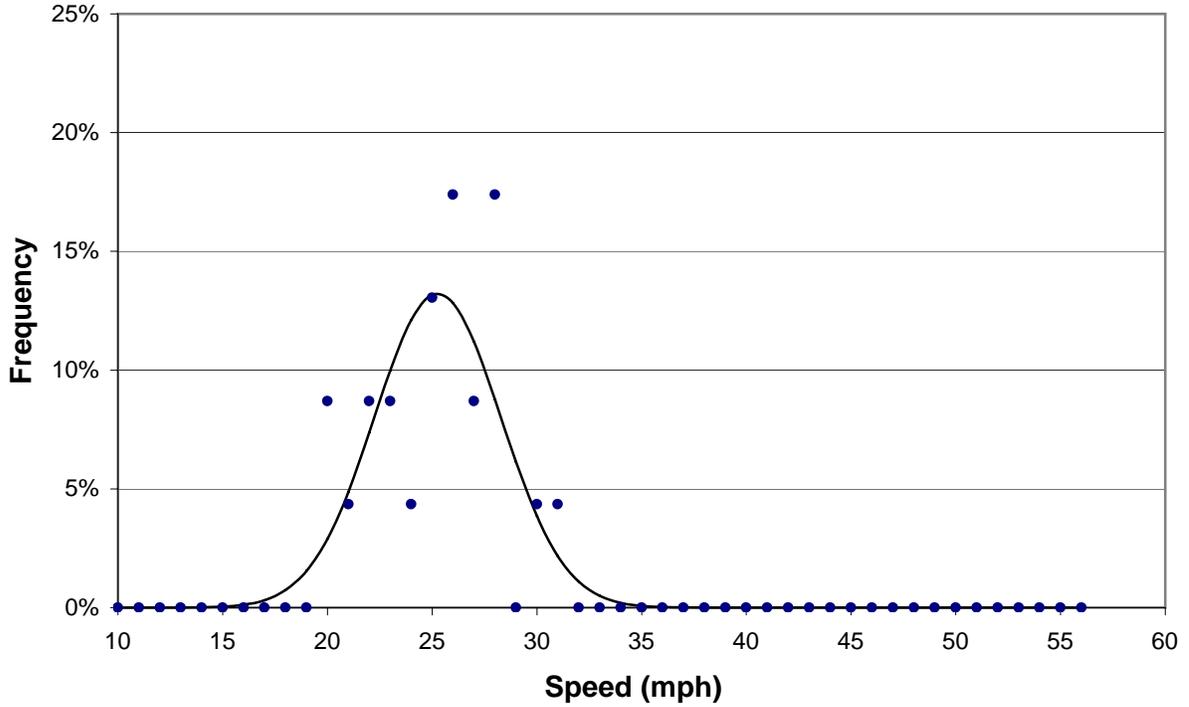
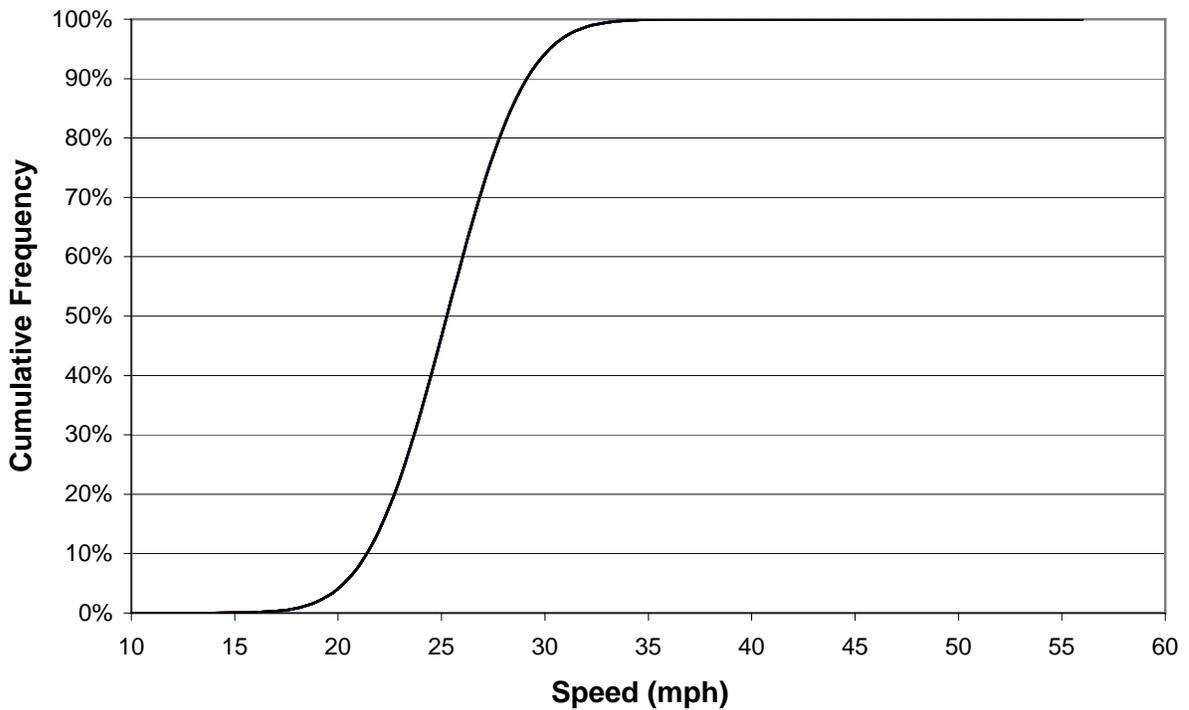
SPOT SPEED STUDY

Date: **10-6-05**
 Location: **130th Street between Rockaway Blvd & Foch Blvd**
 Surveyor: **R. Calvache/H. Salinas**

Mean Speed = 25.3 mph
 Standard Deviation = 3.0 mph
 Margin of Error (95% Confidence) = ± 1.2 mph

Median Speed = 25.3 mph
 15th Percentile Speed = 22.1 mph
 85th Percentile Speed = 28.4 mph

The results of the spot speed surveys indicated that vehicles on 130th Street were traveling at an 85th percentile speed of 28 mph in both directions, which is below the threshold speed of 30 mph.
