771 WASHINGTON STREET  
771 WASHINGTON STREET, NEW YORK, NY 10014

HIGGINS QUASEBARTH & PARTNERS, LLC  
CONSULTANTS IN PRESERVATION AND REHABILITATION OF HISTORIC PROPERTIES

BKSK  
LPC PRESENTATION 11.29.16

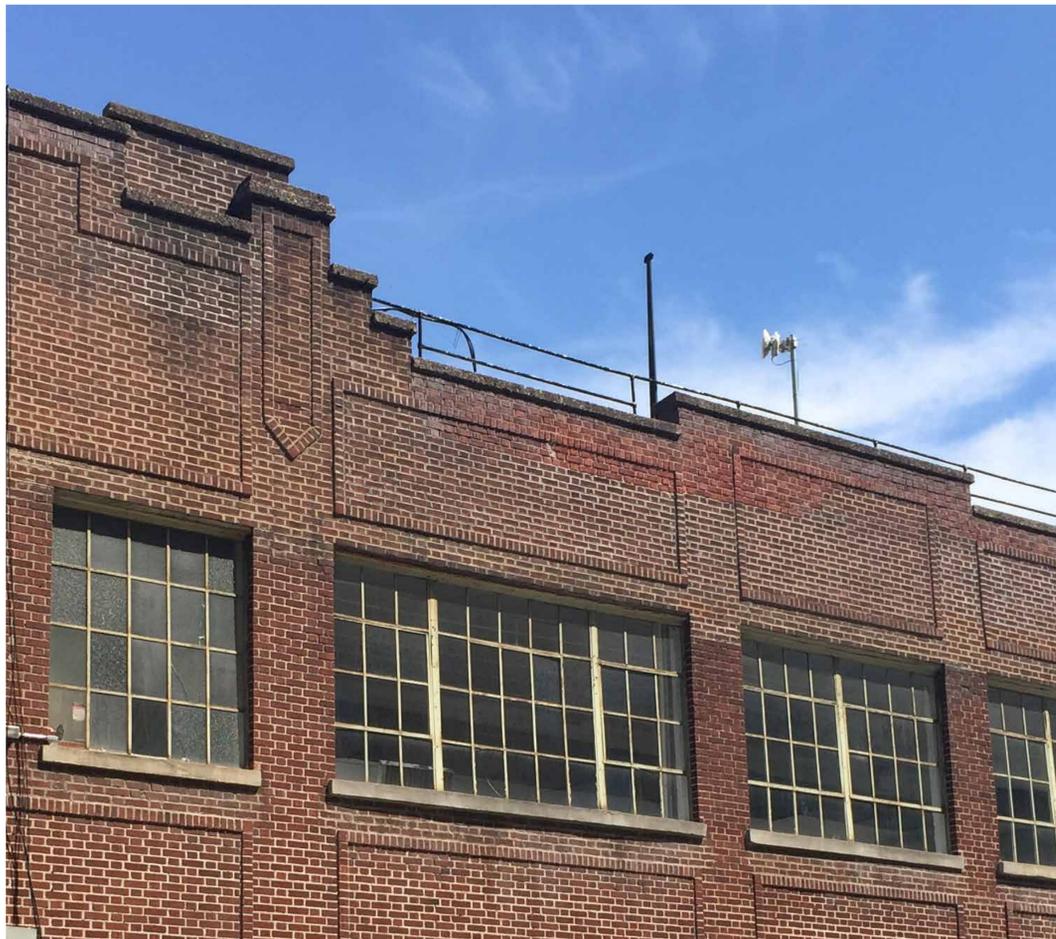
EXISTING WASHINGTON PARAPET - BRICK PARAPET PATCHWORK

1. 50% OF BRICKWORK ALTERED
2. 5 OIL TANK REMOVALS REQUIRED - E DESIGNATION
3. WINDOWS - RUSTED SHUT, ENERGY INEFFICIENT & NOT COMPLIANT W/ E DESIGNATION
4. ROOF STRUCTURE REPLACEMENT REQUIRED - DOB VIOLATION
5. INTERNAL RAMP OBSOLETE

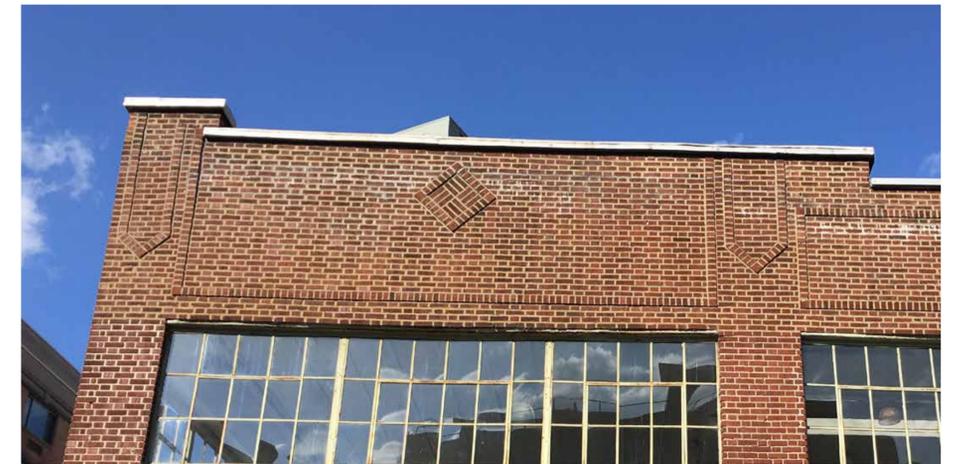
EXISTING WEST 12TH ST. HISTORIC PARAPET DETAIL REMOVED

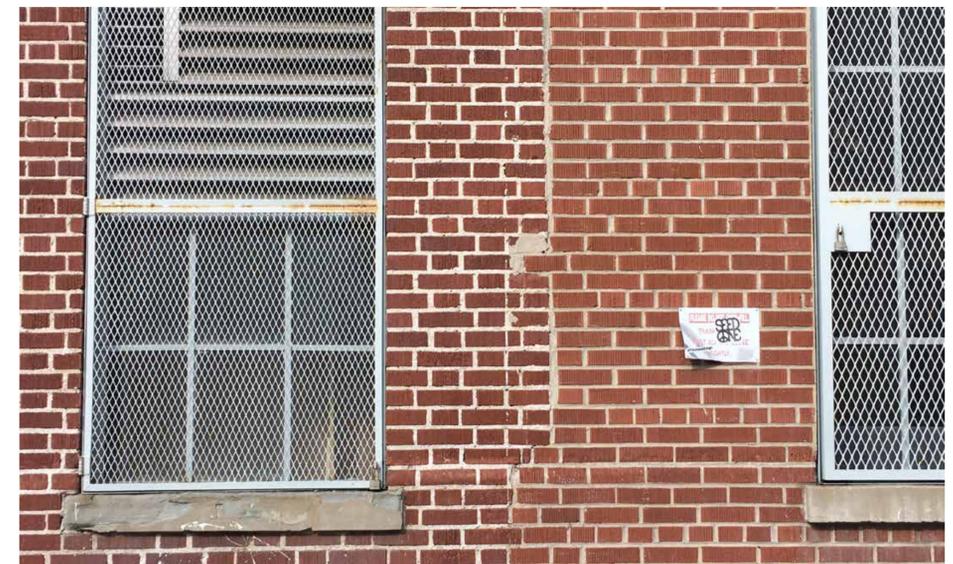
FACADE MASONRY PATCHWORK BRICK, LOUVER

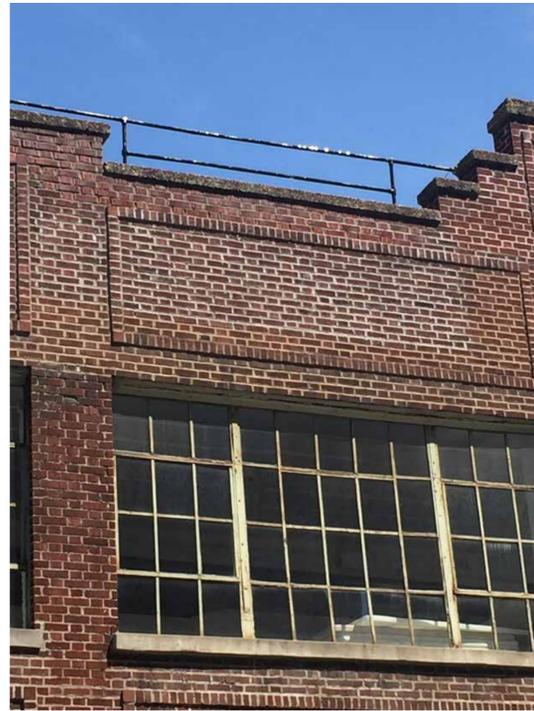
WINDOW CONDITION - EXTERIOR

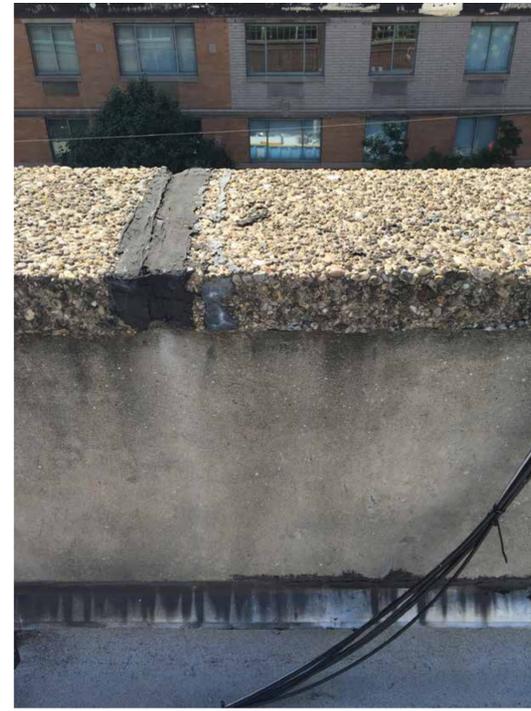
HISTORIC COPING REQUIRING REPAIR

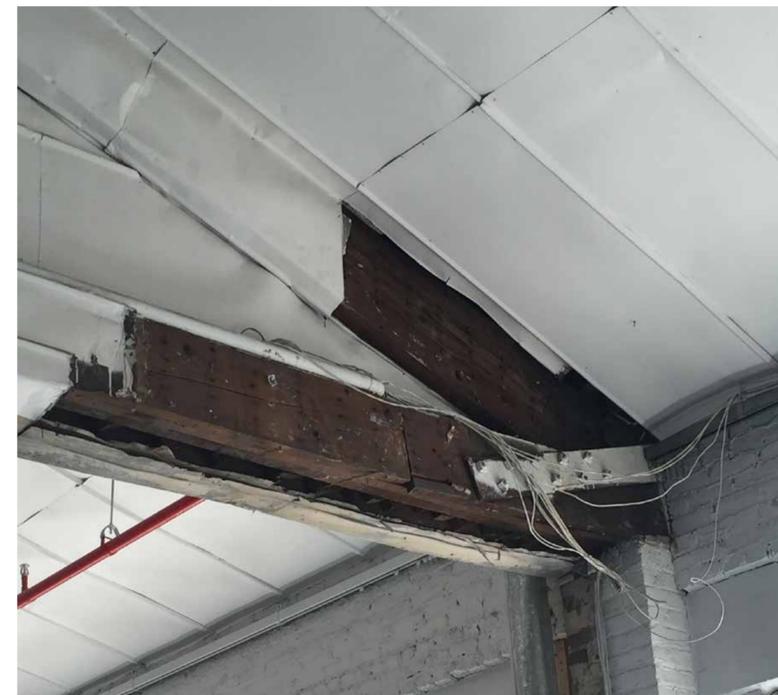
EXISTING ROOF STRUCTURE - DOB VIOLATION

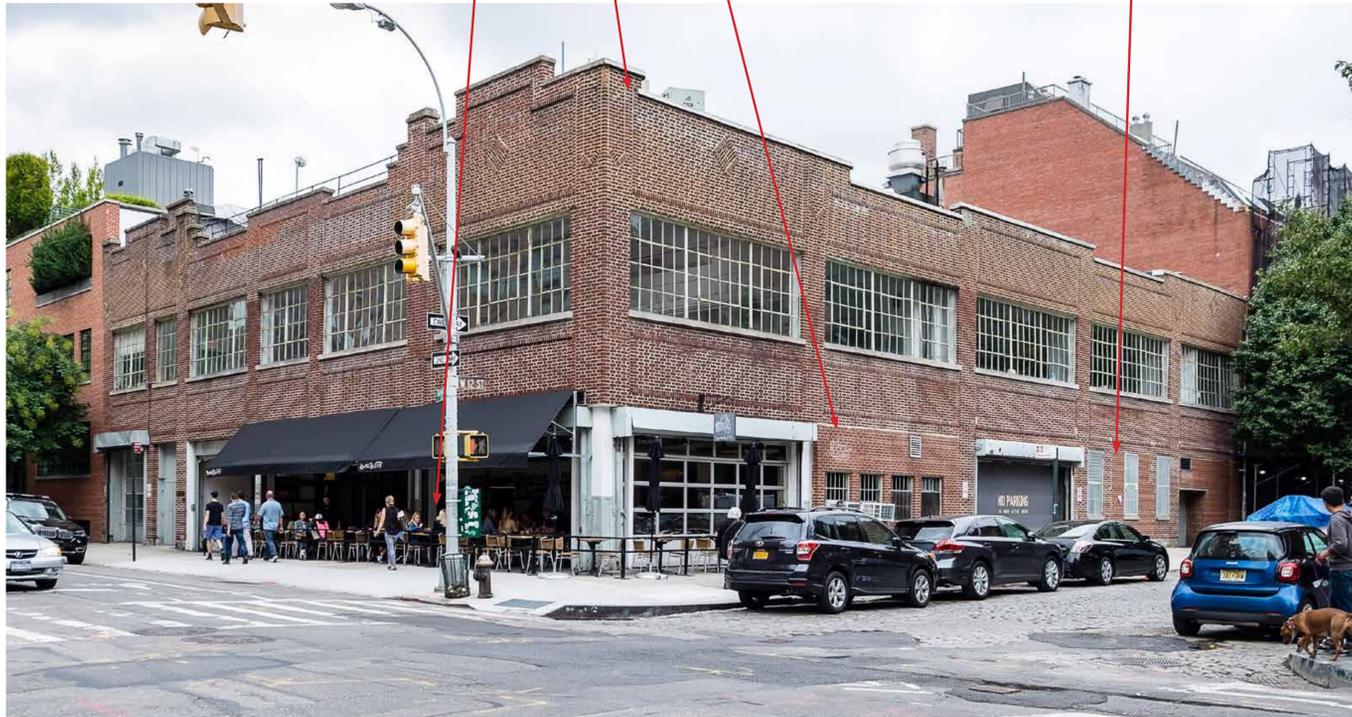
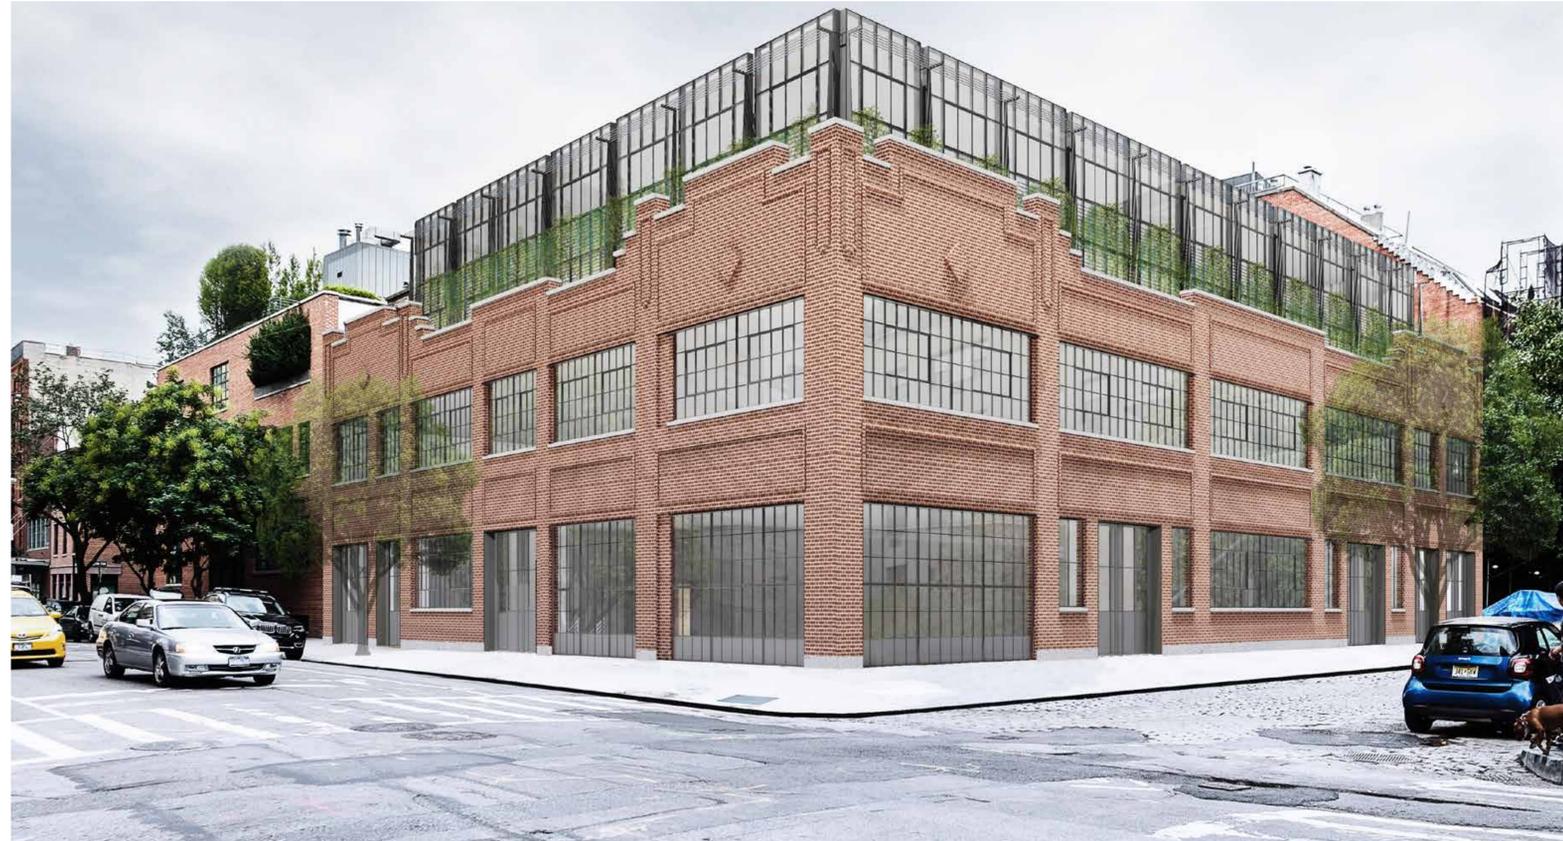
EXISTING 2016

1. BRICK BULKHEADS REMOVED; BRICK FACING REMOVED; AWNINGS, SECURITY GRILLS ADDED
2. REMOVAL OF PARAPET DETAIL & SCALE AT 12TH STREET FACADE
3. WINDOW BAYS BRICKED IN
4. ENTRY BAYS ALTERED

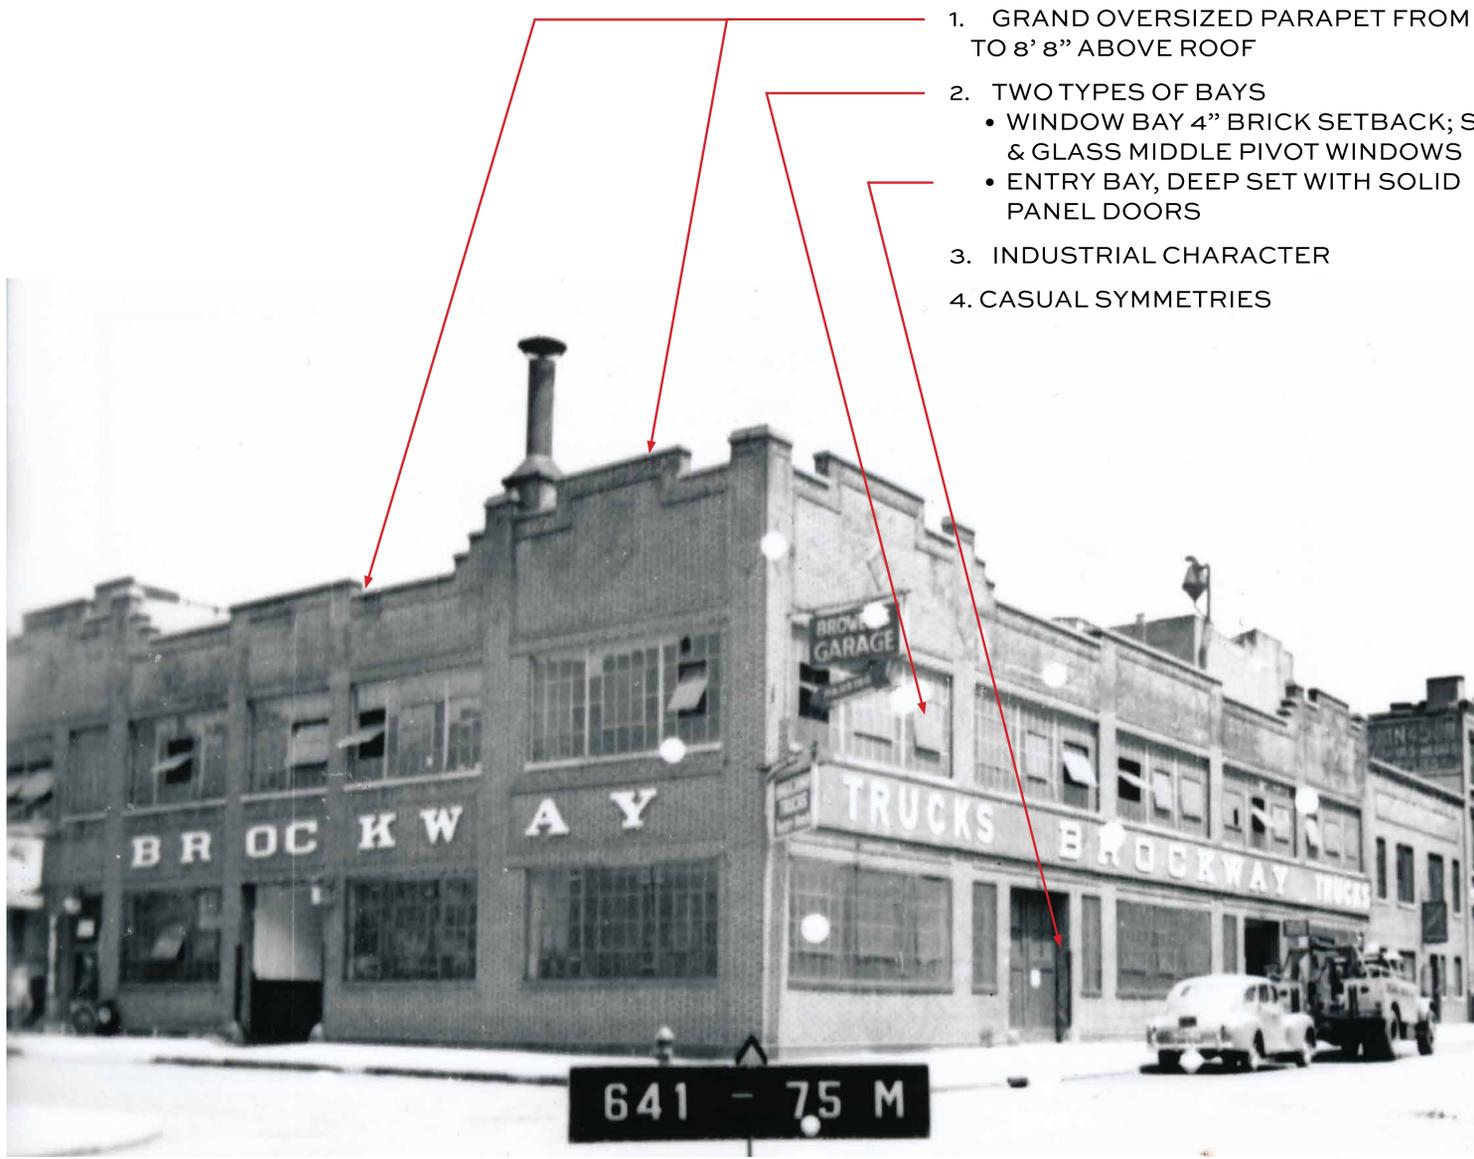
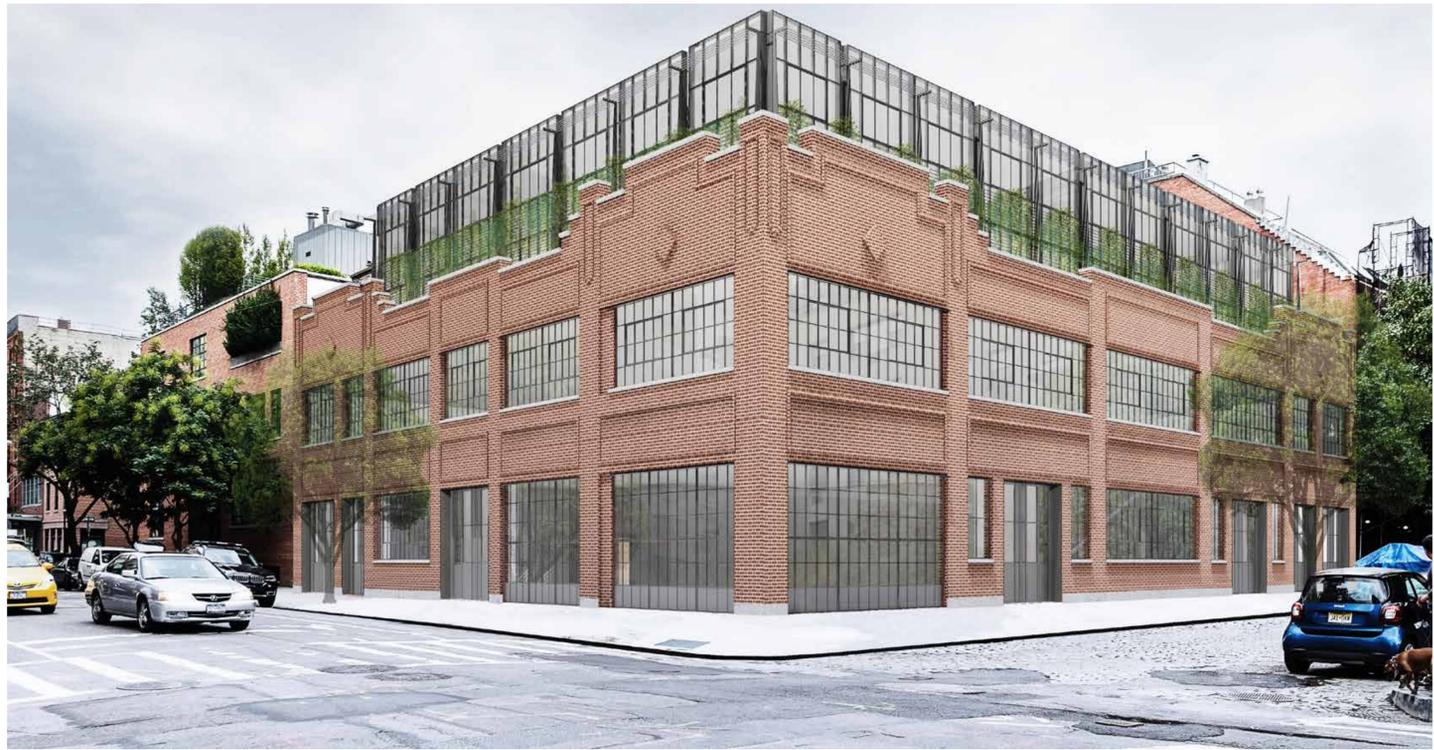
HISTORIC (C.1940)

1. GRAND OVERSIZED PARAPET FROM 3' 8" TO 8' 8" ABOVE ROOF
2. TWO TYPES OF BAYS
  - WINDOW BAY 4" BRICK SETBACK; STEEL & GLASS MIDDLE PIVOT WINDOWS
  - ENTRY BAY, DEEP SET WITH SOLID PANEL DOORS
3. INDUSTRIAL CHARACTER
4. CASUAL SYMMETRIES

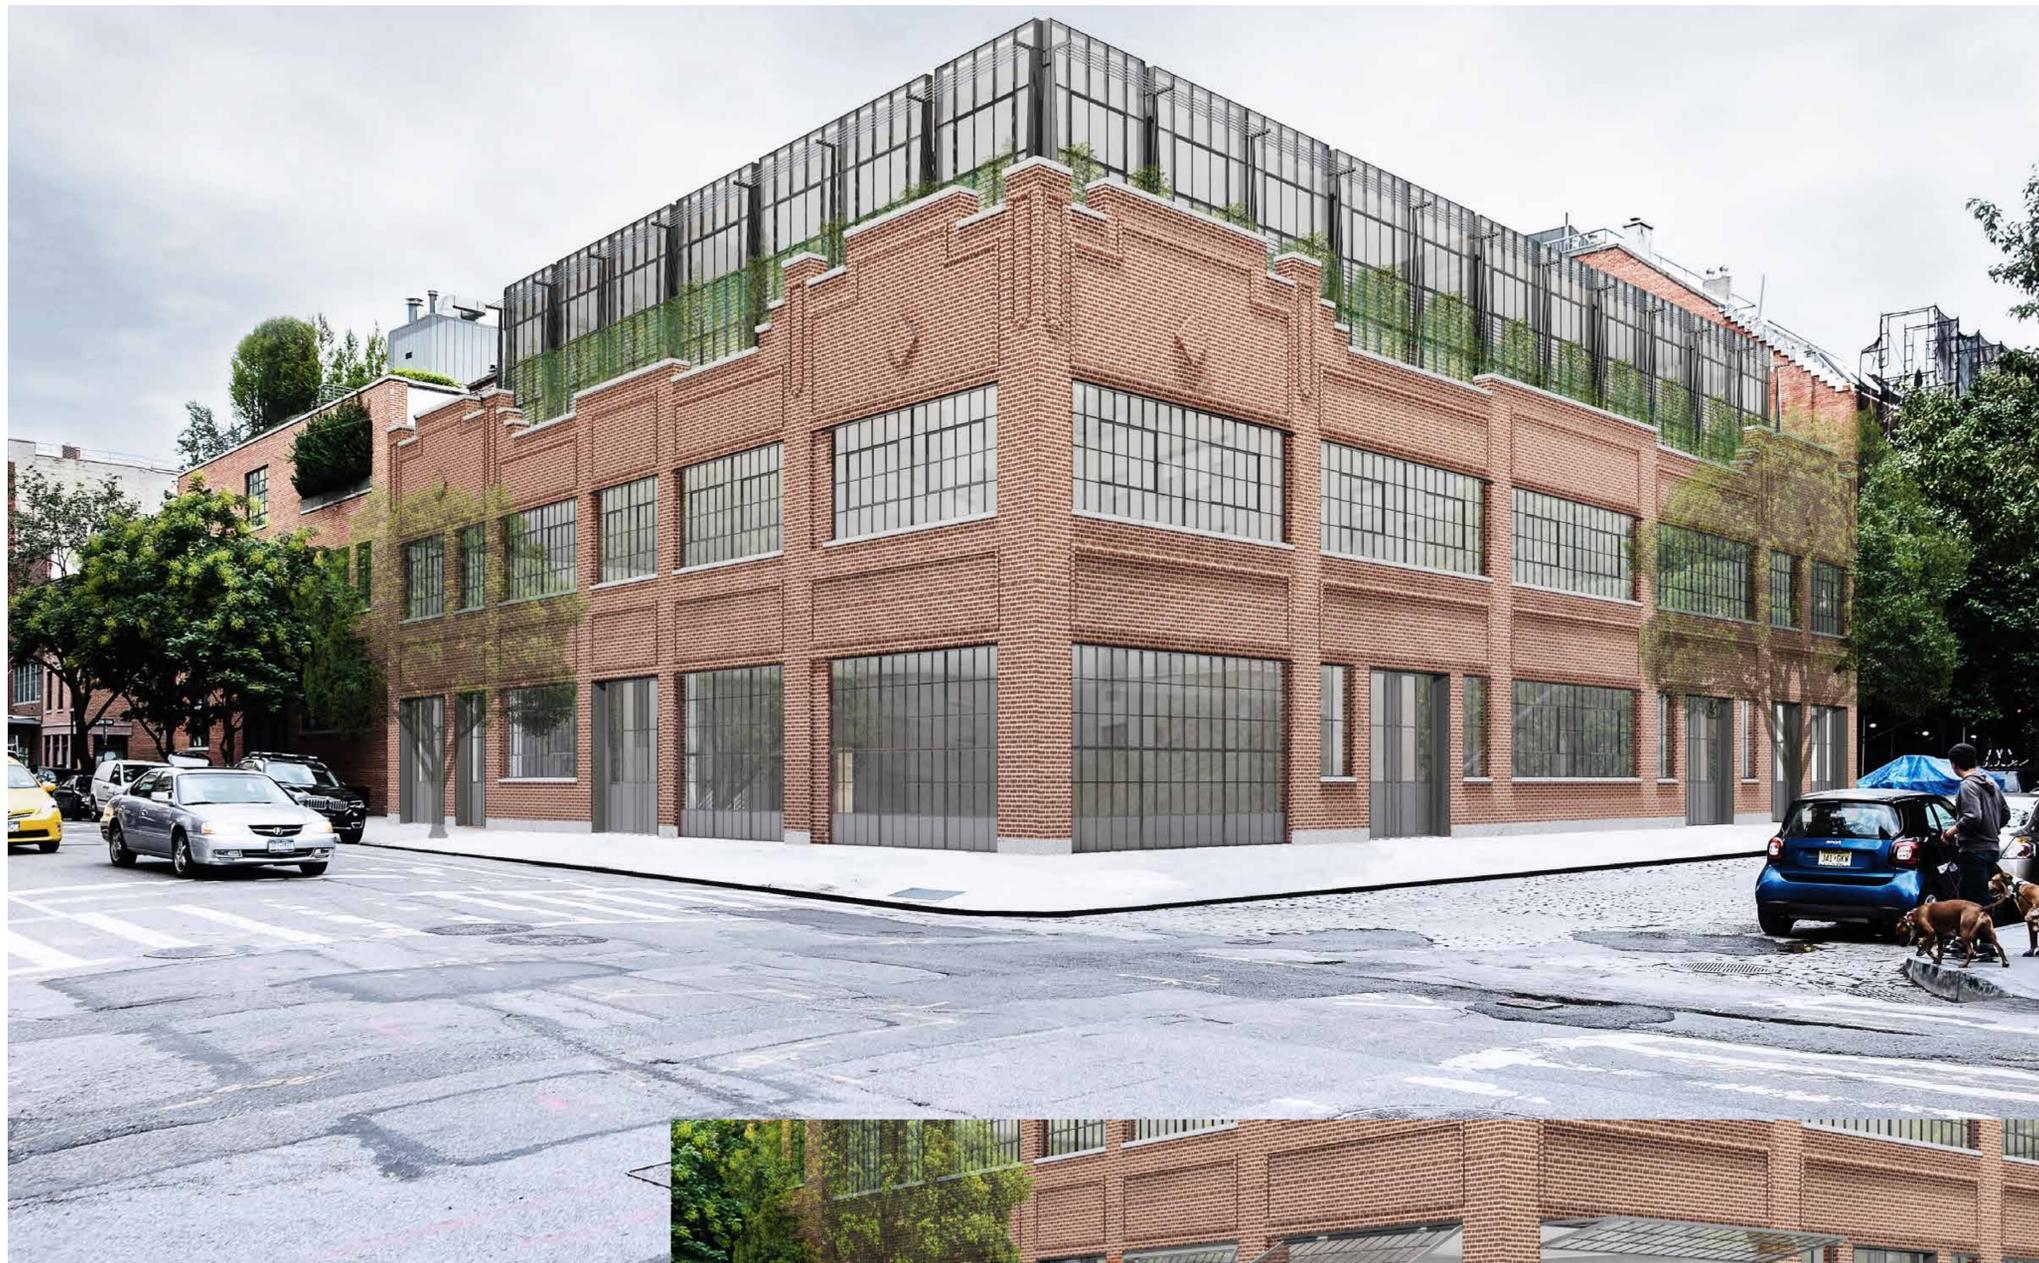
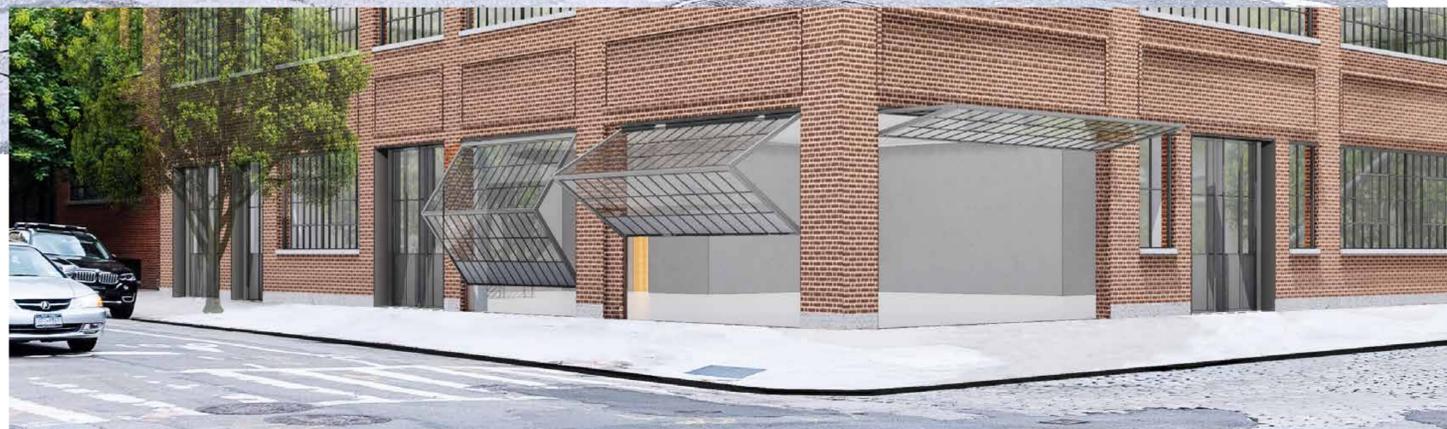
CURRENT OPTION - PERSPECTIVE WITH ANNOTATION

• **BRICK**

- HISTORIC BUILDING HAD TREATED BRICK WORK AND SYMMETRY “CASUALLY”, DEFERRING TO UTILITARIAN REQUIREMENTS WHEN NECESSARY
- PROPOSAL TO BOTH “RESTORE/RECOLLECT” AND “MODIFY” FOR CURRENT UTILITARIAN PURPOSES
  - RAISE AND RESTORE PROFILE OF PROMINENT BRICK PARAPET+ 3 BRICKS
  - INCLUDE ADDITIONAL BRICK RETURNS TO ALLOW INCREASED INSULATION ON INTERIOR
  - RESTORE BRICK STREET BULKHEADS IN SOME LOCATIONS BUT ACKNOWLEDGE RECENT ALTERATIONS AND CURRENT NEEDS WITH OPEN CORNER
  - SHALLOWER RETURNS AT THE BRICK WINDOW BAYS.

• **STEEL AND GLASS**

- HISTORIC BUILDING HAD INDUSTRIAL STEEL CENTRAL PIVOT WINDOWS AND DEEP ENTRY BAYS WITH SOLID DOORS
  - PROPOSAL USES THERMALLY BROKEN STEEL AND GLASS WINDOW WALL AND WINDOWS WITH CENTER PIVOT WINDOWS
  - INTRODUCTION OF STEEL TRELIS AND FIN LANGUAGE TO PROVIDE GREENERY AND SHADING MIMICS UTILITARIAN TRADITION OF STEEL ELEMENTS AS WELL, AS GREENWICH VILLAGE TRADITION OF ORNAMENTAL METAL
  - HISTORIC ENTRY BAYS RECALLED WITH STEEL RETURNS AND MORE SOLID STEEL DOORS AND LARGER WINDOW PROPORTIONS AND CARRIED UP INTO ADDITION AT TOP
  - RECALL ACTIVE USE OF STREET LEVEL OPENINGS WITH “HANGAR” TYPE FULL WIDTH DOORS TO PROVIDE CANOPIES FOR CORNER OUTSIDE SEATING FOR RESTAURANT USE

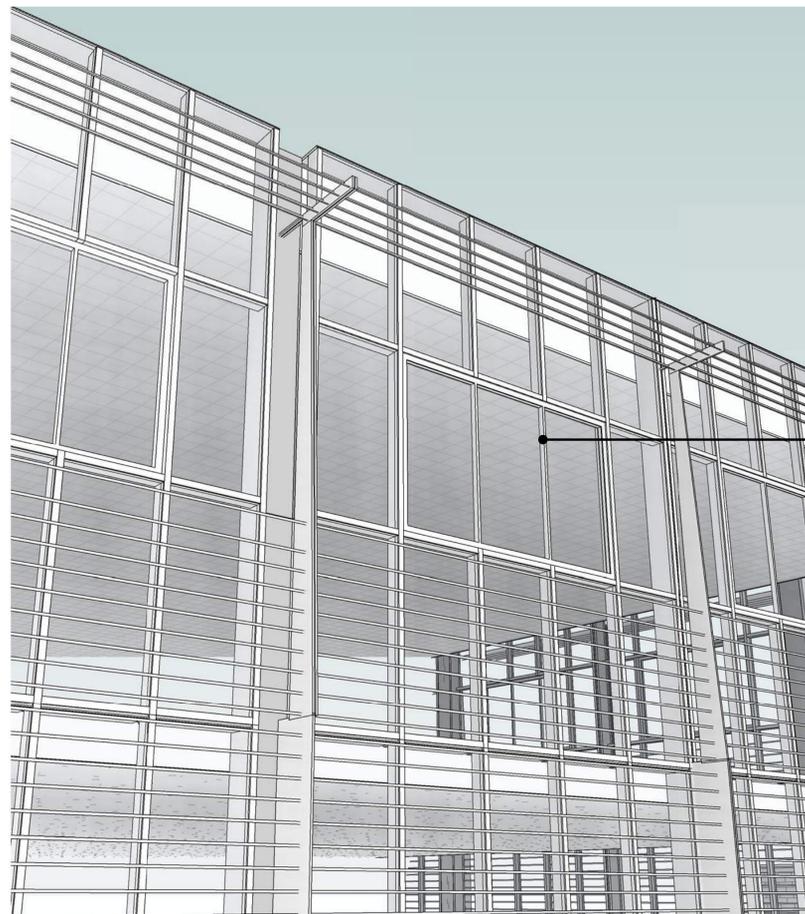
TRELLIS REVEAL - PROFILE/SHADING

TRIPLE GLAZED CURTAIN  
WALL WITH STEEL T-PROFILE  
MULLIONS

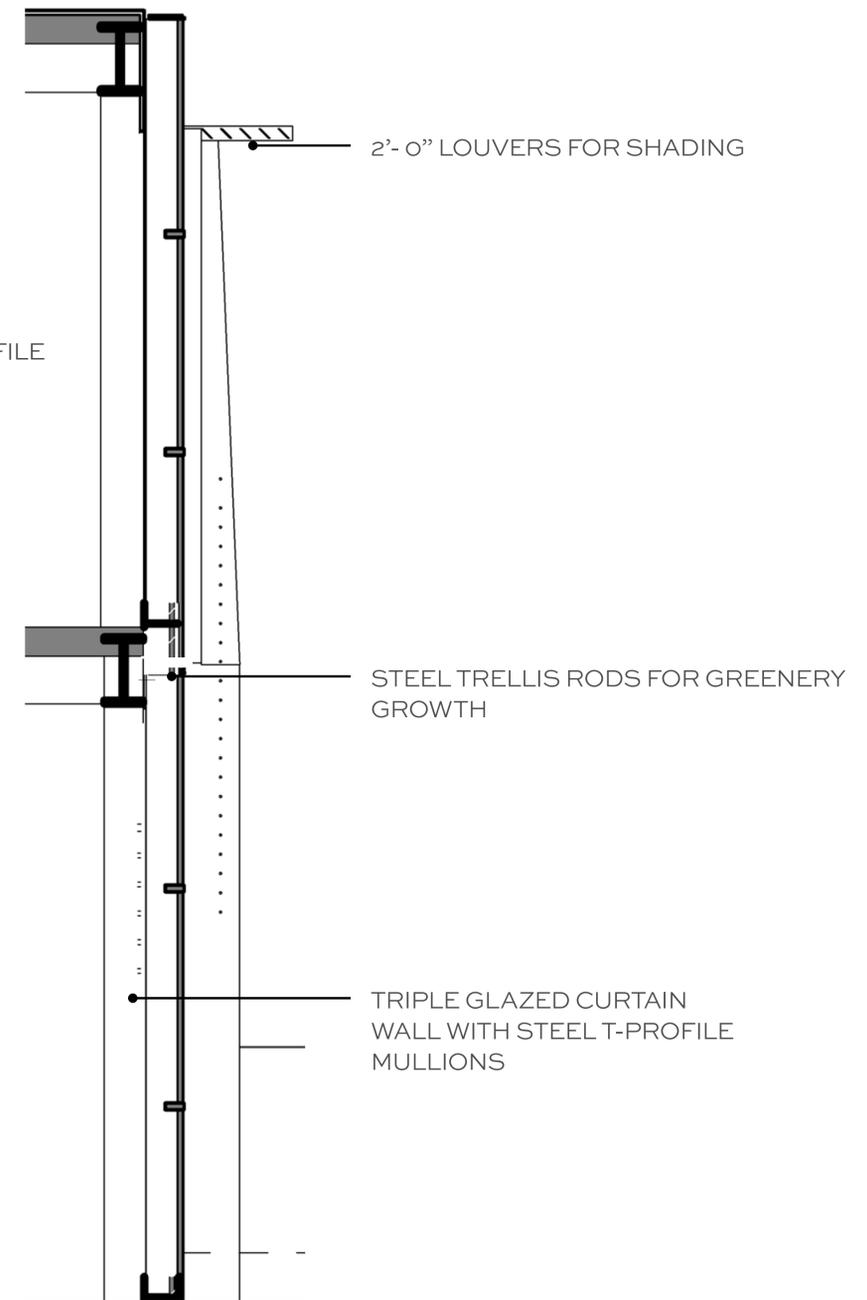
TRELLIS SECTION

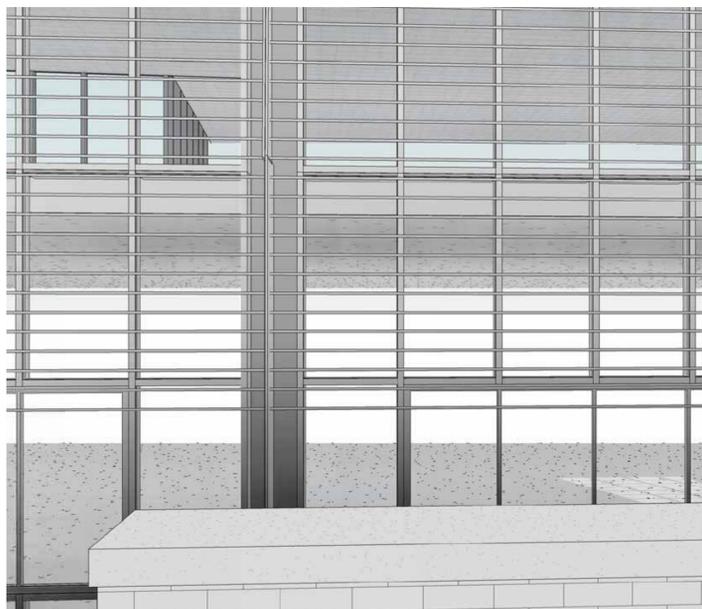
TRELLIS ROD DETAIL

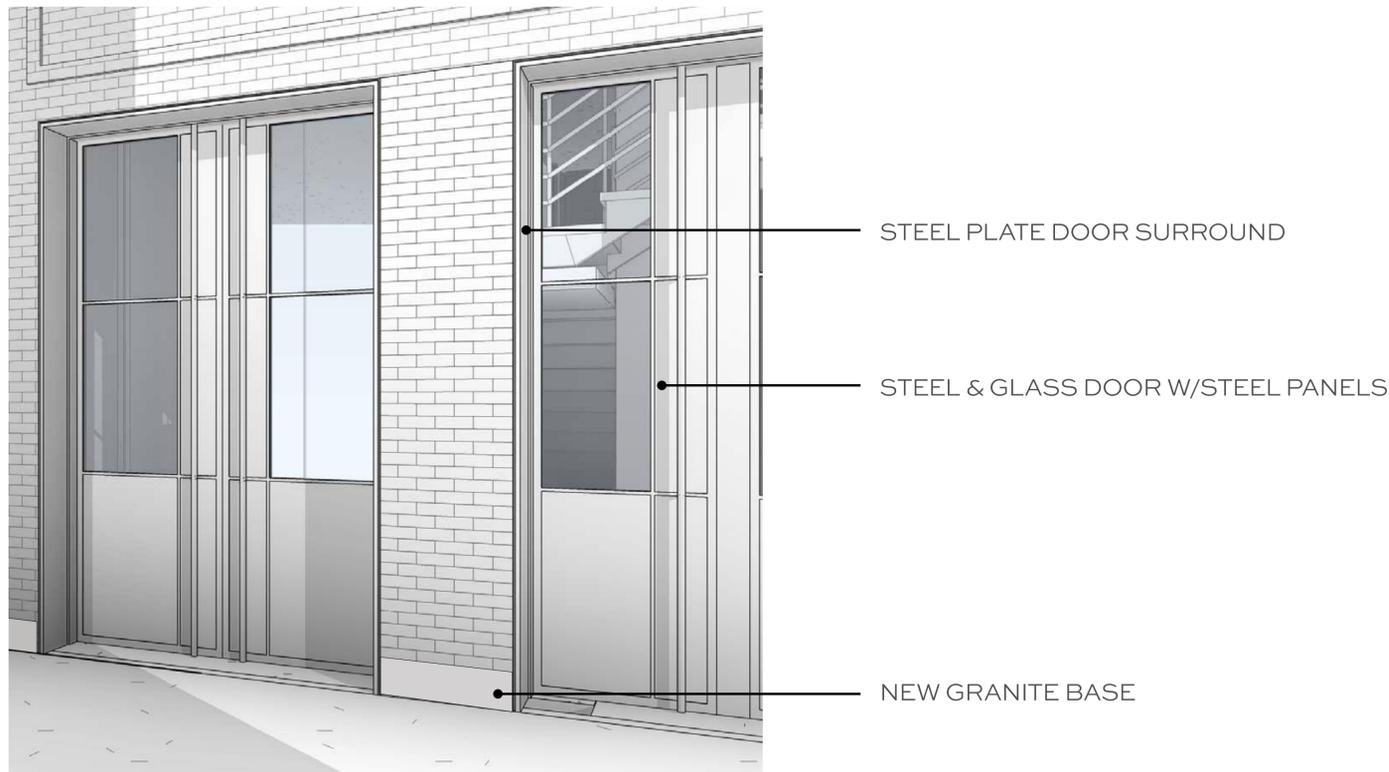
ENTRY DOOR DETAIL

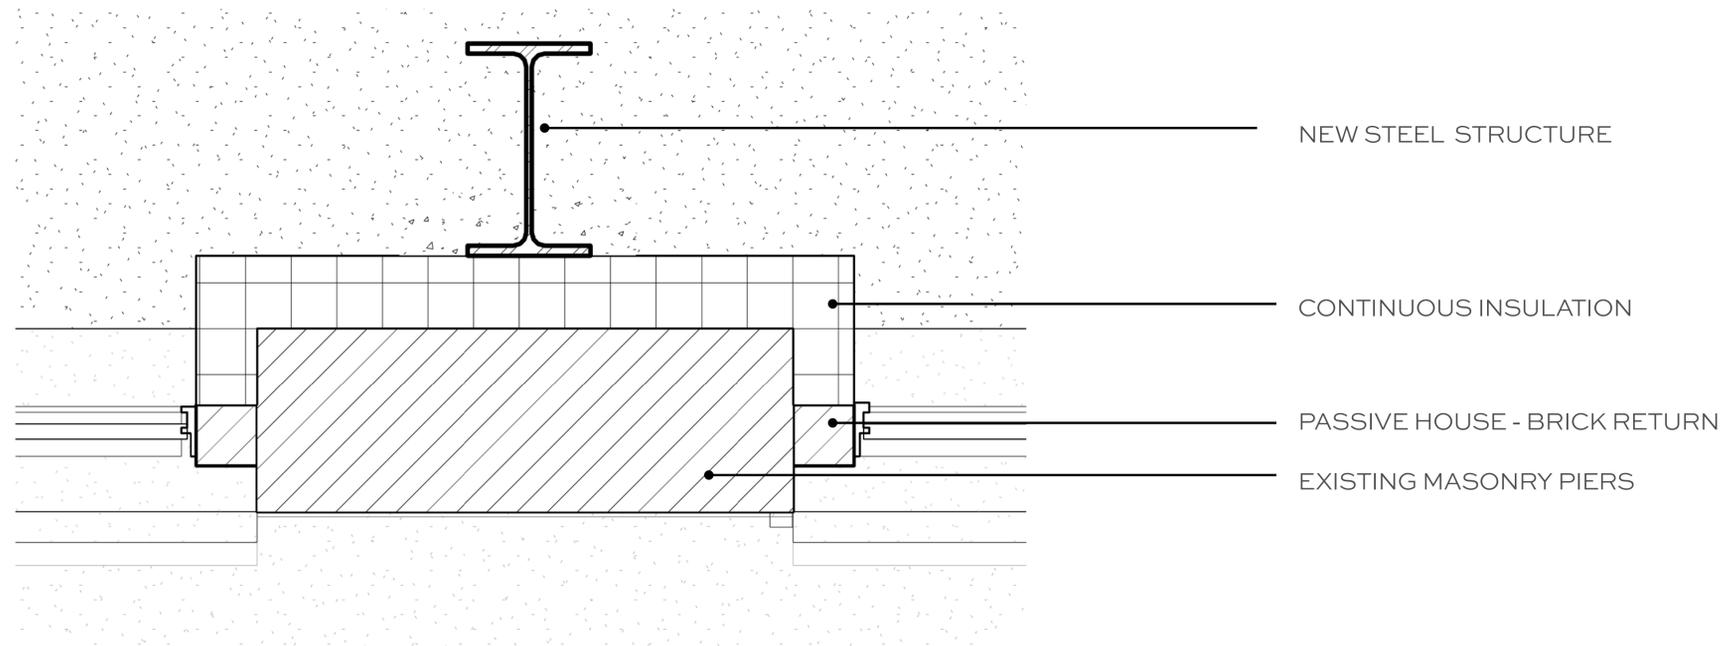
PASSIVE HOUSE/HISTORIC PROFILE @ WINDOW JAMB

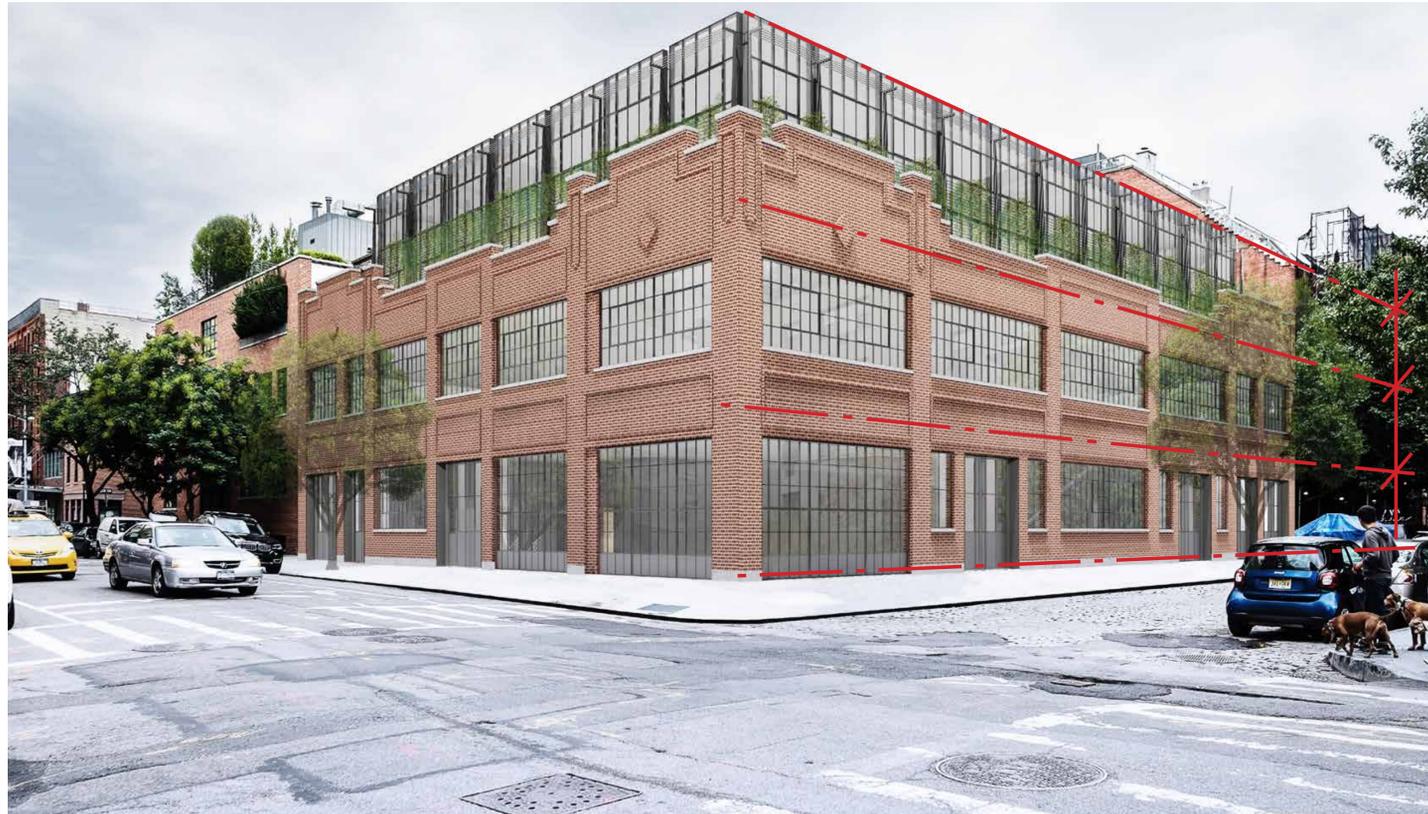
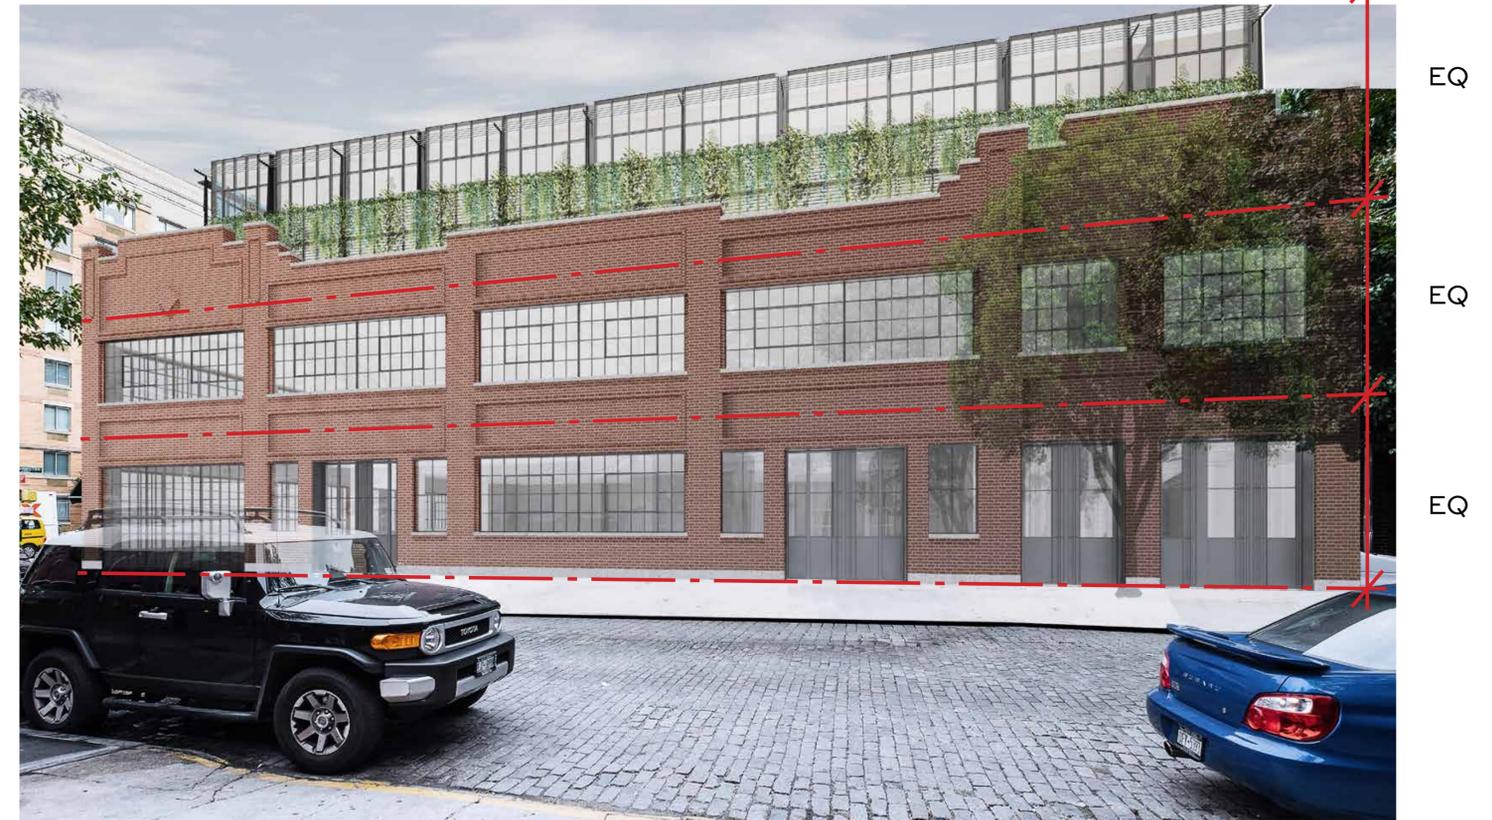
ADDITION IS DESIGNED TO BE PERCEPTUALLY LESS THAN 1/2 OF EXISTING 2 STORY BUILDING HEIGHT

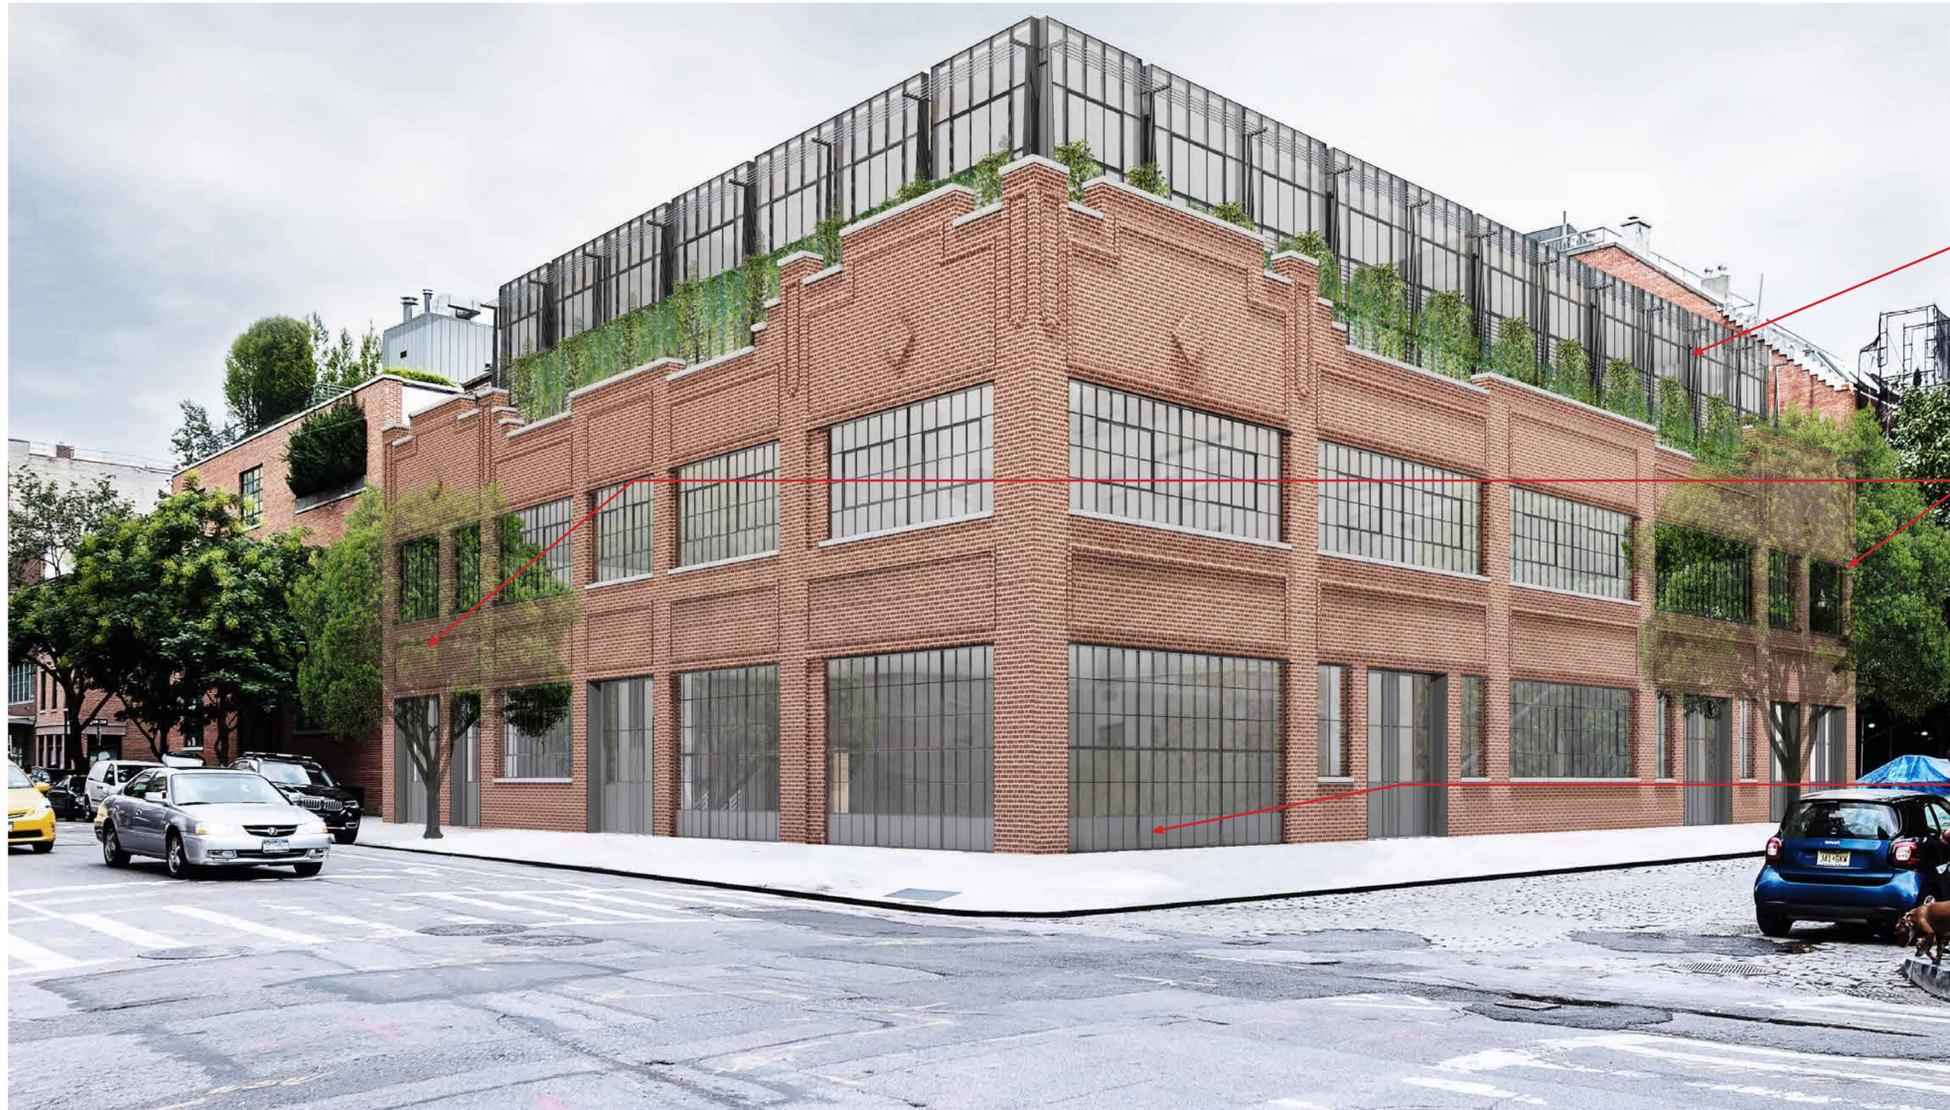
TRELLIS STRUCTURE IS MEANT TO SUSTAIN PLANTINGS ORIGINATING AT SETBACK

NEW TREES CONTINUE TREELINE OF 12TH STREET AND WASHINGTON STREET ONTO SITE

KEEP HISTORICALLY OPEN CORNER WITHOUT TREES
