Subject: Phase I Environmental Site Assessment
37-27 31st Street and 37-26 32nd Street
Long Island City, New York 11101

**PHASE I ENVIRONMENTAL
SITE ASSESSMENT
37-27 31ST STREET AND 37-26 32ND STREET
BLOCK 373, LOTS 6 AND 45
LONG ISLAND CITY, NEW YORK**

January 2015
File No. 41.0162268.20

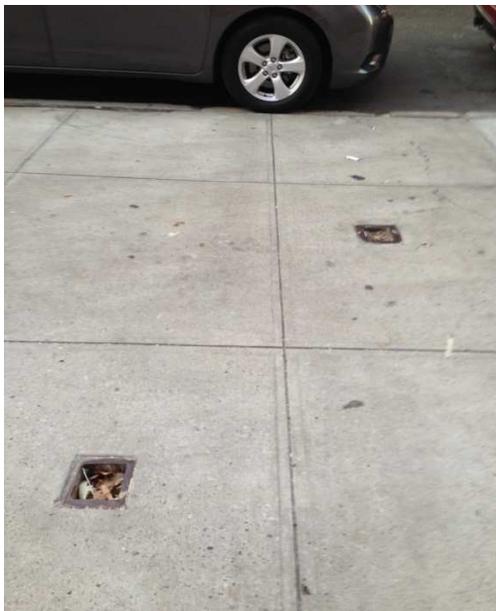
Photo 3: View of 31st St sidewalk with old fill ports

Mr. Cosma indicated that a fuel-oil fill port existed on the sidewalk of 37-36 32nd Street, but the fill port reportedly was removed during reconstruction of the sidewalks in front of the building. No other surficial evidence of USTs (i.e., fill ports, vent pipes, pavement repairs, etc.) was observed during the exterior site reconnaissance.

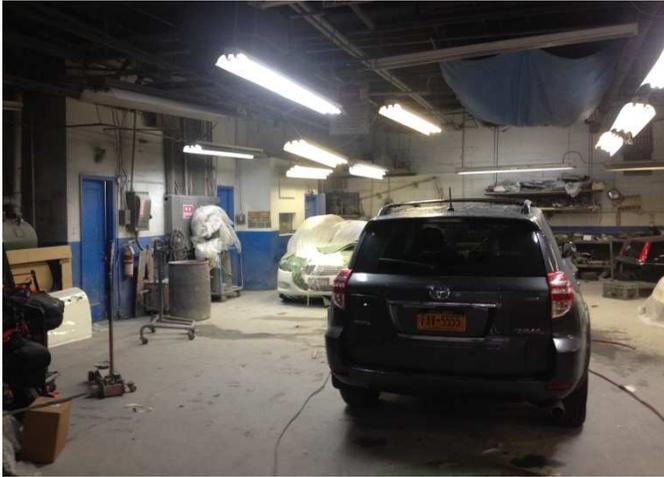
Photo 5: View of auto-body/collision main floor with the office/ bathroom/ paint mixing room (blue door) in the left background

Auto Body Shop – The space is mainly used by Network Collision Co. for auto-body repair and painting. The main floor area is used for staging the cars. Small locker rooms were used as a paint mixing area. Drums, buckets and pints of solvents (e.g. lacquer thinner, reducer, stripper etc.) and paints (e.g., acrylic, urethane primer etc.) are stored in storage spaces near the office and bathroom. Open containers of unknown liquid were observed inside the storage spaces. Several unlabeled drums also were noted during the site reconnaissance.

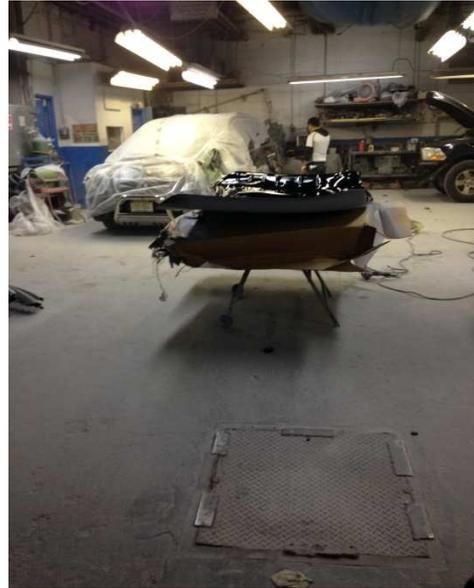
Photo 6: square-shaped floor drain in the middle of the main floor of the auto-body/collision

Auto Body Shop – One square-shaped floor drain was observed on the main floor of the auto body shop. The floor drain is reportedly connected to New York City’s sewer system.

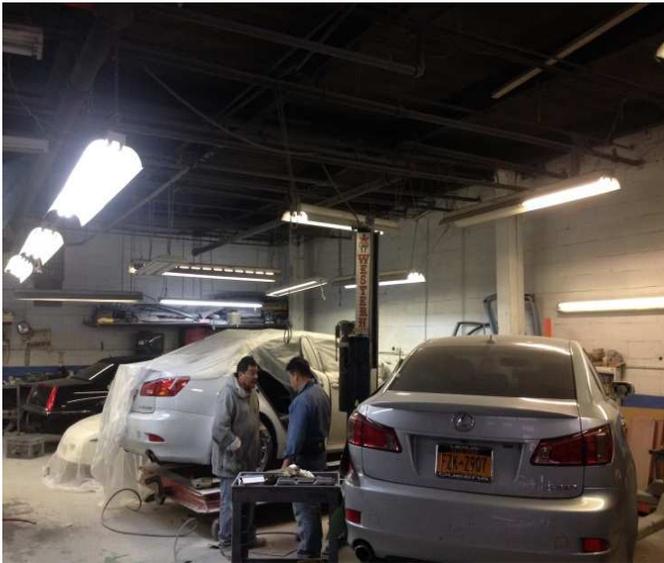
Photo 7: View of the main floor with the two hydraulic lifts in the foreground

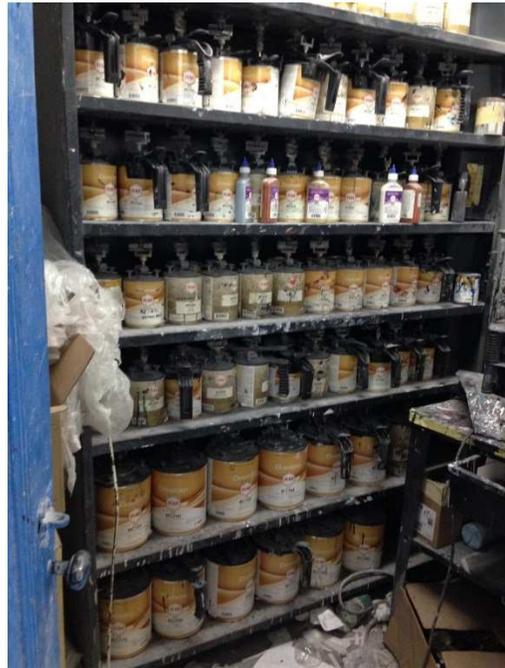
Photo 8: view inside the automatic refining and paint mixing machine room.

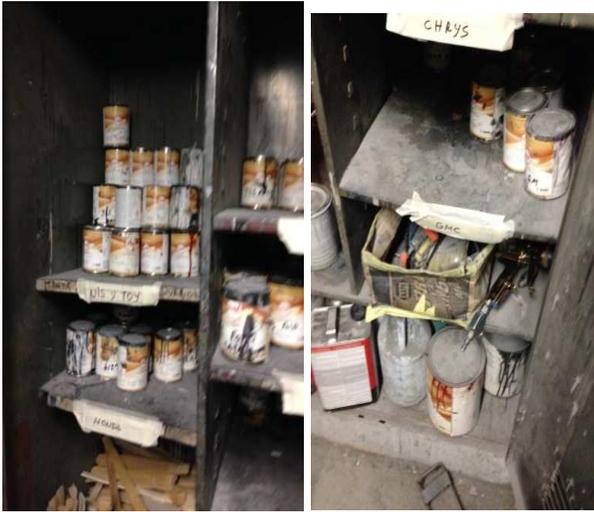
Photo 9: view inside the steel cabinets in the storage rooms.

Auto body Shop - More than a hundred pint-sized to gallon-sized containers of paint, paint thinners, car wash detergent, cleaning polish, car wax, reducer, and stripper solvents are stored in a steel cabinet located near the office. Three acetylene and oxygen tanks were located in the main floor detailing area. At least three unlabeled 55-gallon drums with unknown liquid were observed near the paint mixing area. An auto refinish automatic paint-mixing machine was located in a small room adjacent to the office. Evidence of historic paint releases was observed near the cabinet floors and the paint mixing area. The historic paint releases did not appear to be proximate to any of the floor drains, which according to Steven Feinberg are reportedly connected to New York City's sewer system.

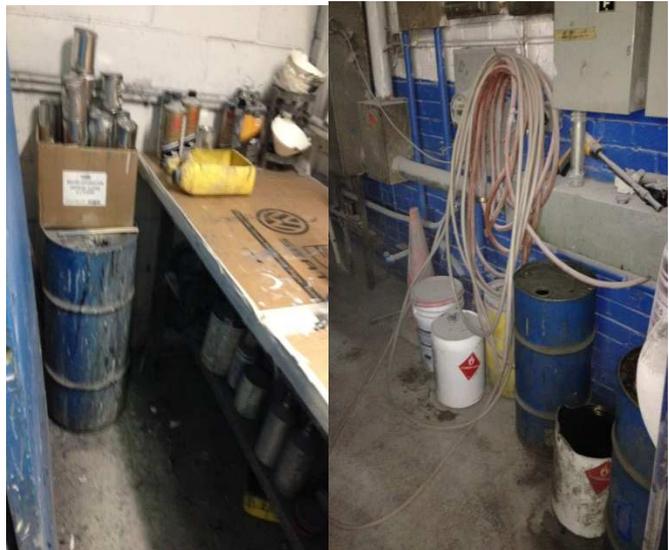
Photo 10: Unlabeled 55-gallon drums and buckets with paint containers right beside office wall.

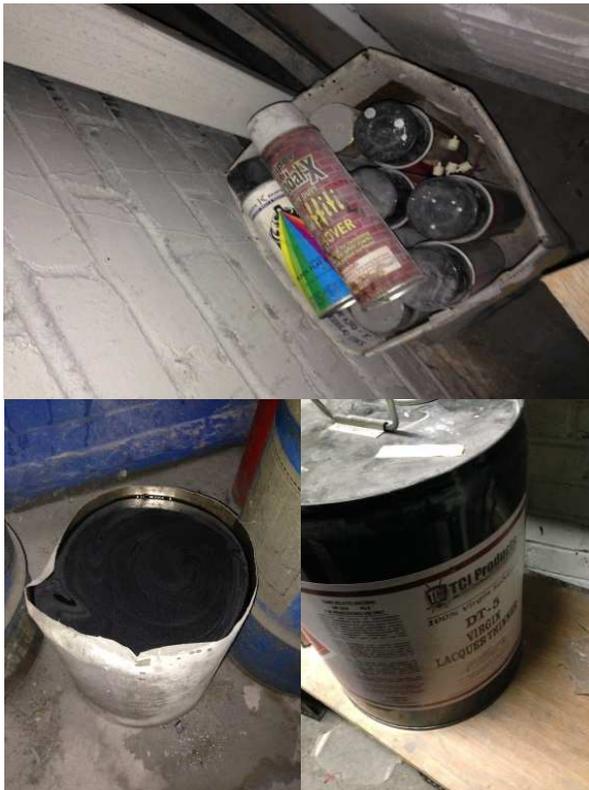
Photo 11: An open container with unknown liquid, lacquer thinner, and spray paints

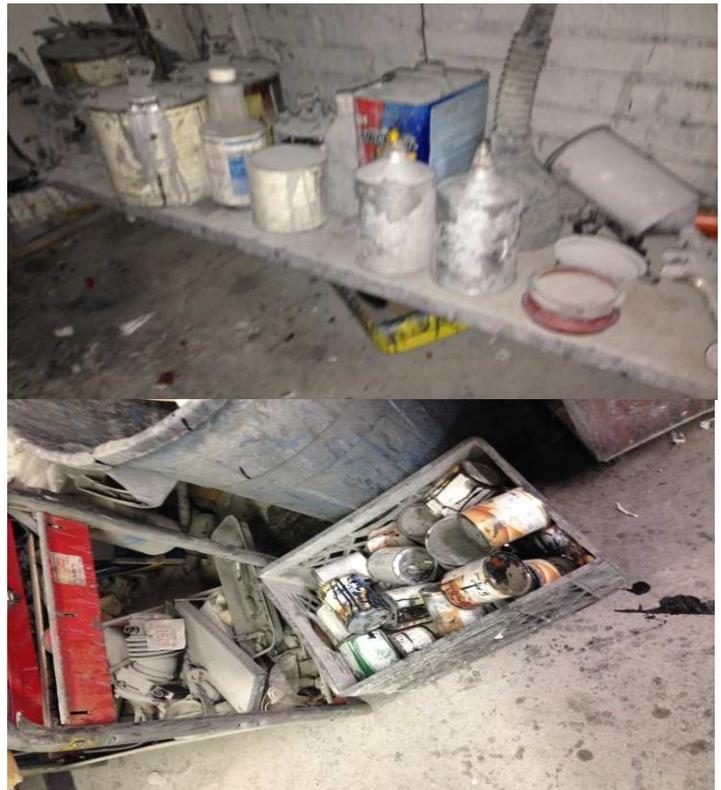
Photo 12: paint and solvent containers surround the main floor

Auto body Shop - Evidence of historic paint releases was observed near the cabinet floors and the paint mixing area. Fluid stains on the floor also were observed near the bathroom and office area.

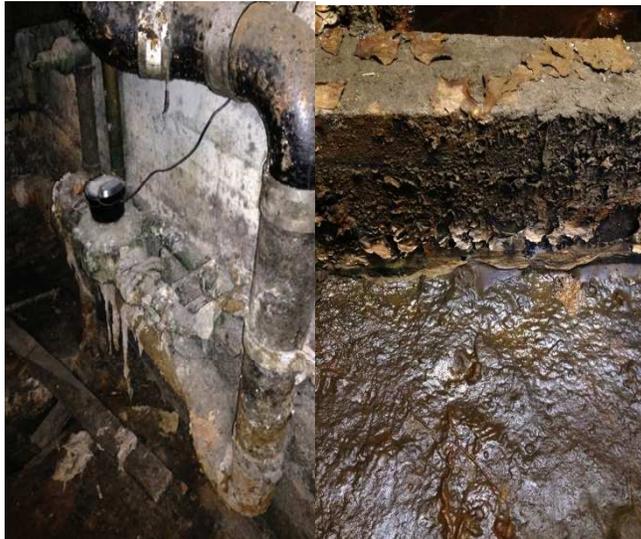
Cellar - Extensive staining was observed at the cellar floor. The boiler pipes were observed to be extensively corroded. GZA observed refuse and sewage material that indicated historic flooding from a backup in the sewer system.

Photo 13: Note evidence of flooding/ sewer backup of the cellar

Cellar – This space houses the boiler that heats the entire building at this address. Some staining was observed at the cellar floor although there were no indications of breaches or breaks in the slab. GZA observed refuse and sewage material that indicated historic flooding from a backup in the sewer system. Steven Feinberg indicated there was a recent sewer line backup in the cellar.

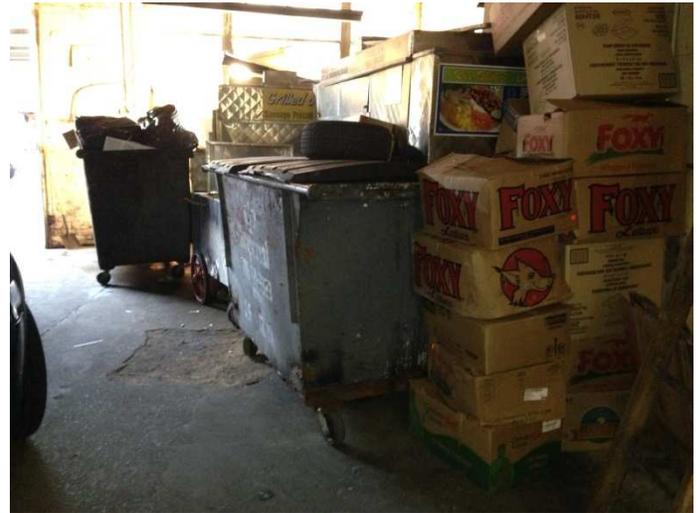
Steven Feinberg indicated that hazardous waste is not generated from any areas within the facility at this address. Dumpsters for municipal waste collection and storage are located to the left as one enters the south bay door, which is the common entrance to the food cart preparation and food cart manufacturing area.

Photo 15: Dumpsters near the south bay door for municipal waste. Note the cement floor patch – previous UST location

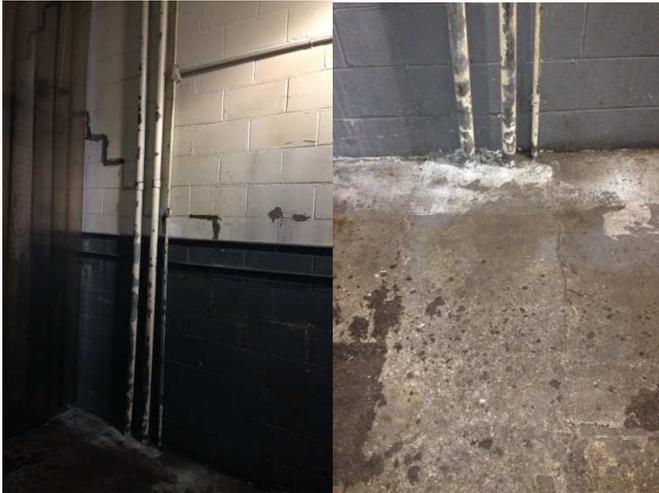
GZA observed a cement floor patch near the south bay door (the common entrance to the food cart preparation and food cart manufacturing areas) that was consistent with a patch resulting from in-place abandonment of a UST. Two vertical exhaust pipes were located on the common partition wall with the auto body shop (the center hallway to the food cart space). The location of the USTs and the vertical exhaust pipe is presented on **Figure 2**. Steven Feinberg explained that two 4,000-gallon USTs were closed in-place at this location in the 1990s.

Photo 16: – Floor patch and vent pipes from historical USTs

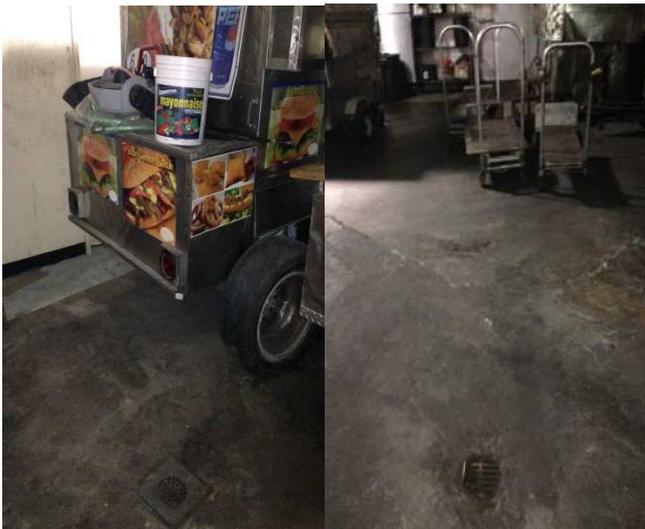
Food Cart Preparation and Refrigeration Area – GZA observed two floor drains located in the main floor of the food cart preparation and refrigeration area, and based on the floor cuts, the floor drains are believed to be connected by a pipe that diagonally traverses the site. A drainage trench covered by steel plates is located adjacent to the north wall of the area. According to Steven Feinberg, these floor drains reportedly discharge to New York City’s sewer system. A small sump also was observed near the entrance to the refrigeration area.

Photo 18: Floor drains in the main floor

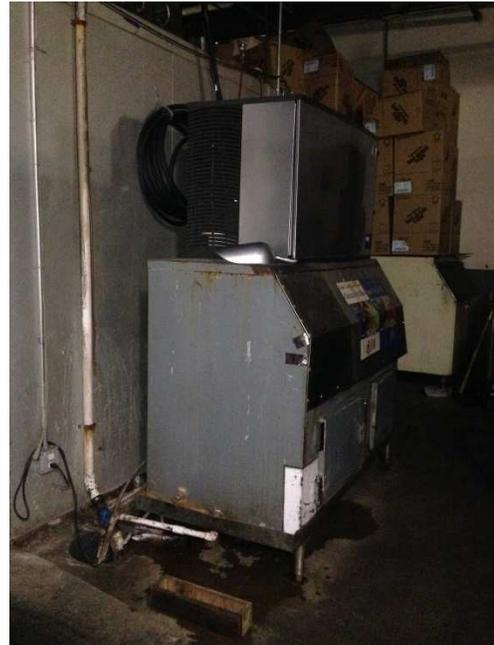
Photo 19: View of small sump/ drain near the refrigeration area

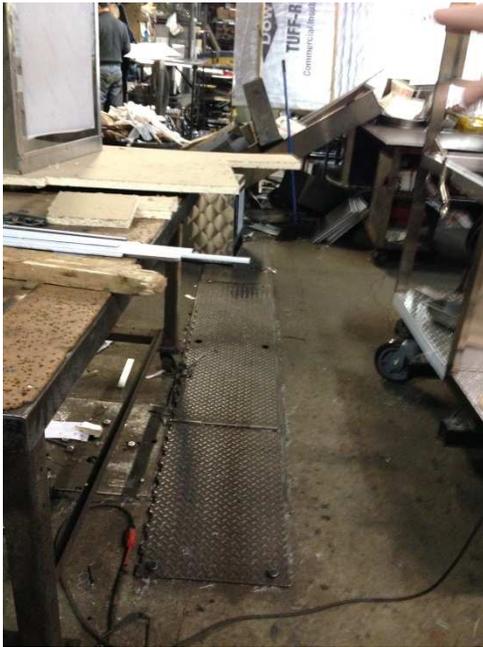
Food Cart Manufacturing Area – GZA observed linear floor drains on the main floor of the food cart manufacturing area. The drains are covered by steel grates/plates. According to Steven Feinberg, these floor drains reportedly are connected to New York City’s sewer system.

Photo 22: View of linear floor drains

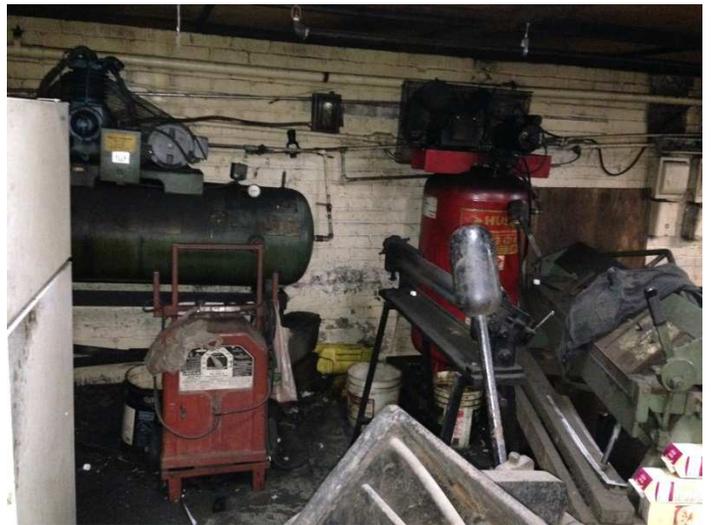
Food Cart Manufacturing Area - GZA observed one unlabeled 55-gallon drum near the compressor on the southeast section of the food cart manufacturing area. Open containers of unknown liquid also were observed adjacent to the compressor.

Photo 23: View of two compressors located at the southeast corner of the food cart manufacturing area.

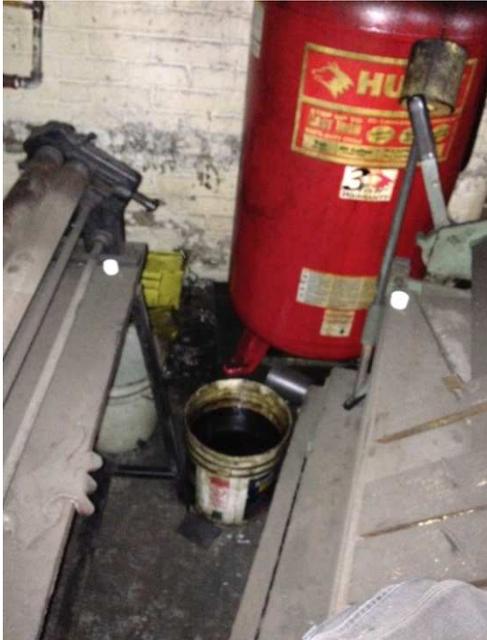
Food Cart Manufacturing Area – Extensive oily stains and an accumulation of a petroleum-like thickness were observed around the compressor area.

Photo 24: Closer view of compressor surrounded by open container

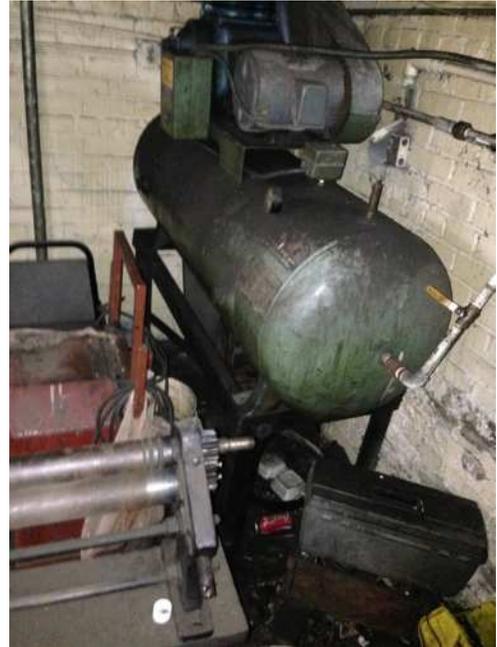
Food Cart Manufacturing Area –An old abandoned compressor was located adjacent to the current compressor. According to Steven Feinberg, the compressor has not been utilized since the food cart manufacturing company occupied the area. Some staining was observed around the old compressor, but we did not observe any obvious pathway through the concrete floor slab.

Photo 25: View of old compressor with floor stains around the base.

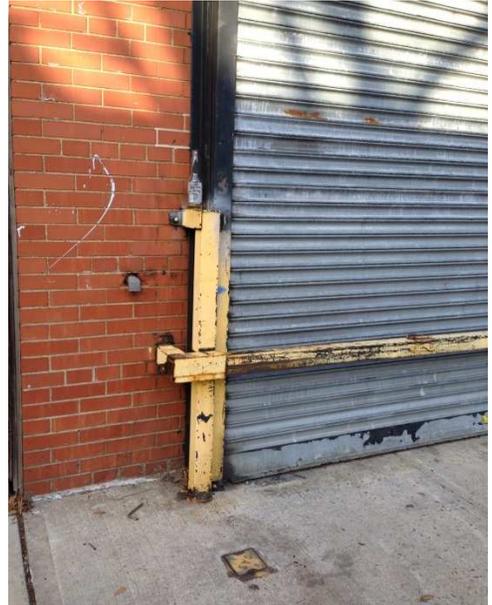
A vent line for a former AST was observed on the exterior of the 37-36 32nd Street building. The AST was identified by Mr. Cosma as an AST that supplied fuel oil to the former oil-fired boiler, which is referenced in the Preliminary Environmental Site Screening Report. The fill port referenced in Section 6.10.1 might be associated with the former AST. No ASTs were observed on the exterior portions of the remainder of the site.

Photo 29: View of old fill port and historic AST vent pipe beside north garage bay door

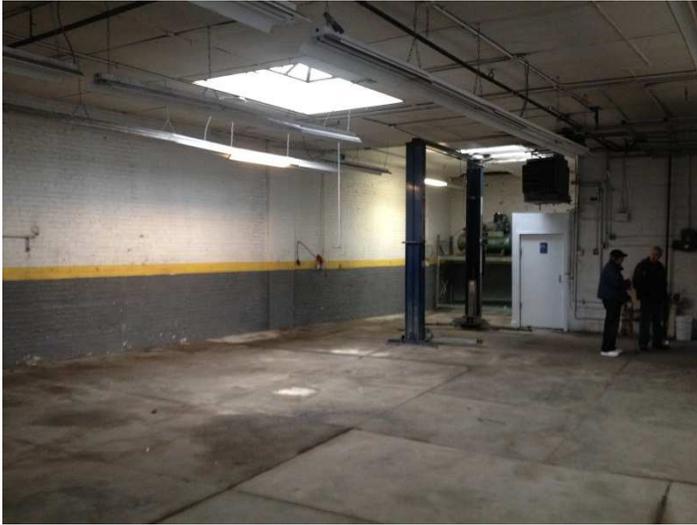
Street Level - At the time of GZA's site reconnaissance, this building was unoccupied. Evidence of the previous use as an auto body shop and auto service garage was still apparent. One hydraulic lift was located at the main floor and an unlabeled drum and open container were located near the entrance to the site. No evidence of discharge was observed. There were no indications of where the hydraulic tank(s) might have been located.

Photo 43: View inside garage facing northwest, Note the old hydraulic lift and old compressor in the background

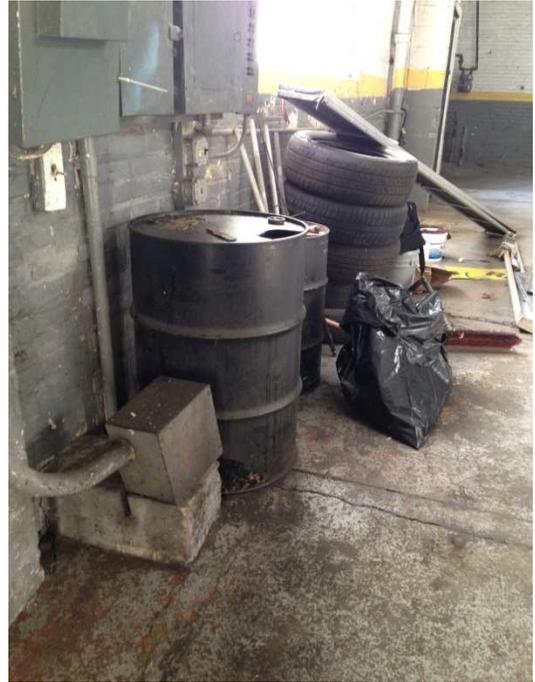
Street Level - Two unlabeled 55-gallon drums were located near the east wall of the site between the two bay doors. A bucket with unknown liquid also was observed.

Fluid stains were observed in the main floor area of the site. Evidence of oily stains near the 55-gallon drums and open container also were observed. However, no visible cracks were evident in the floor slab.

Photo 45: View of unlabeled 55-gallon drum with open containers.

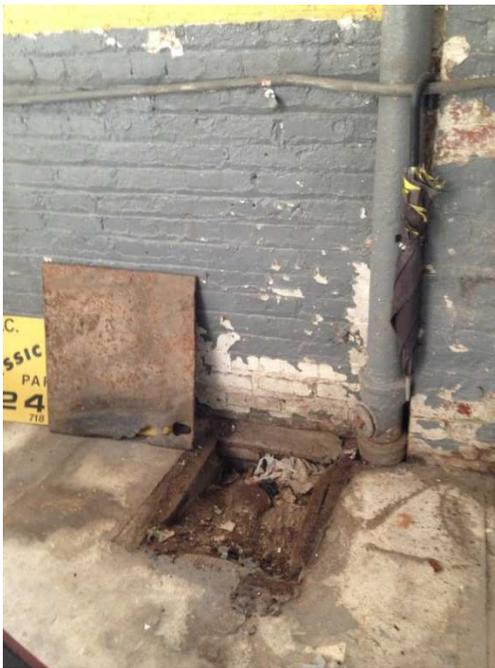
Photo 46: Closer view of sump

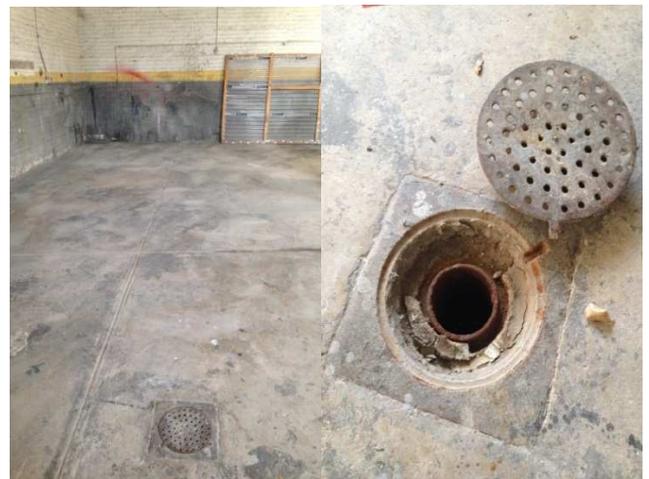
Photo 47: View of floor drain

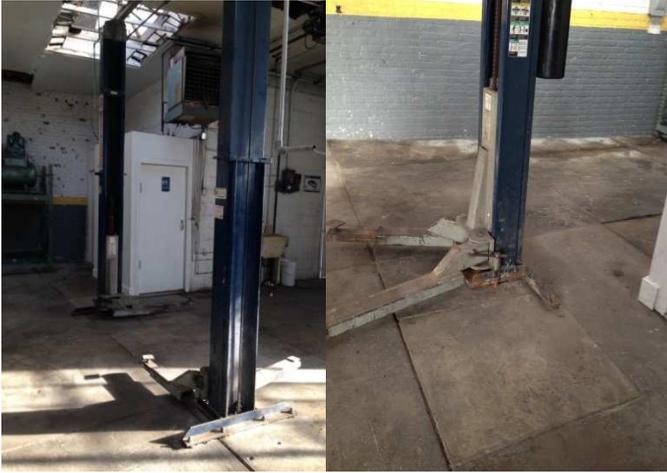
Photo 48: View of hydraulic lift and the closer view of floor patch (location of historic UST).

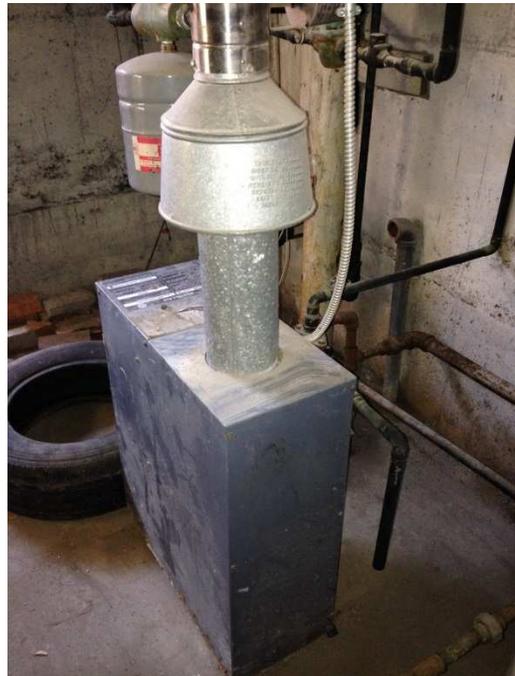
Cellar - A small cellar was located north of the site with the egress/ingress located from a steel hatch in the sidewalk along 32nd Street. The cellar housed the boiler that heats the building at this address. GZA did not observe any evidence of release or staining in this area.

Photo 51: View of boiler inside cellar

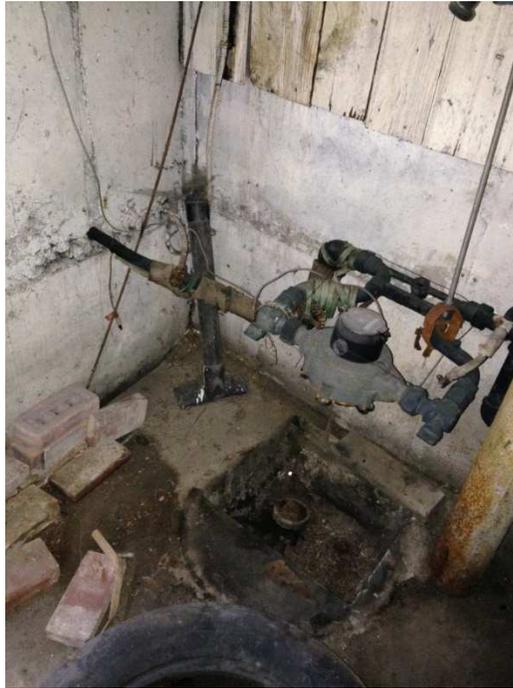
Cellar - Some staining was observed on the cellar floors and walls, but the type of stain and its source were not evident.

Photo 50: View inside cellar
