131 BERRY STREET

BROOKLYN, NEW YORK

Remedial Investigation Report

NYC OER Site Number: 13CVCP112K

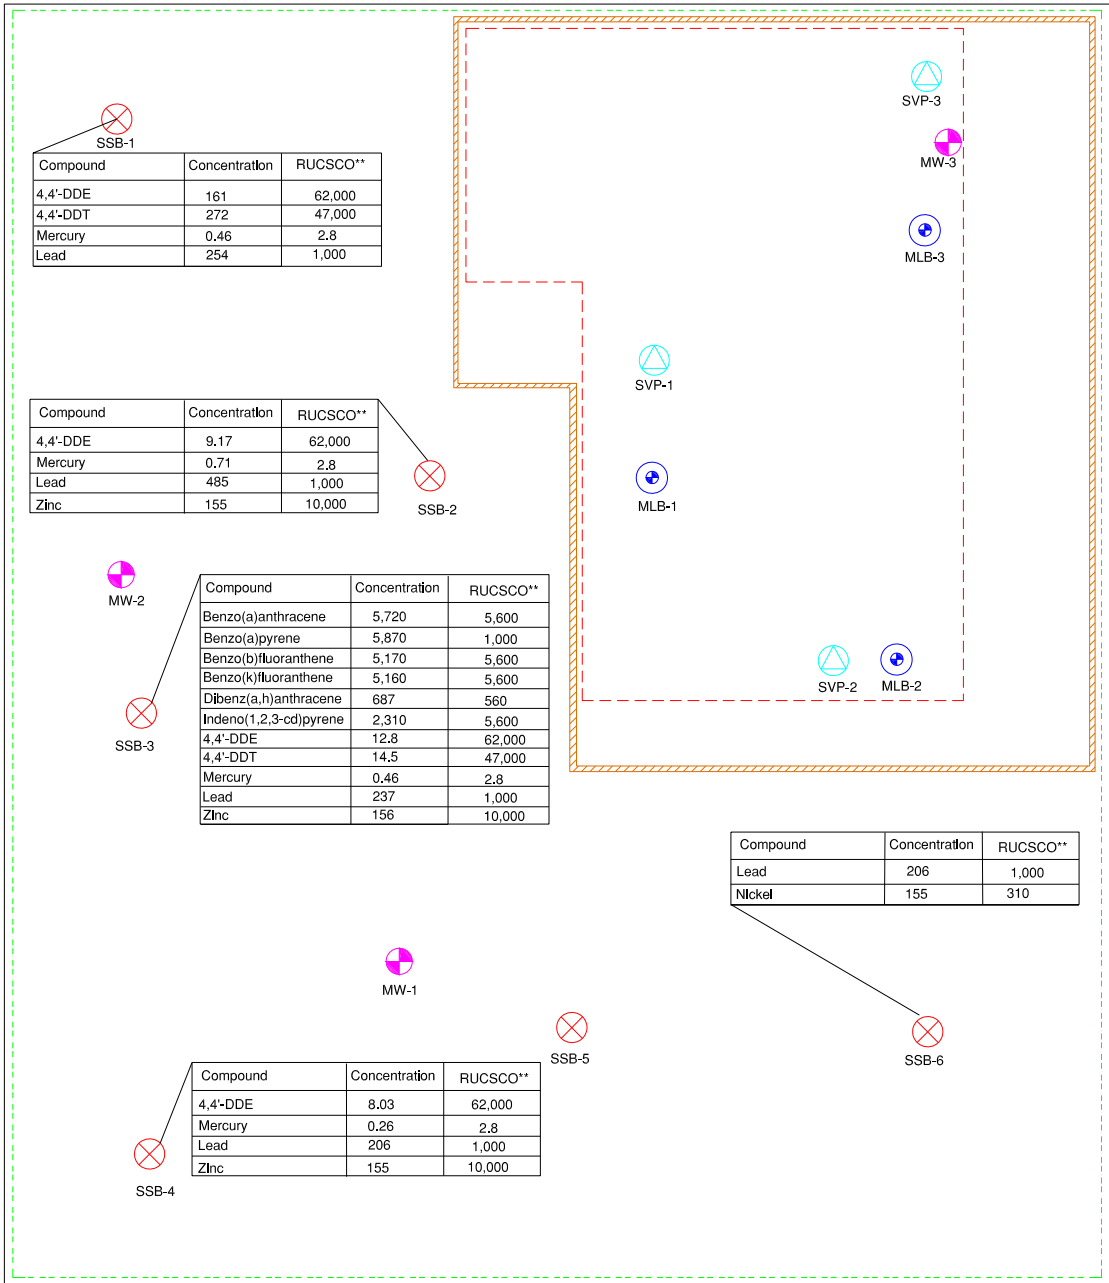
Compound	Concentration	RUCSCO**
4,4'-DDE	161	62,000
4,4'-DDT	272	47,000
Mercury	0.46	2.8
Lead	254	1,000

Compound	Concentration	RUCSCO**
4,4'-DDE	9.17	62,000
Mercury	0.71	2.8
Lead	485	1,000
Zinc	155	10,000

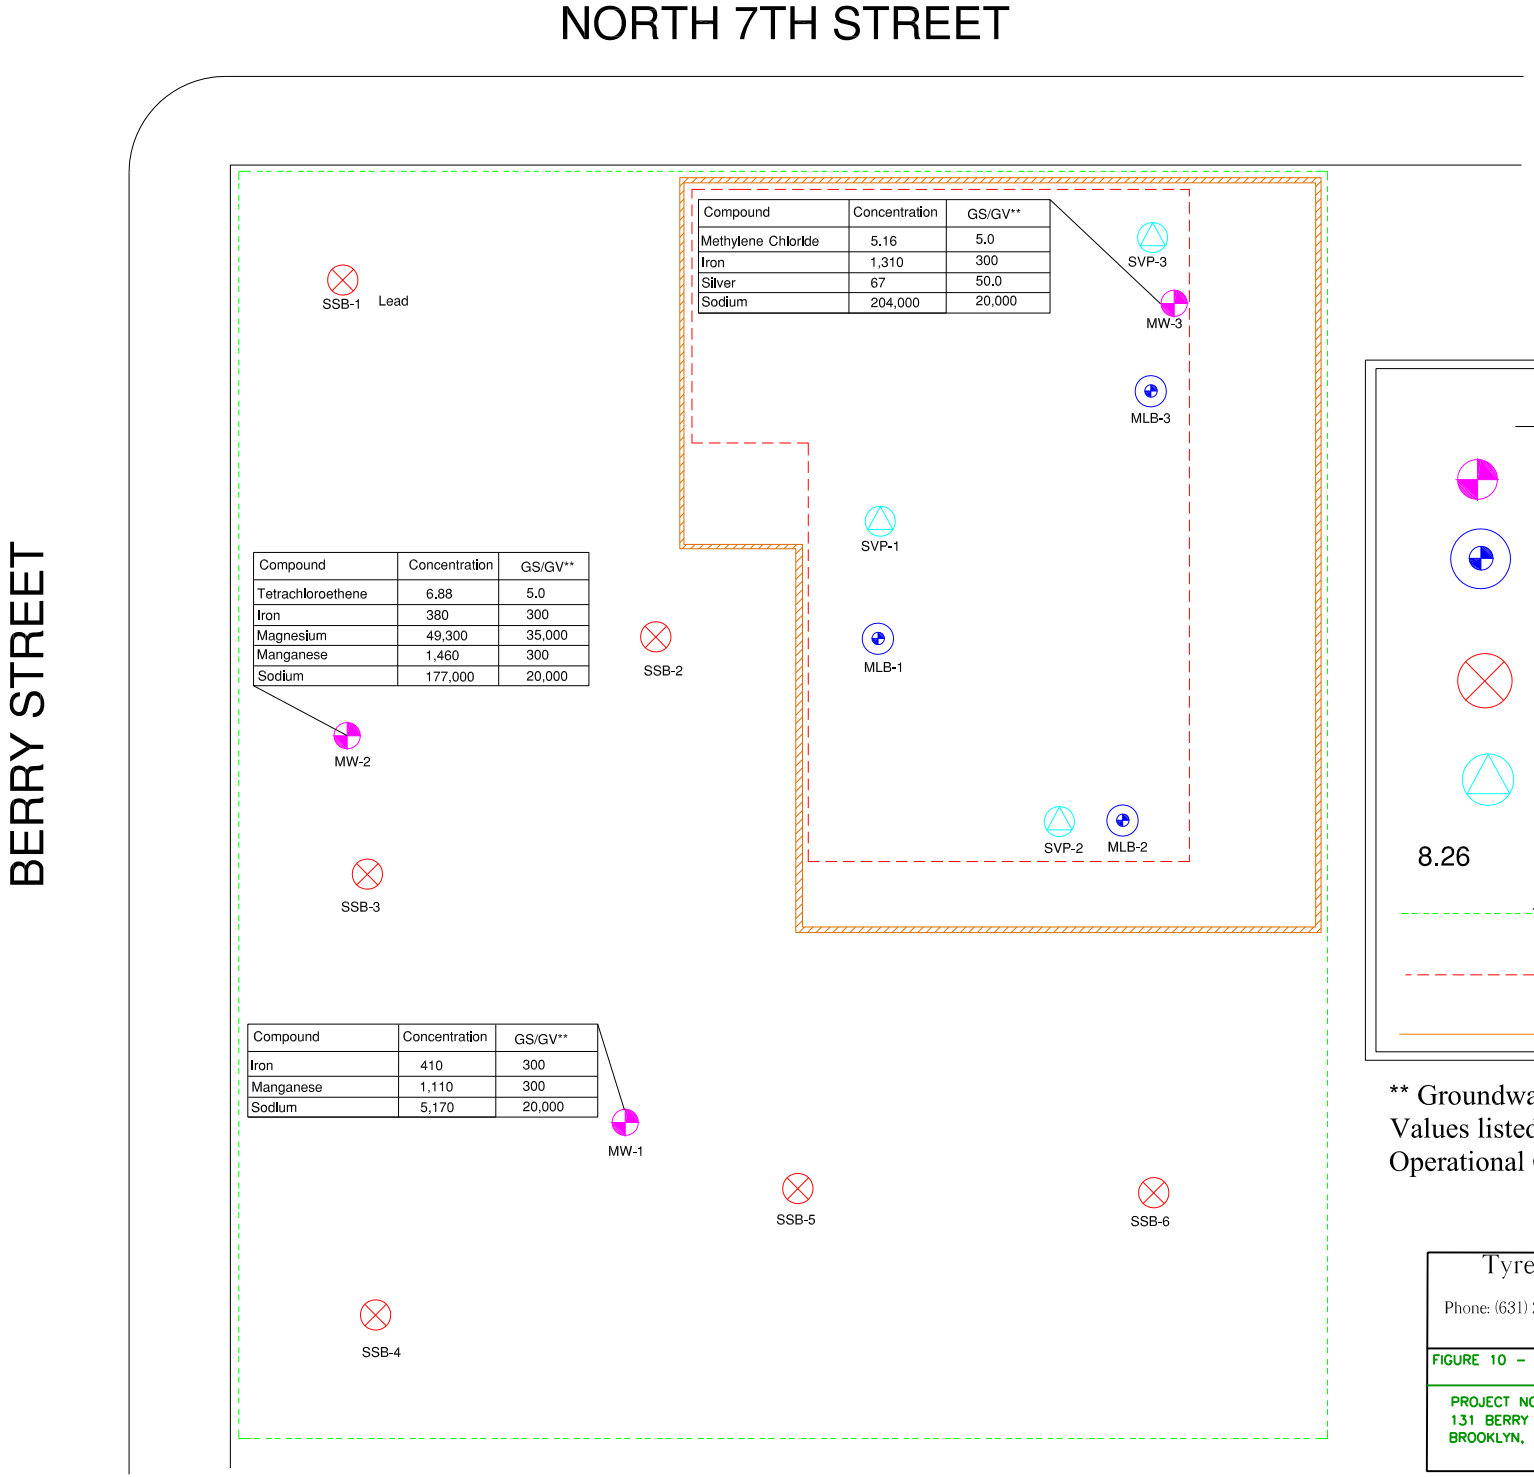
Compound	Concentration	GS/GV**
Methylene Chloride	5.16	5.0
Iron	1,310	300
Silver	67	50.0
Sodium	204,000	20,000

Compound	Concentration	GS/GV**
Tetrachloroethene	6.88	5.0
Iron	380	300
Magnesium	49,300	35,000
Manganese	1,460	300
Sodium	177,000	20,000

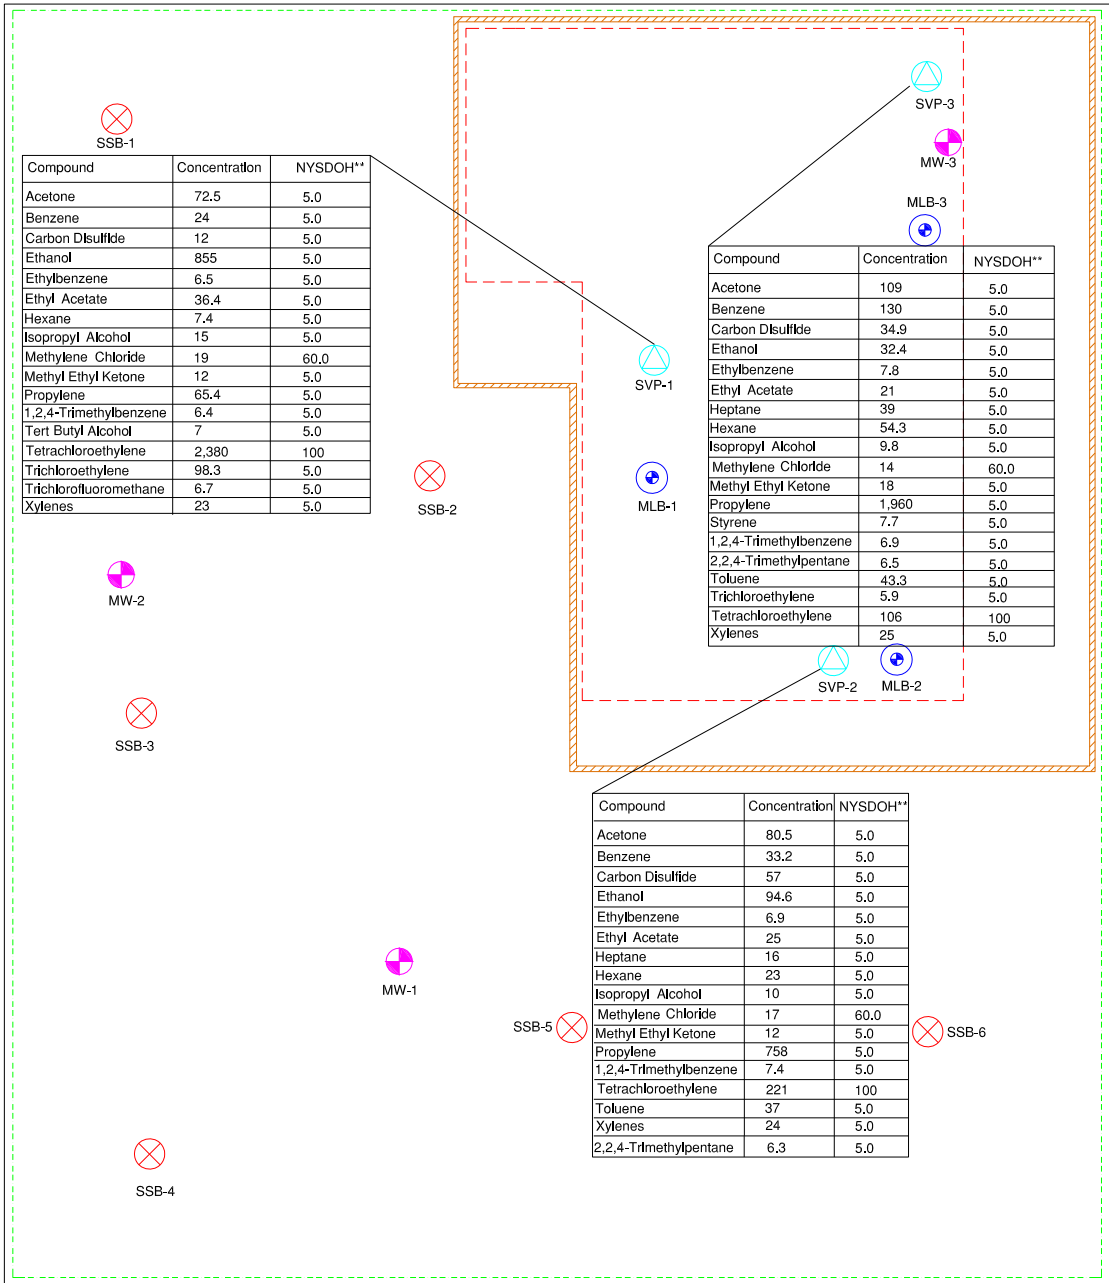
Compound	Concentration	NYSDOH**
Acetone	72.5	5.0
Benzene	24	5.0
Carbon Disulfide	12	5.0
Ethanol	855	5.0
Ethylbenzene	6.5	5.0
Ethyl Acetate	36.4	5.0
Hexane	7.4	5.0
Isopropyl Alcohol	15	5.0
Methylene Chloride	19	60.0
Methyl Ethyl Ketone	12	5.0
Propylene	65.4	5.0
1,2,4-Trimethylbenzene	6.4	5.0
Tert Butyl Alcohol	7	5.0
Tetrachloroethylene	2,380	100
Trichloroethylene	98.3	5.0
Trichlorofluoromethane	6.7	5.0
Xylenes	23	5.0

Compound	Concentration	NYSDOH**
Acetone	109	5.0
Benzene	130	5.0
Carbon Disulfide	34.9	5.0
Ethanol	32.4	5.0
Ethylbenzene	7.8	5.0
Ethyl Acetate	21	5.0
Heptane	39	5.0
Hexane	54.3	5.0
Isopropyl Alcohol	9.8	5.0
Methylene Chloride	14	60.0
Methyl Ethyl Ketone	18	5.0
Propylene	1,960	5.0
Styrene	7.7	5.0
1,2,4-Trimethylbenzene	6.9	5.0
2,2,4-Trimethylpentane	6.5	5.0
Toluene	43.3	5.0
Trichloroethylene	5.9	5.0
Tetrachloroethylene	106	100
Xylenes	25	5.0
