FIGURE 1
SITE LOCATION MAP
CHURCH AVENUE
2244 CHURCH AVENUE
BROOKLYN, NEW YORK

FIGURE 2
SITE PLAN

2244 CHURCH AVENUE
BROOKLYN, NEW YORK

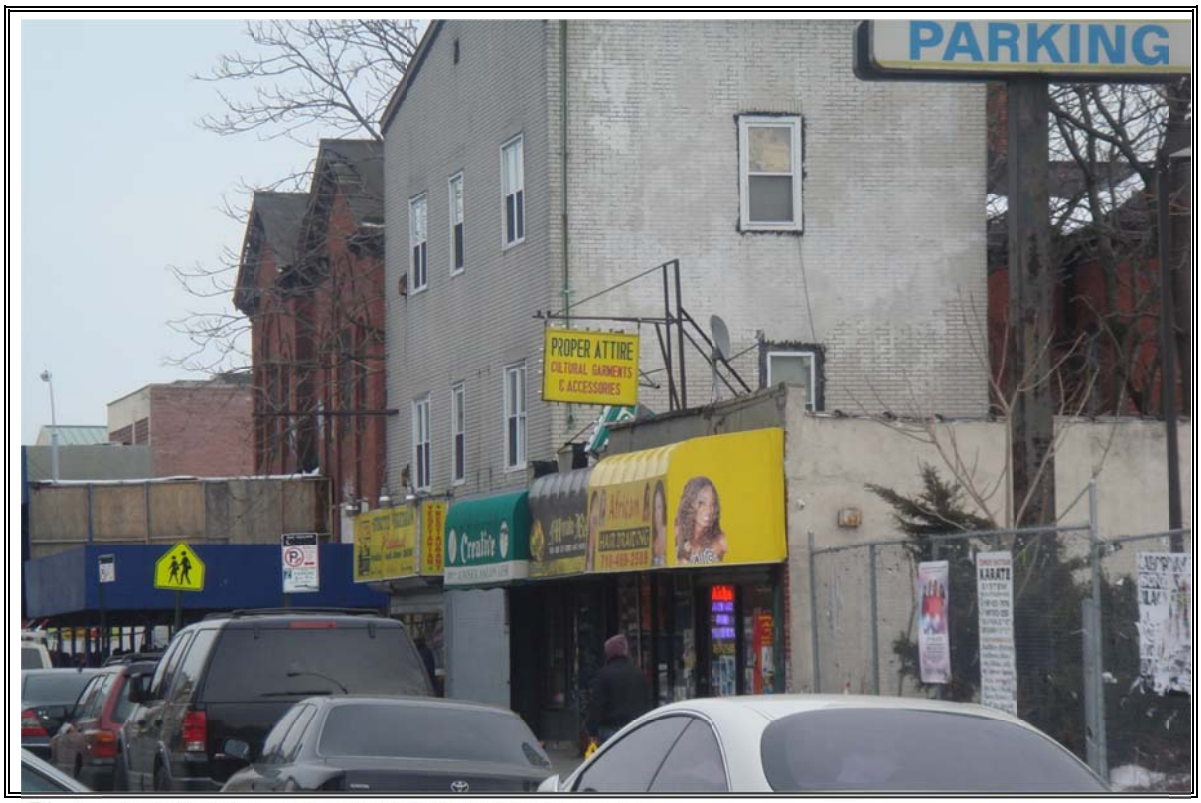
Photograph Number 7: Property located to the east
